HISTORIC PRESERVATION REVIEW APPLICATION

Property Development Name: 626 NORTH 6TH AVENUE

626 NORTH 6TH AVENUE
HPZ PACKAGE
T21DV00835

Brief Description of Proposed Work: REPLACE WINDOWS, ENCLOSE GARAGE DOOR OPENING

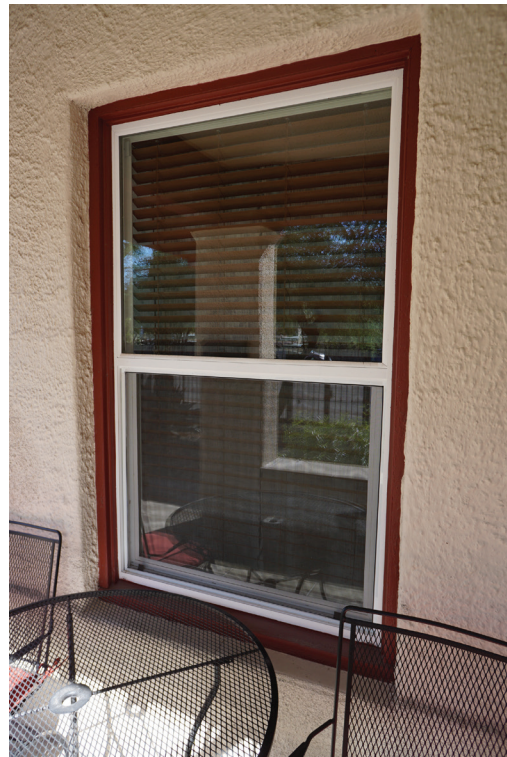
REPLACED
ORIGINAL: WOOD SINGLE HUNG, 1/1
NEW: VINYL SINGLE HUNG, 1/1

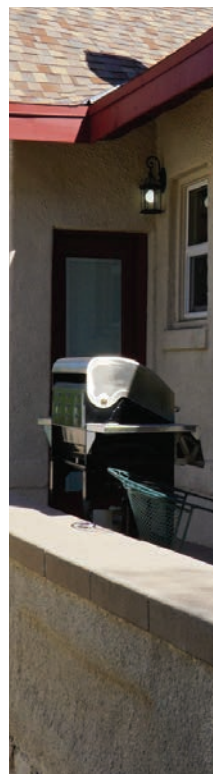
REPLACED DOOR
ORIGINAL: BOARDED UP PLYWOOD
NEW: WOOD, SINGLE LITE

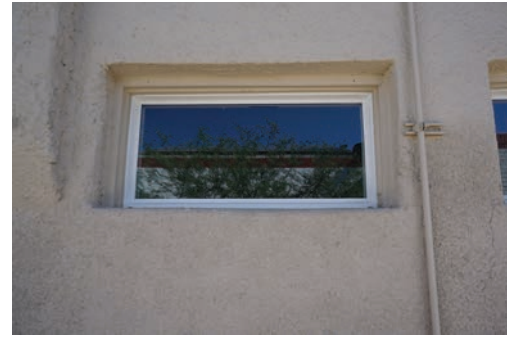
REPLACED
ORIGINAL: WOOD SINGLE HUNG, 1/1
NEW: VINYL FIXED PICTURE

In two openings, fixed windows replaced single hung wood windows. The openings had AC units that caused extensive damage to the wood windows and frames. The interior space is a kitchen, so the owner made the sill height higher.

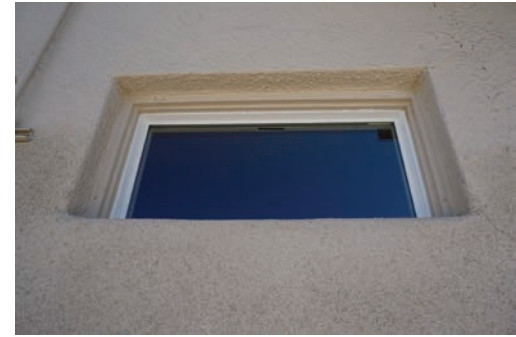
EXISTING
ORIGINAL: WOOD SINGLE HUNG, 1/1
NEW: VINYL FIXED PICTURE

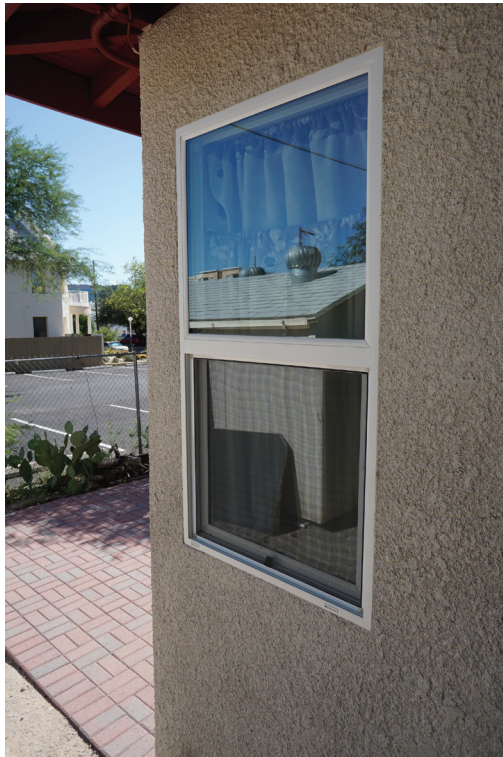
REPLACED
ORIGINAL: WOOD SINGLE HUNG, 1/1
NEW: VINYL SINGLE HUNG, 1/1

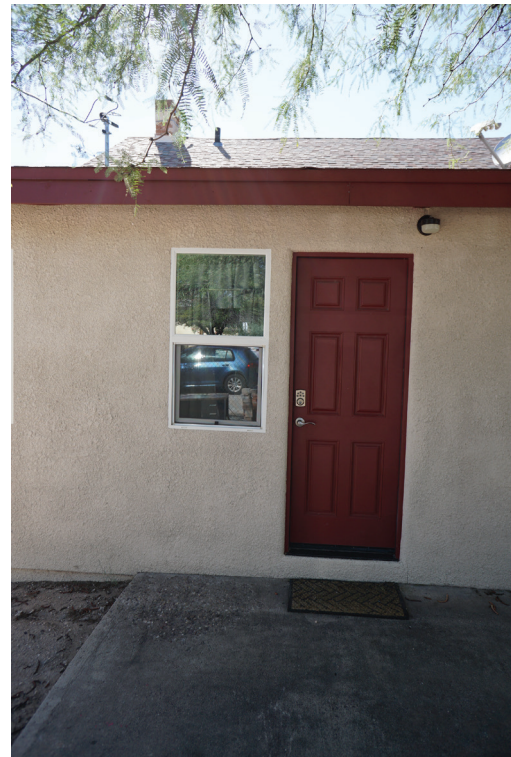
REPLACED
ORIGINAL: WOOD SINGLE HUNG, 1/1
NEW: VINYL SINGLE HUNG, 1/1
DOOR REPLACED
ORIGINAL: WOOD
NEW: WOOD

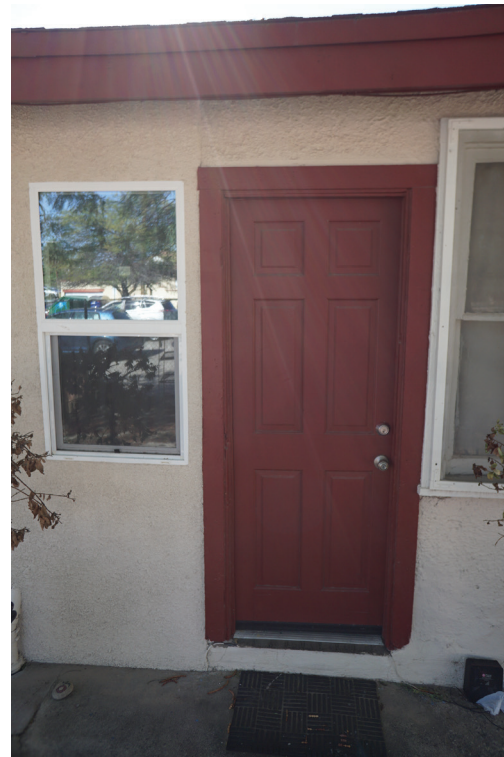
REPLACED
ORIGINAL: WOOD SINGLE HUNG, 1/1
NEW: VINYL SINGLE HUNG, 1/1
DOOR IS EXISTING, NOT REPLACED

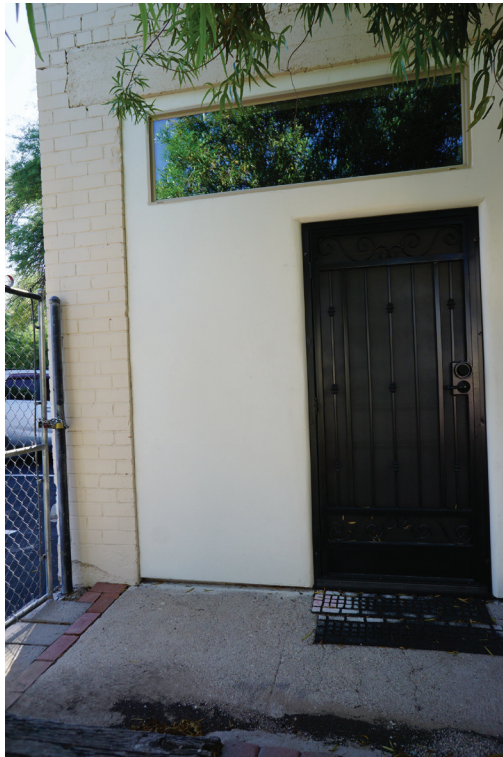
REPLACED
 ORIGINAL: WOOD FIXED, PICTURE
 NEW: VINYL FIXED, PICTURE
 DOOR REPLACED
 ORIGINAL: HOLLOW CORE WOOD
 NEW: SOLID CORE WOOD

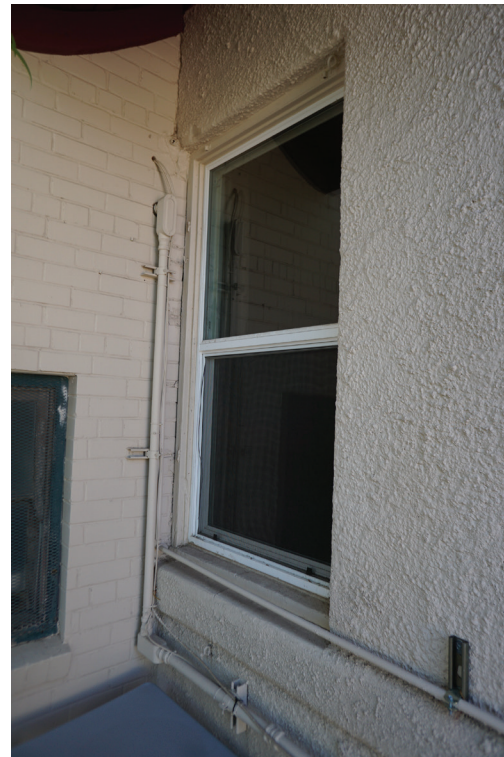
REPLACED
 ORIGINAL: WOOD SINGLE HUNG, 1/1
 NEW: VINYL SINGLE HUNG, 1/1

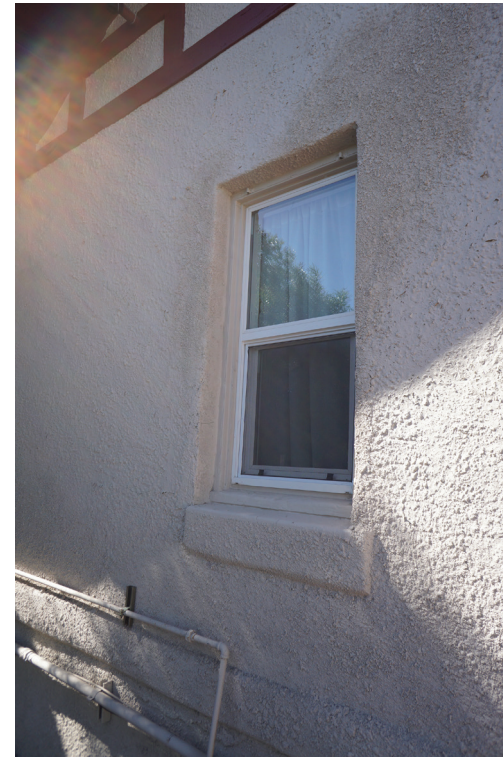
REPLACED
 ORIGINAL: WOOD SINGLE HUNG, 1/1
 NEW: VINYL SINGLE HUNG, 1/1

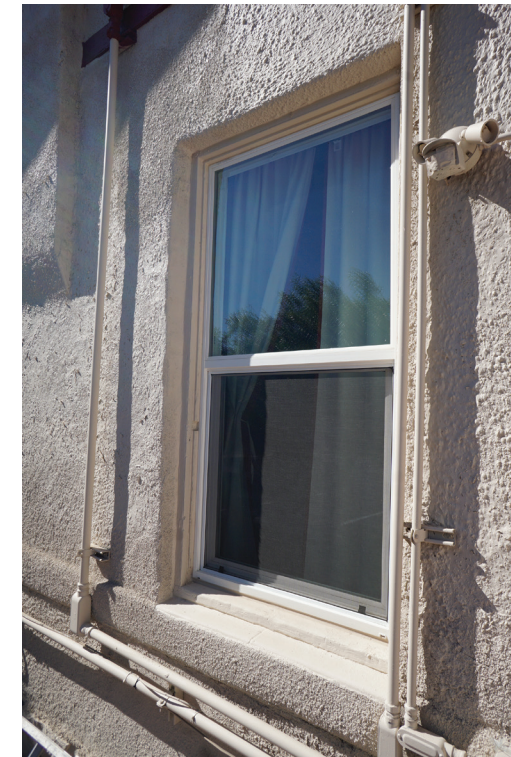
REPLACED
 ORIGINAL: WOOD SINGLE HUNG, 1/1
 NEW: VINYL SINGLE HUNG, 1/1

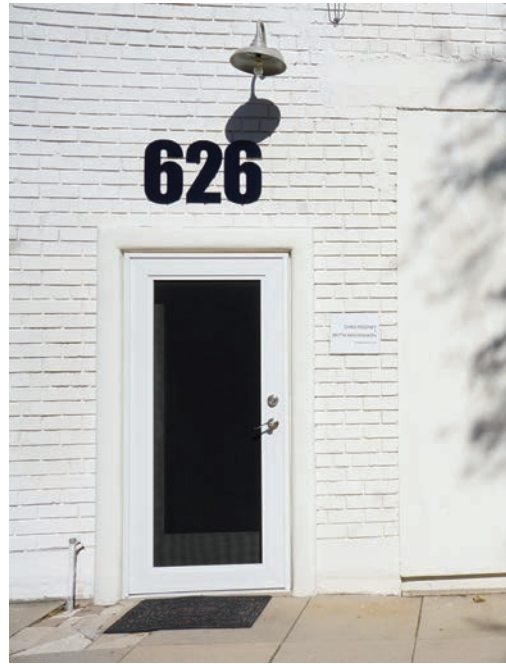
REPLACED
ORIGINAL: WOOD SINGLE HUNG, 1/1
NEW: ALUM CLAD WOOD DOOR

An existing window opening was replaced with a door on the west facade. The width of the opening and rhythm of the facade was not altered.

The replacement door is located in an existing window opening on the west facade of the incompatible addition. The door is commercial grade aluminum door with a single, centered lite. A stucco reveal was placed around the door opening.

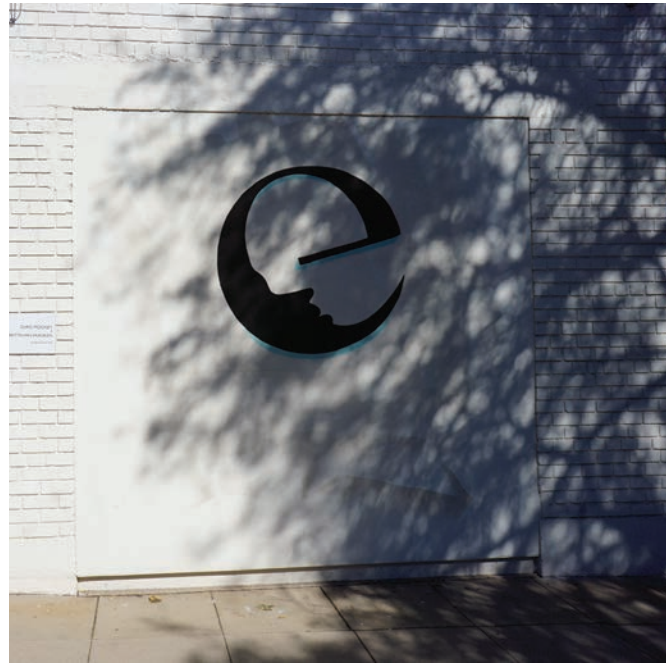
REPLACED
ORIGINAL: OVERHEAD GARAGE DOOR
NEW: STUCCO FINISH WOOD FRAME
WALL

The garage door opening, which is situated in a structure that was identified as "ruining" the architectural integrity of the property, is replaced with a solid stucco surface. The opening dimensions are apparent because the material is differentiated from the surface of the brick building.

The garage door opening was enclosed and door replaced a window on the west facade. It is arguable if the garage door opening is considered a character defining feature because the entire addition in which it is situated "ruined" the architectural integrity of the original bungalow.
