HISTORIC PROPERTY INVENTORY FORM

For Properties identified through survey: Site No. 091 Survey Area Barrio El Hoyo

Address 522 W. 17th St.

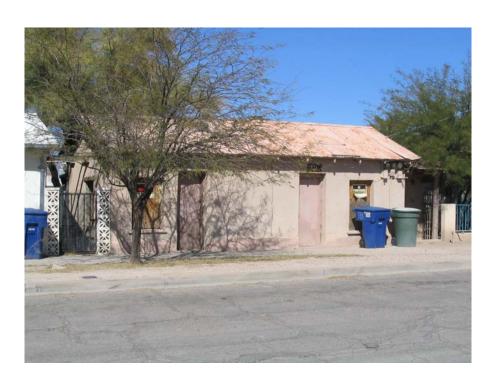
Negative No. Roll A3/Frame 153

[x] Fair (some problems apparent) Describe: currently uninhabited, needs maintenance.

Date of photo February 2007

View/Direction (looking towards) N

B. PERSONS List and describe persons with an important association with the building.
None.
C. ARCHITECTURE. Style Sonoran Tradition [] no style
Stories 1 [] Basement Roof form gabled
Describe other character-defining features of its massing, size, scale
The dwelling consists of a linear block of contiguous rooms; it is modest in size and scale, like its neighbors.
INTEGRITY To be eligible for the National Register, a property must have integrity, i.e., it must be able to visually convey its importance. The outline below lists some important aspects of integrity. Fill in the blanks with as detailed a description of the property as possible.
LOCATION. [x] Original site [] Moved: date original site
DESIGN. Describe alterations from the original design, including dates
None.
MATERIALS. Describe the materials used in the following elements of the property.
Walls (structure) adobe brick Walls (sheathing) stucco

Windows wood Describe window structure double-hung sash
Roof corrugated metal Foundation stone masonry
SETTING. Describe the natural and/or built environment around the property
The front of the dwelling is flush with the City right-of-way (zero lot line).
How has the environment changed since the property was constructed?
The south side of the street was formerly residential, but is now occupied by the expanded facilities of Tucson Water.
WORKMANSHIP. Describe the distinctive elements, if any, of craftsmanship or method of construction
The dwelling's construction, using traditional, inexpensive materials, is typical of the neighborhood.
NATIONAL REGISTER STATUS (if listed, check the appropriate box)
[] Individually listed; [] Contributor [] Noncontributor to Historic District
Date listed: [] Determined eligible by Keeper of National Register (date)
RECOMMENDATIONS ON NATIONAL REGISTER ELIGIBILITY (opinion of SHPO staff or survey consultant)
