MAIN HOUSE FLOOR PLANS AND NOTES

ALTERATIONS AT 825 N 3RD AVE TUCSON, AZ 85705

GENERAL ELEVATION AND OBLIQUE PHOTOS

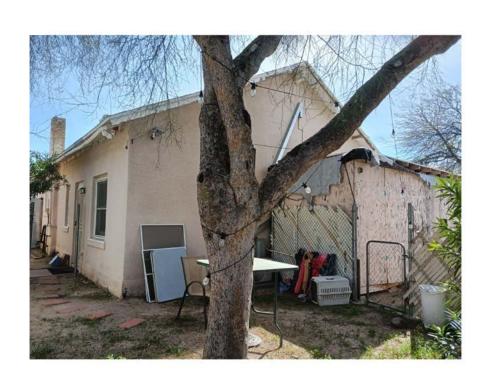
#7 NW corner (Note unattached plywood shed to be demolished)

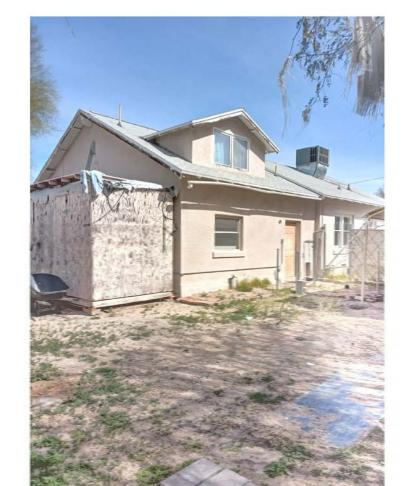
#8 SW corner (Note Unattached plywood shed to be demolished

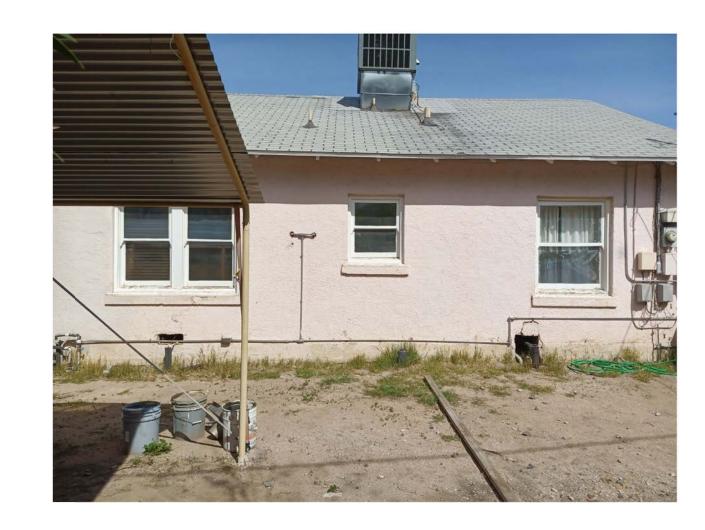
#9 South face of Main House (Note corner of metal carport in foreground to be removed)

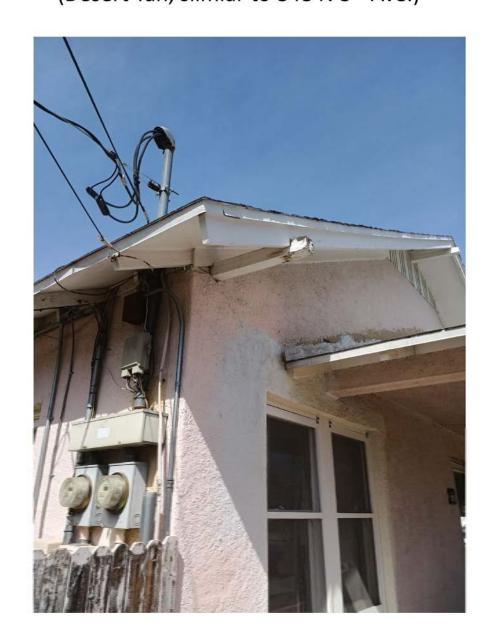
#1 Repair sagging brace

Tear of and replace existing asphalt shingles, installing OwensCorning LandMark 30 year Architectural Shingles (Desert Tan, siimlar to 848 N 3rd Ave.)

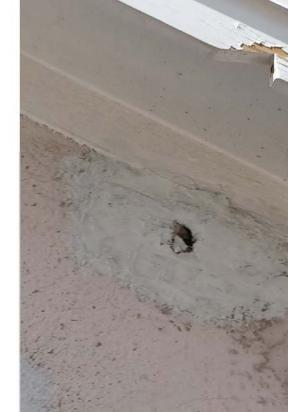
#3 Replace missing brace

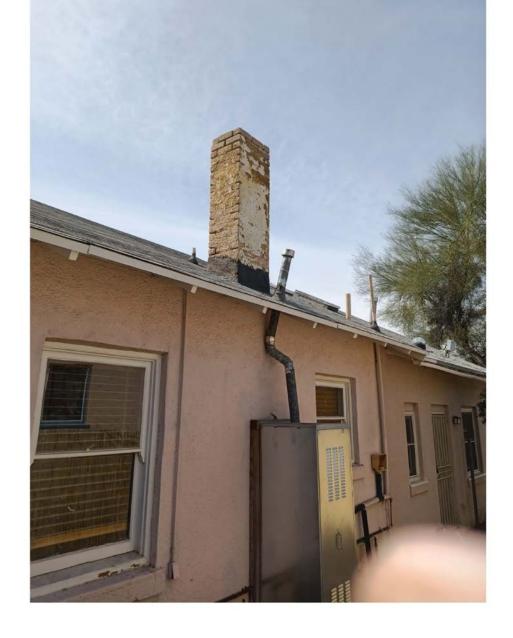
#4 Remove Existing stucco-brick chimney to ground, creating interior space for WH. Replace with stucco-framing chimney to match original.
