National Register of Historic Places Registration Form

Historic name: University of Arizona Campus Agricultural Center
 Other names/site number: Campus Farm, Campbell Avenue Farm, University Farm; University Campus Farm Complex
 Name of related multiple property listing:
N/A
 (Enter "N/A" if property is not part of a multiple property listing)

Street & number: 4101 N. Campbell Avenue
 City or town: Tucson State: Arizona County: Pima County
 Not For Publication: Vicinity:

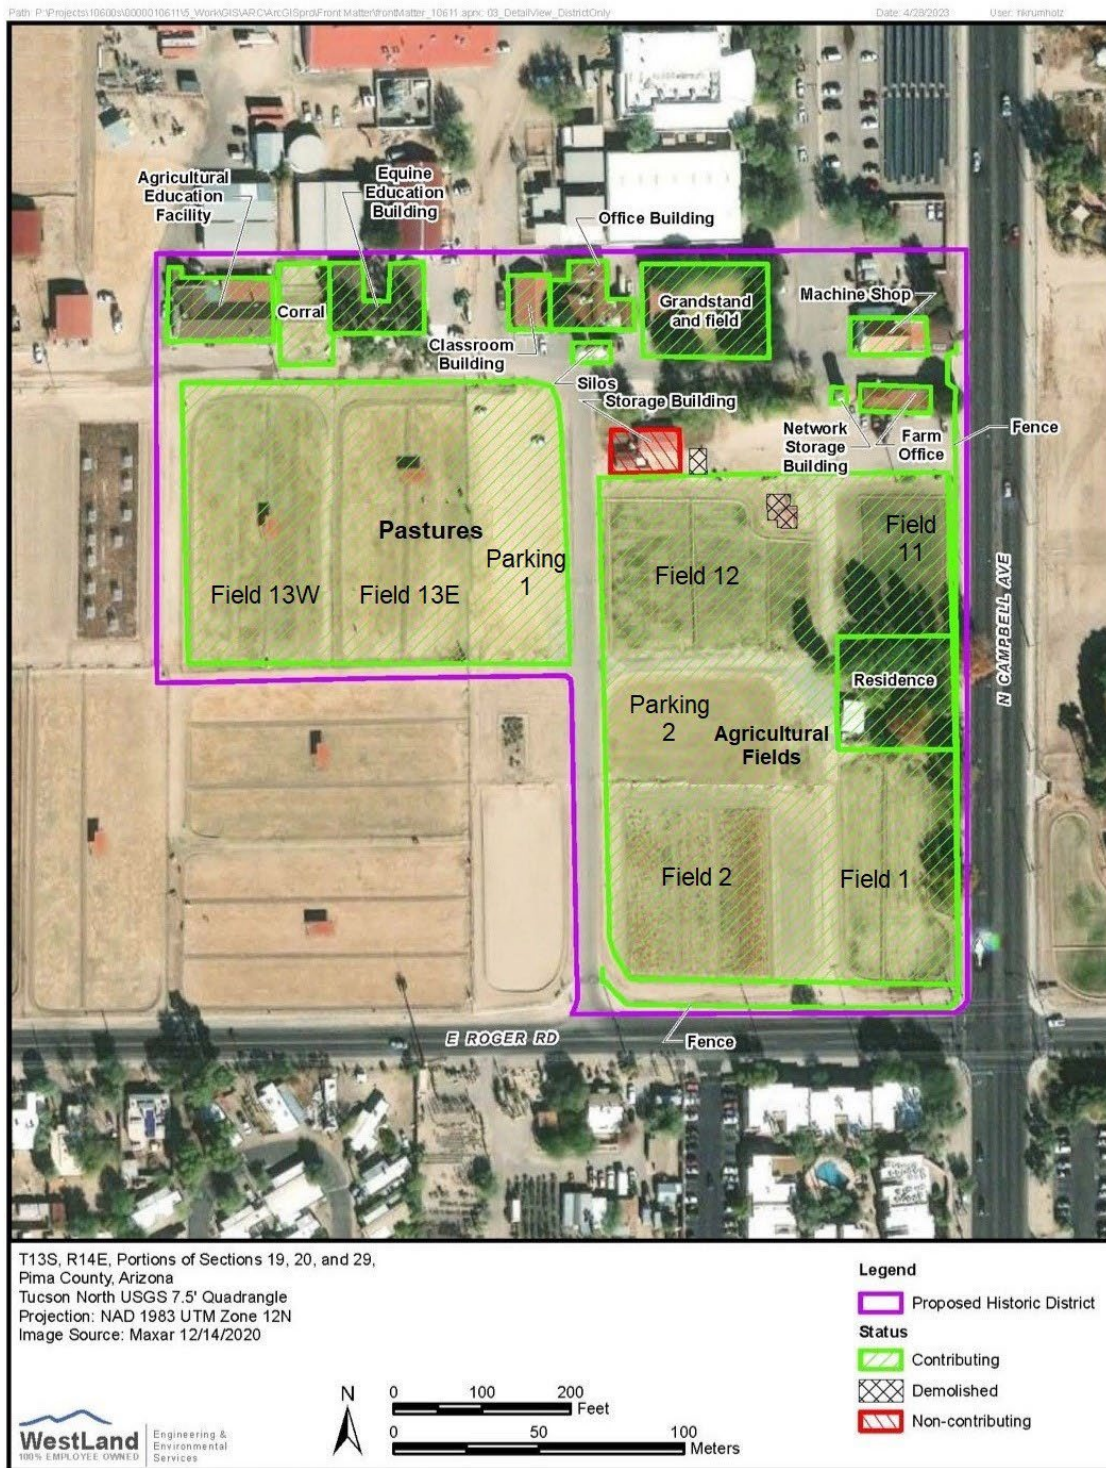
Figure 4. Map showing contributing and non-contributing resources within the CAC Historic District

The portion of the district that meets the requirements of a designed landscape includes the original buildings, the corral, grandstand, and original main entrance road, all located along the northern portion of historic district boundary. The remaining areas are vernacular in design and changed over time to accommodate the research and planning needs of the University. Within the district, 13 properties were found to possess the requisite significance and integrity for listing as contributing resources to the district, and one property was found to not contribute to the district based on its age (**Table 1, Figure 4**).

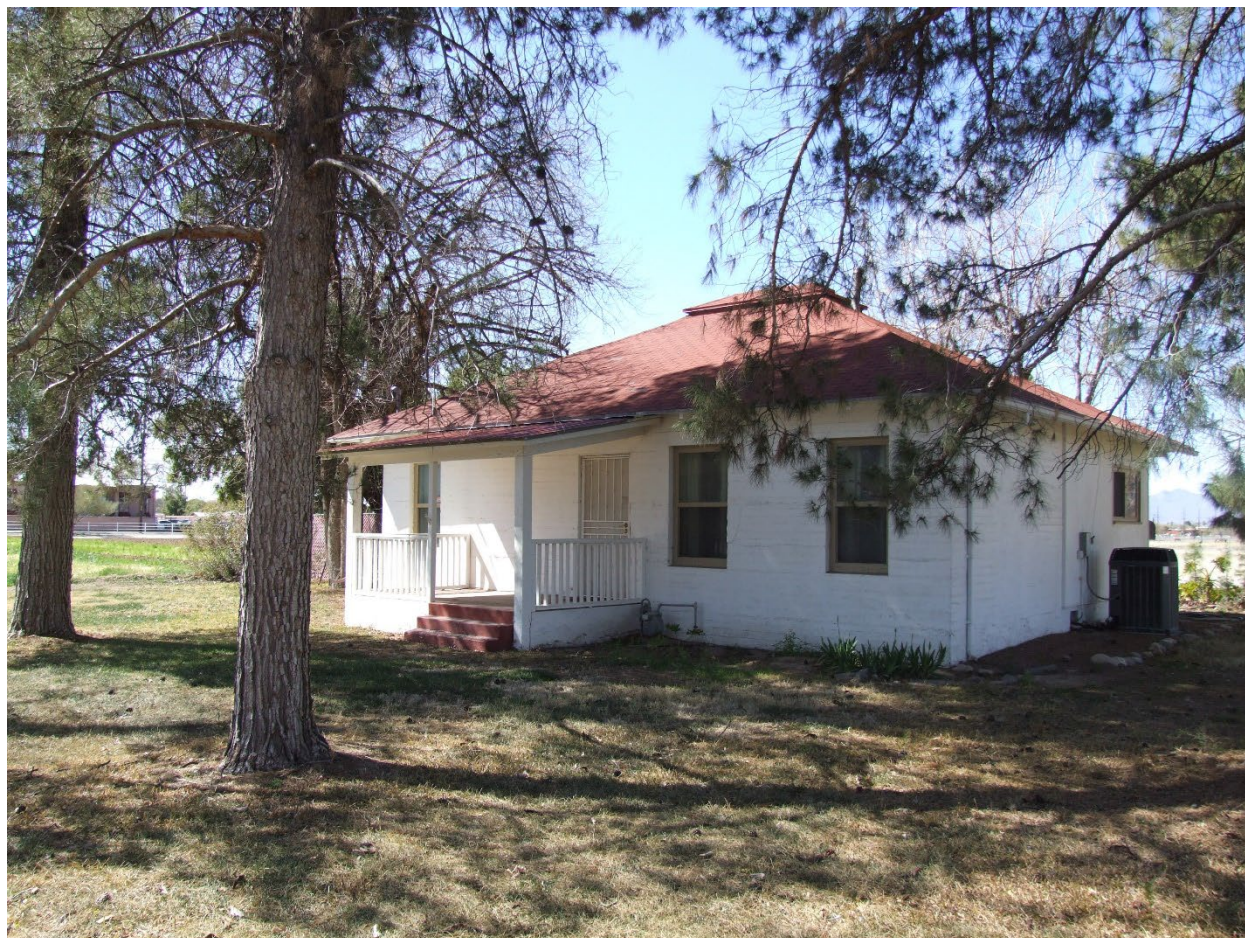
Photograph 1. East and north elevations of the Residence; view facing southwest (UA_Pima County_UA Campus Agricultural Center Historic District_0001)

A single residence is located within the CAC Historic District, on the west side of North Campbell Avenue. The main residence is a one-story American Territorial/National Folk style building with a rectangular footprint. The exterior walls are constructed of board-formed cast-in-place concrete. The original portion of the house has an L-shaped footprint (**Photographs 1–3**). The former porch on the northwest corner was later filled and framed in with wood frame and is covered with painted wood veneer. The walls are topped with an asphalt shingle pyramidal roof with slight overhanging eaves with exposed rafters and a hipped ridge vent at the top (**Photograph 4**). There is a chimney located on the west side. The original wood sliding sash and double hung windows have been replaced with vinyl sliding sash and double hung windows on all elevations.

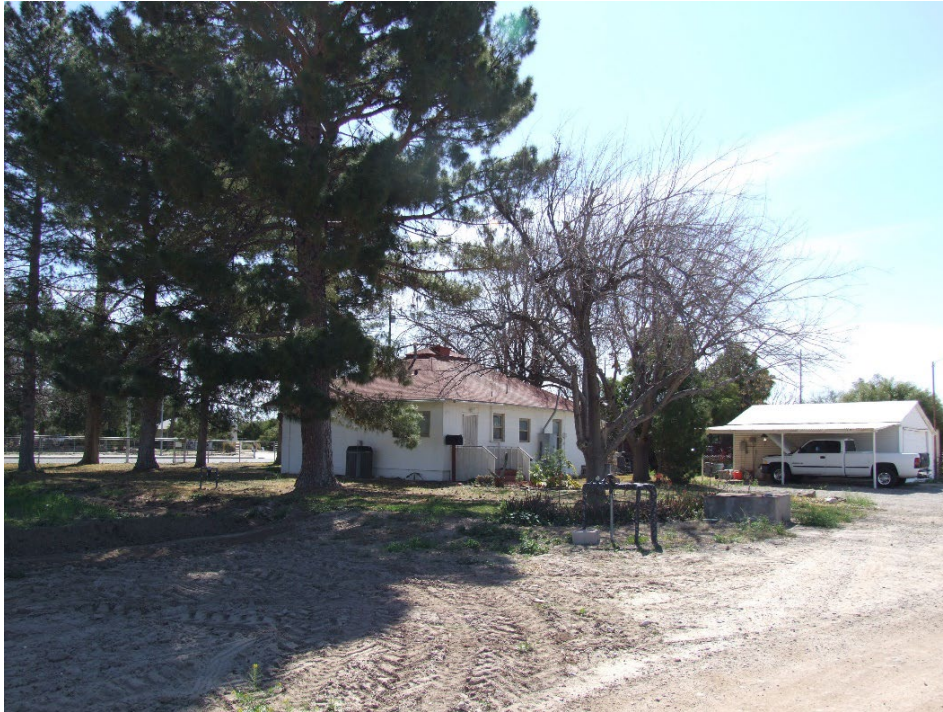
Photograph 2. North and west elevations of the Residence with carport; view facing southeast (UA_Pima County_UA Campus Agricultural Center Historic District_0002)

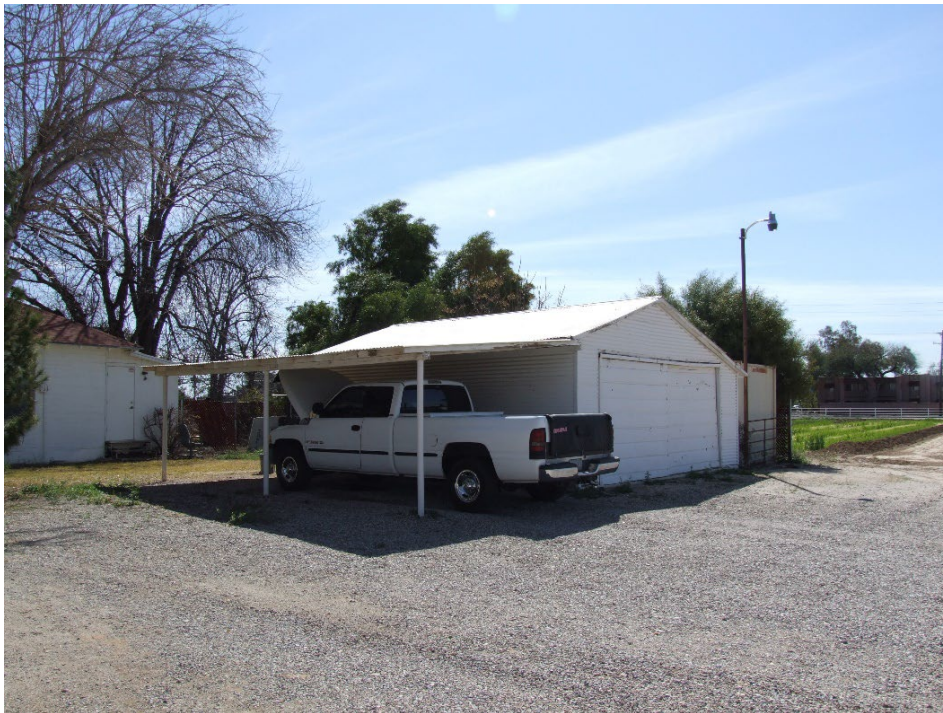
Photograph 3. Overview of the carport at the Residence; view facing southeast (UA_Pima County_UA Campus Agricultural Center Historic District_0003)

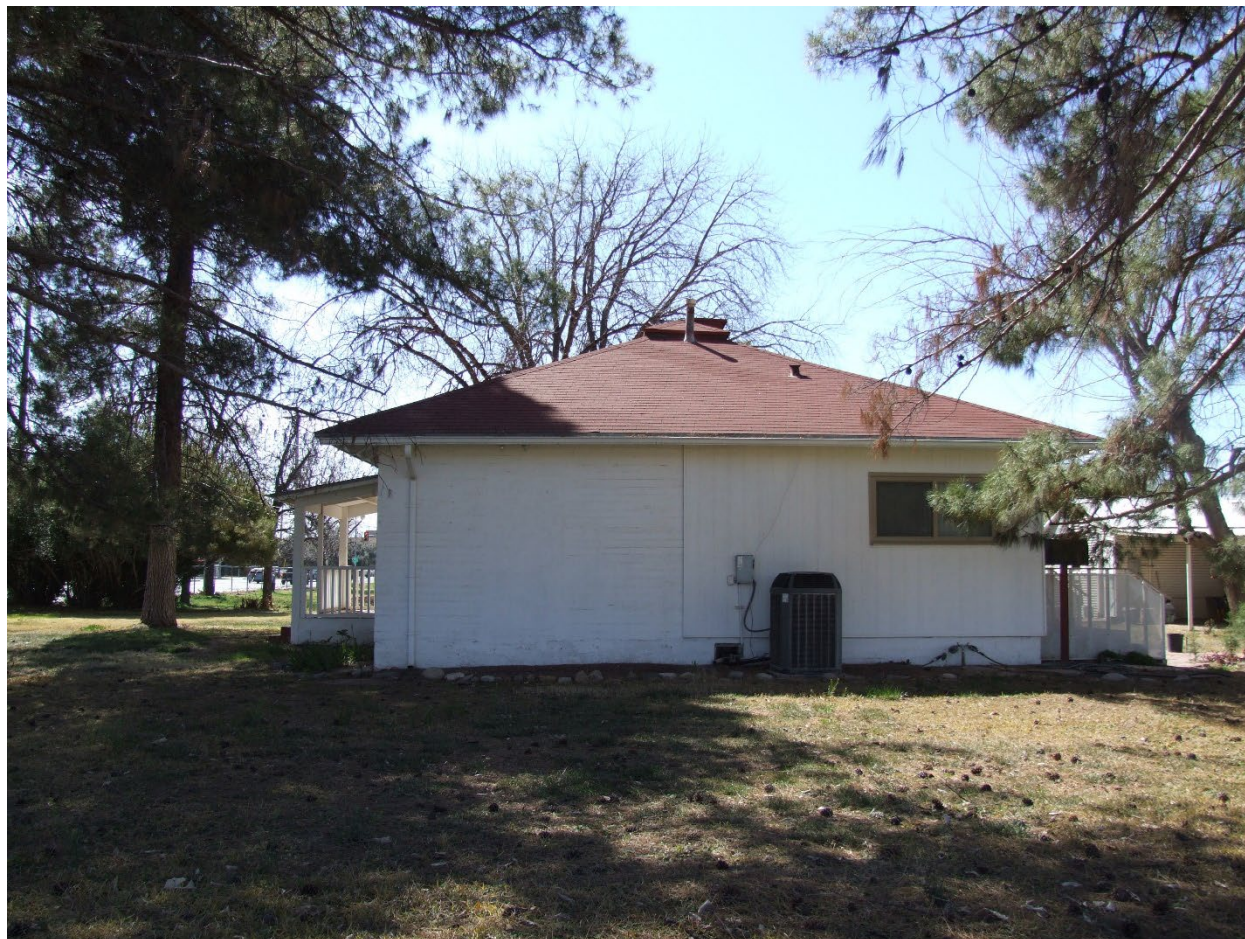
Photograph 4. Overview of north elevation of the Residence; view facing south (UA_Pima County_UA Campus Agricultural Center Historic District_0004)

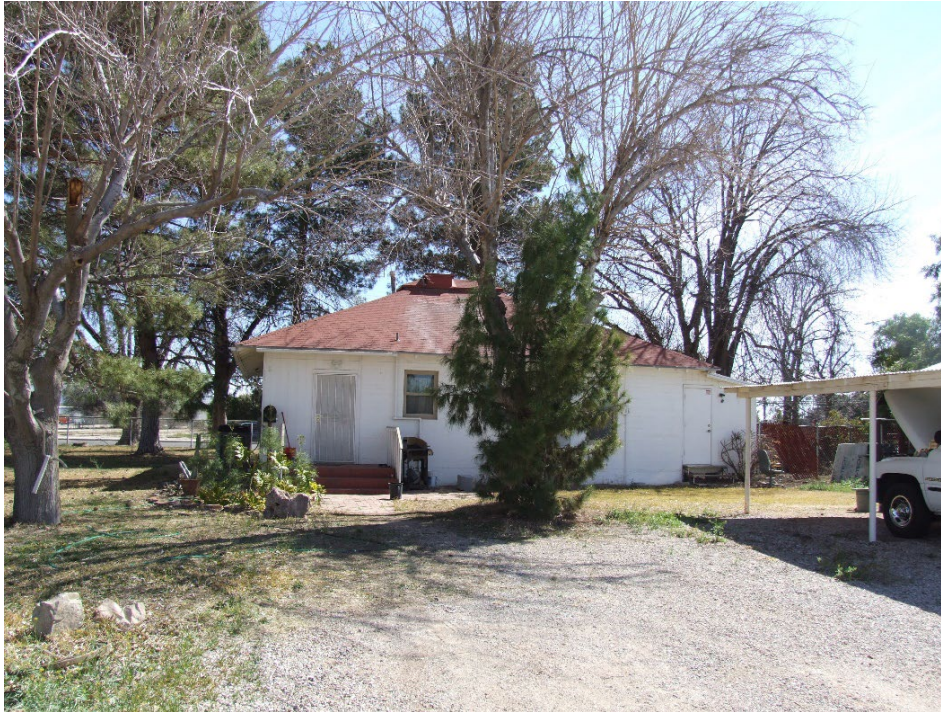
Photograph 5. West elevation of the Residence and back entryway; view facing east (UA_Pima County_UA Campus Agricultural Center Historic District_0005)

Along the east elevation there is an open shed roof porch supported by wooden columns on a concrete slab floor, topped by a galvanized metal roof. Wooden railings surround and enclose the porch. Along the west elevation, the back entrance has a decorative security gate covering the door. There are concrete pavers and steps attached to a metal railing leading up to the entrance (**Photograph 5**). A shed-style addition is located along the south elevation, constructed of wood frame walls on top of concrete piers, topped by a shed roof covered with asphalt shingles (**Photograph 6**). Historic aerial imagery indicates that the addition was added sometime after 1972.

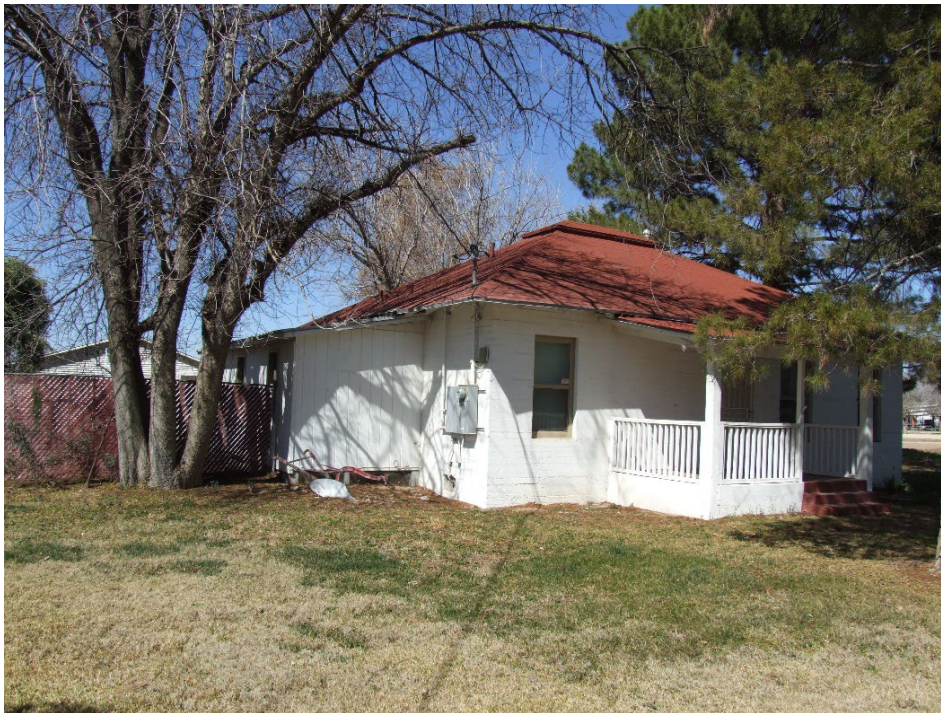
Photograph 6. East and south elevations with south addition of the Residence; view facing northwest (UA_Pima County_UA Campus Agricultural Center Historic District_0006)

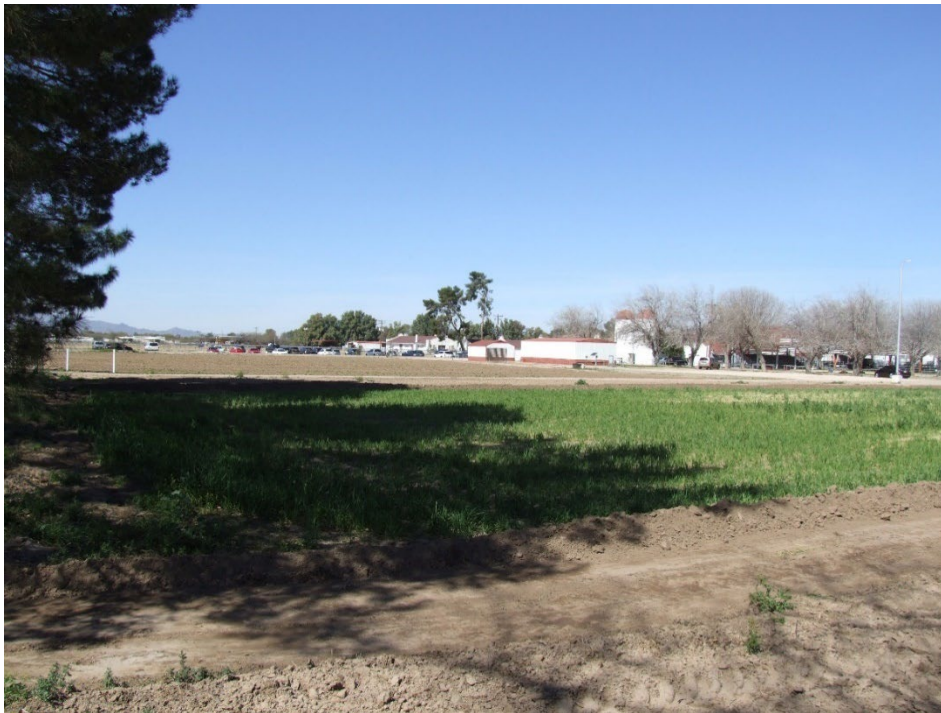
Photograph 8. Overview of agricultural fields and pastures; view facing west-northwest (AZ_Pima County_UA Campus Agricultural Center Historic District_0008).

There are eight agricultural fields and pastures (P1, P2, 1, 2, 11, 12, 13E, and 13W) at the CAC within the proposed historic district (listed as a single contributing site). The fields are oriented north-south and east-west. They are not uniform in size and are edged by gravel roads and driveways. There are raised berms with irrigation boxes along the edges of each (**Photograph 7**). Field use has varied over the years, with much of the early work done on cotton genetics, including the development of widely used Pima Cotton variety. Past uses have also included work with legumes, corn, beans, and guayule. In recent years small stand crop projects have largely been replaced by projects focused on ecological restoration, desert trees, and entomological studies. Some of the former fields are used for grazing horses, with fields 13E and 13W converted to Bermuda pastures, and more recently, some have been used for student parking and community events (University of Arizona CAC, personal correspondence) (**Photograph 8; see Figure 4**).

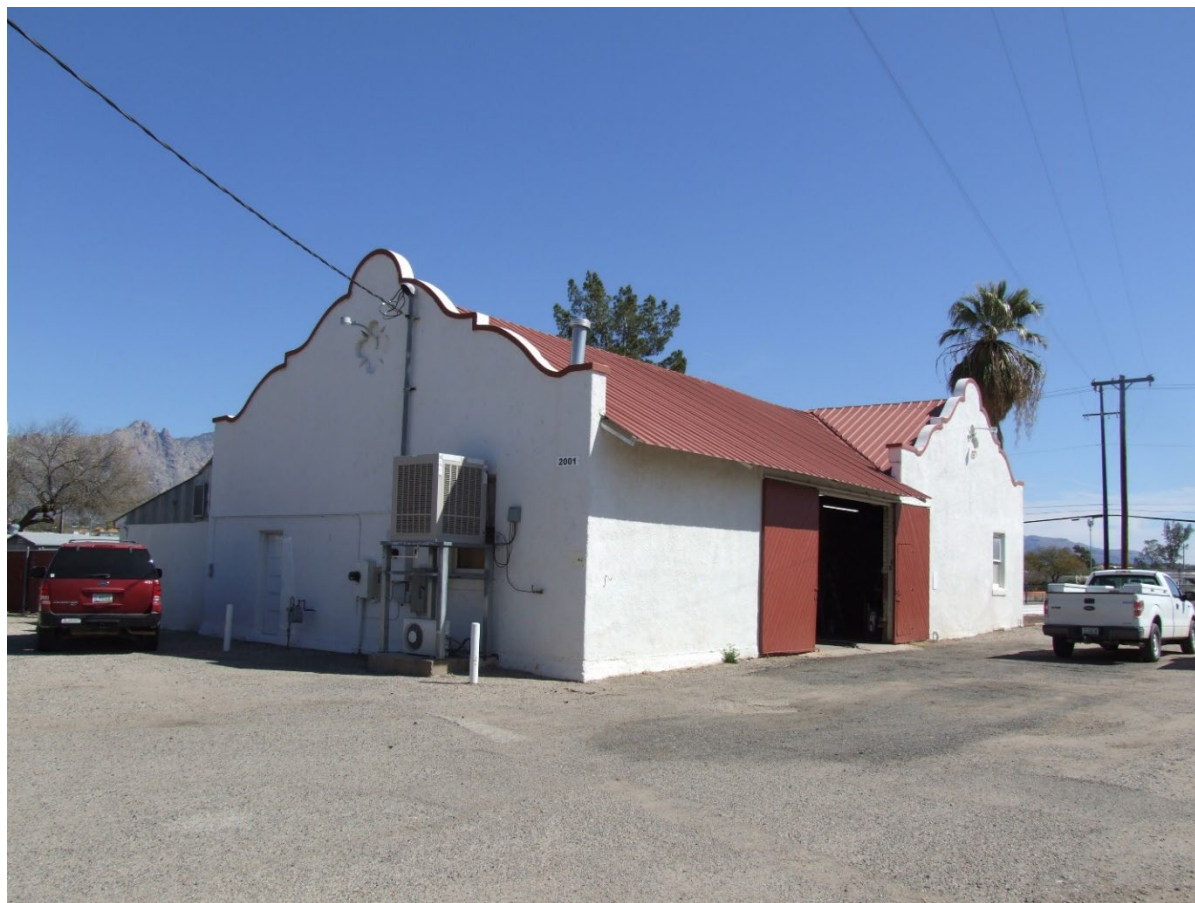
The Machine Shop is a one-story Mission Revival style building with a rectangular footprint constructed of masonry brick walls covered in stucco on a concrete foundation. The walls are topped by a medium pitch cross gable roof constructed of galvanized steel with low overhanging eaves. There is a Mission-style arched parapet with brick coping on the west, north, and south elevations, with stucco quatrefoil details around the attic vents. **(Photograph 9)**. The parapet on the Machine Shop differs slightly from the other buildings in that the parapet has been stuccoed over and painted, while others have been left as exposed brick.

Photograph 9. West and south elevations of the Machine Shop; view facing northeast (AZ_Pima County_UA Campus Agricultural Center Historic District_0009)

The exterior walls are penetrated by the original wood casement and double hung windows and original wood doorways with glass panels. Located on the south elevation is a painted sliding barn door, likely historic. A shed roof addition is located on the north elevation and is constructed of CMU with stucco sheathing and topped with a galvanized steel roof. Additionally, there is a historic concrete water holding tank and water pump located in front of the east elevation **(Photograph 10)**.

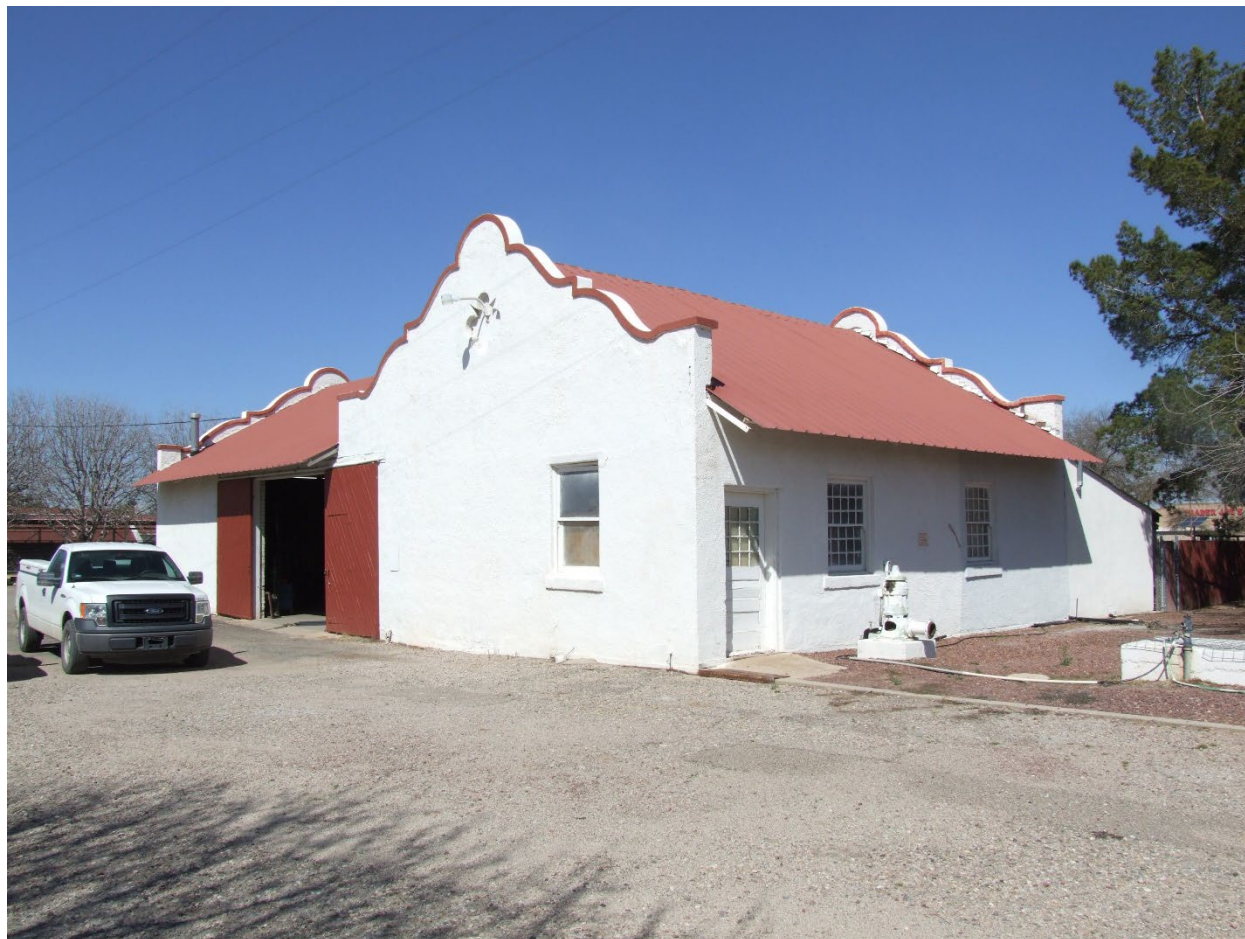
Photograph 10. East and south elevations of the Machine Shop; view facing northwest (AZ_Pima County_UA Campus Agricultural Center Historic District_0010)

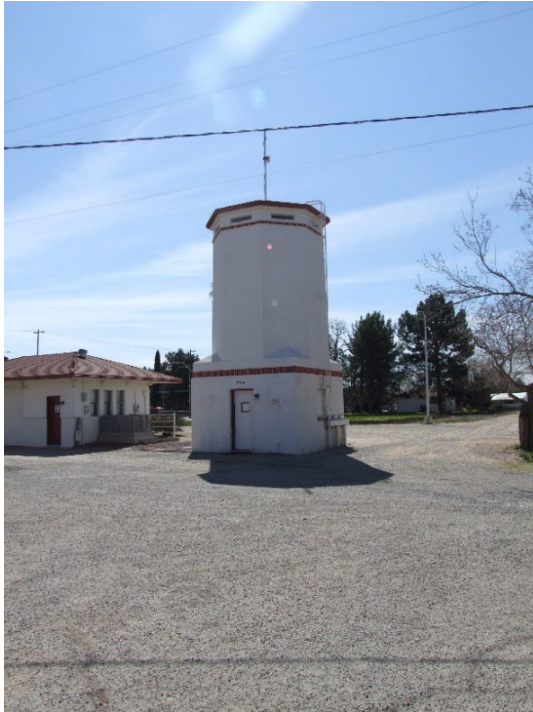
Photograph 11. East and north elevations of the Network Storage Building and Water Tower; view facing southeast (AZ_Pima County_UA Campus Agricultural Center Historic District_0011)

The Network Storage Building/Water Tower has a square building base with an octagonal water tower and is approximately 40 feet in height. The exterior walls are constructed of poured concrete and covered in stucco. The tower is covered by a pyramidal/low pitch roof constructed of concrete. A brick cornice is located at both the top of the building and at the top of the tower, and each elevation contains decorative vents (**Photograph 11**). Former windows have been removed and boarded on three of the elevations on the lower portion of the building. The windows were likely steel or wood casement. The main entryway is located along the north elevation, and the door appears to have been replaced within the last decade. The building has approximately 8-foot walls measuring from base of the building to cornice (**Photograph 12**). Atop the base is an octagonal unit which rises to a height of approximately 30 feet (per the City of Tucson Historic Landscape Nomination 2020).

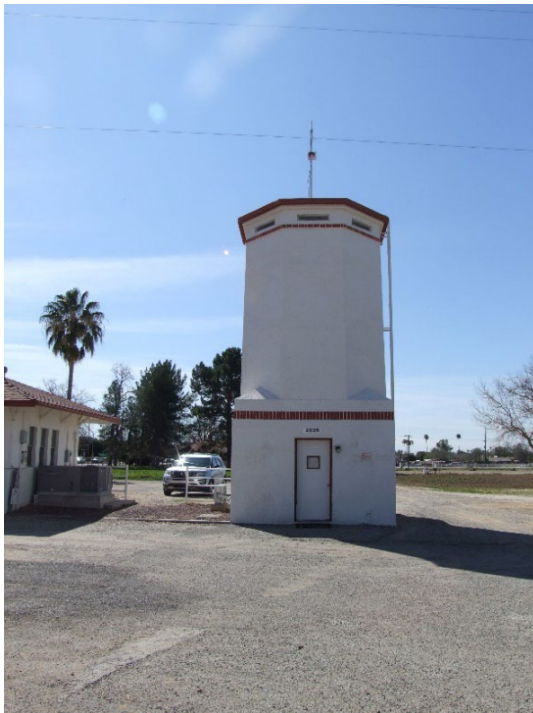
Photograph 12. Overview of north elevation of the Network Storage Building and Water Tower; view facing southeast (AZ_Pima County_UA Campus Agricultural Center Historic District_0012)

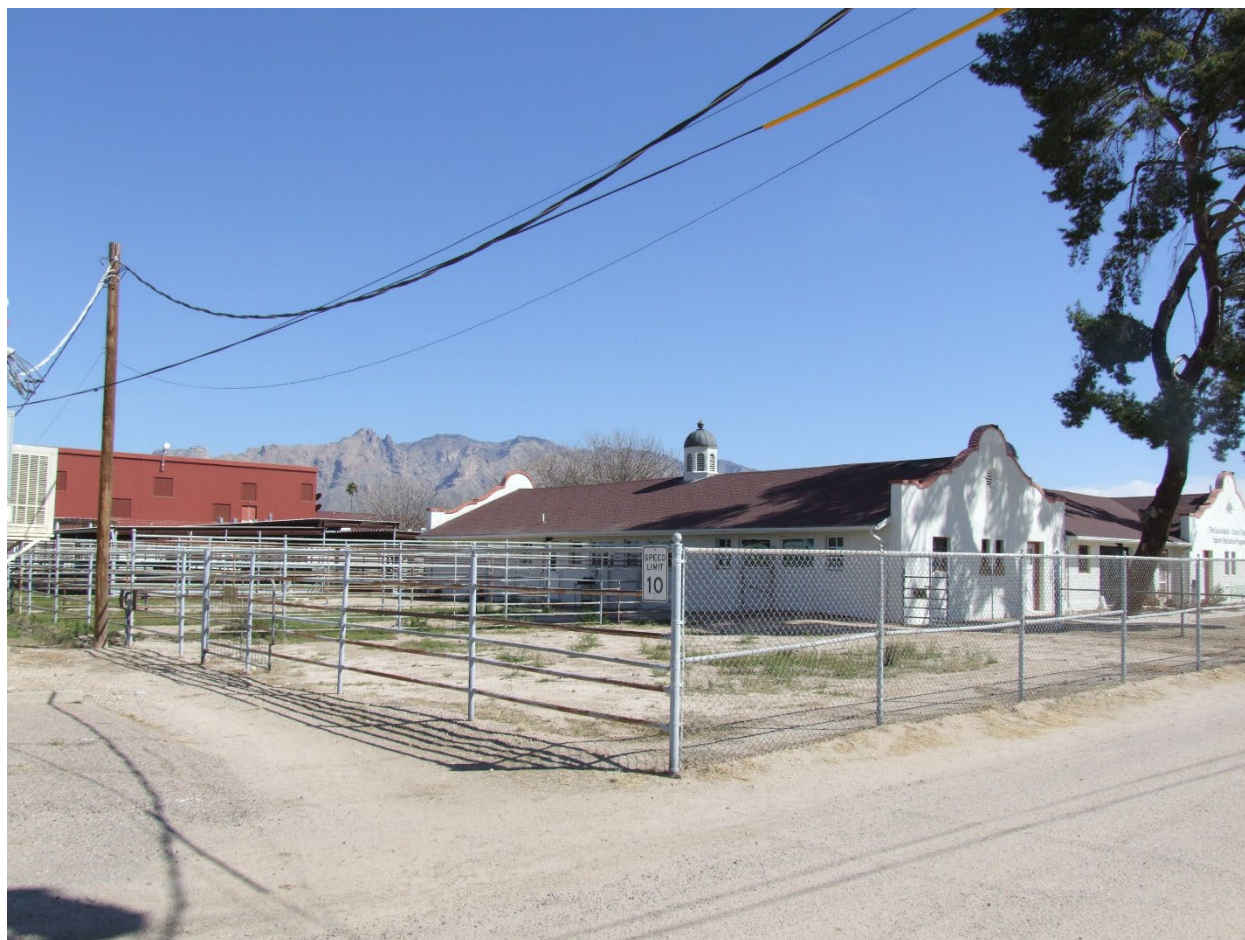
Photograph 13. Overview of Corral and fencing; view facing northeast
(AZ_Pima County_UA Campus Agricultural Center Historic District_0013)

A rectangular corral is located between the Agricultural Education Center building and the Equine Education building. The corral is edged in galvanized pipe fencing measuring 6 feet tall along the perimeter and upwards of 6½ feet tall within holding pen areas. The galvanized pipe is welded between posts, with the top rung threaded through a welded ring with a ball cap on top of each post. Portions of the corral have chain-link (a later addition) wired to the front of the corral along the dirt road between both buildings and farm fields. This was used to prevent horses from interfering with or biting one another. Within the corral is a single concrete and metal water trough. Access to and from the corral is via one of five gates between pens and the ends of the corral. The corral is no longer in use but was once used to house horses, who would enter the corral via stall doors that opened into individual pens within the corral (**Photographs 13 and 14**).

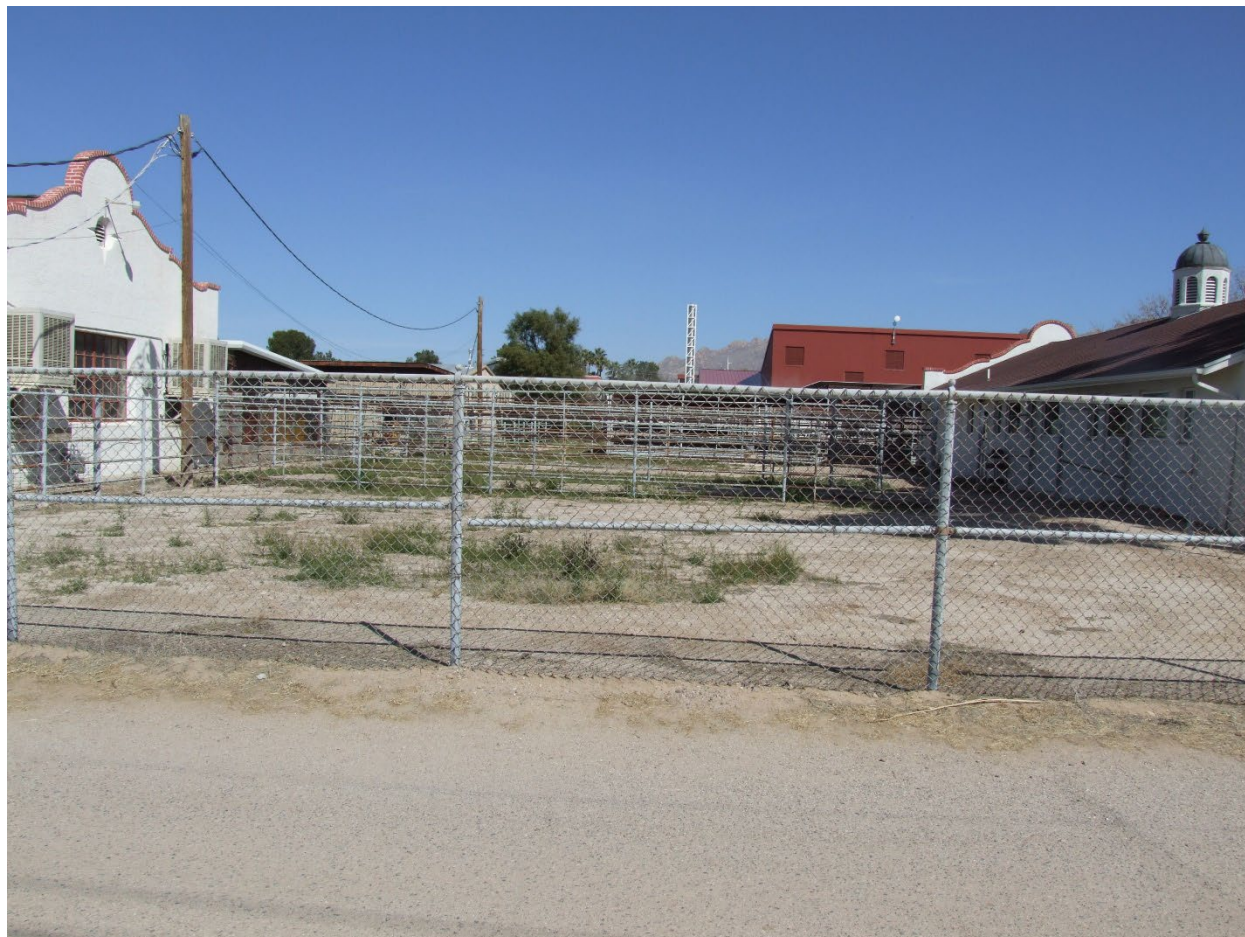
Photograph 14. Overview of Corral and fencing; view facing north
(AZ_Pima County_UA Campus Agricultural Center Historic District_0014)

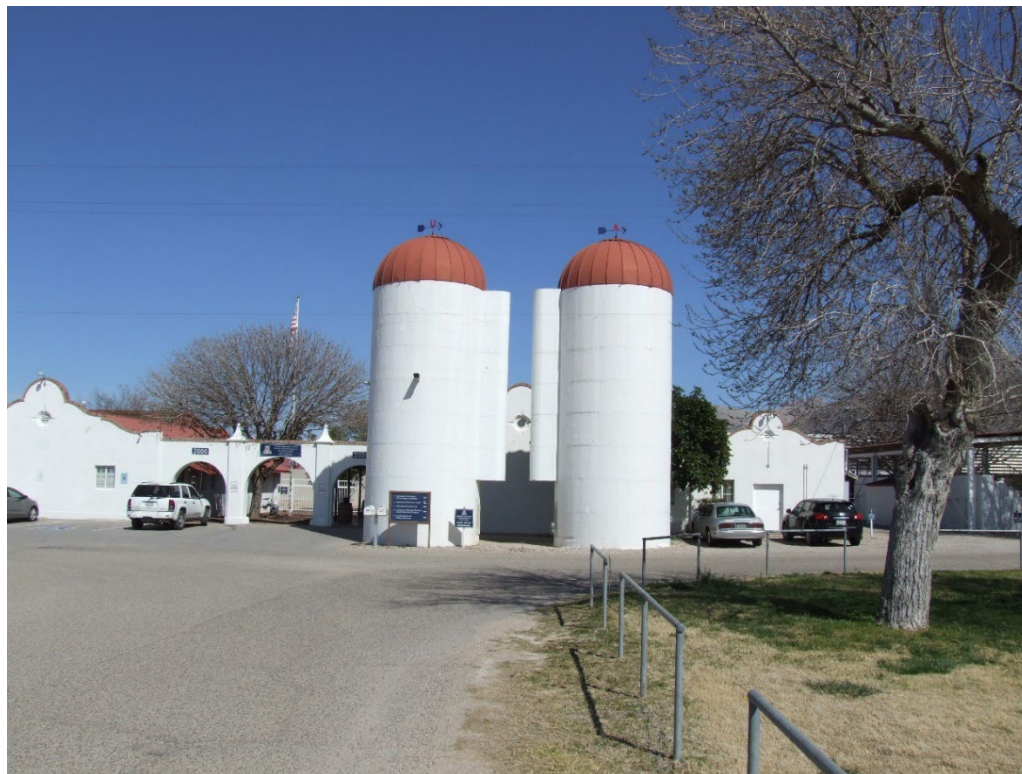
Photograph 15. Overview of south elevations of the two paired silos; view facing north (UA_Pima County_UA Campus Agricultural Center Historic District_0015)

Two paired silos situated immediately south of the Classroom Building and the Office Building are approximately 41 feet tall, with poured concrete walls sheathed in a thin plaster whitewash set on a concrete apron foundation. Both silos are capped with galvanized standing seam domed roofs with a “U of A” weathervane on top. Both have enclosed stairwells facing each other between the silos, on the east and west elevations. An air vent is located near the base of the silos (**Photograph 15**).

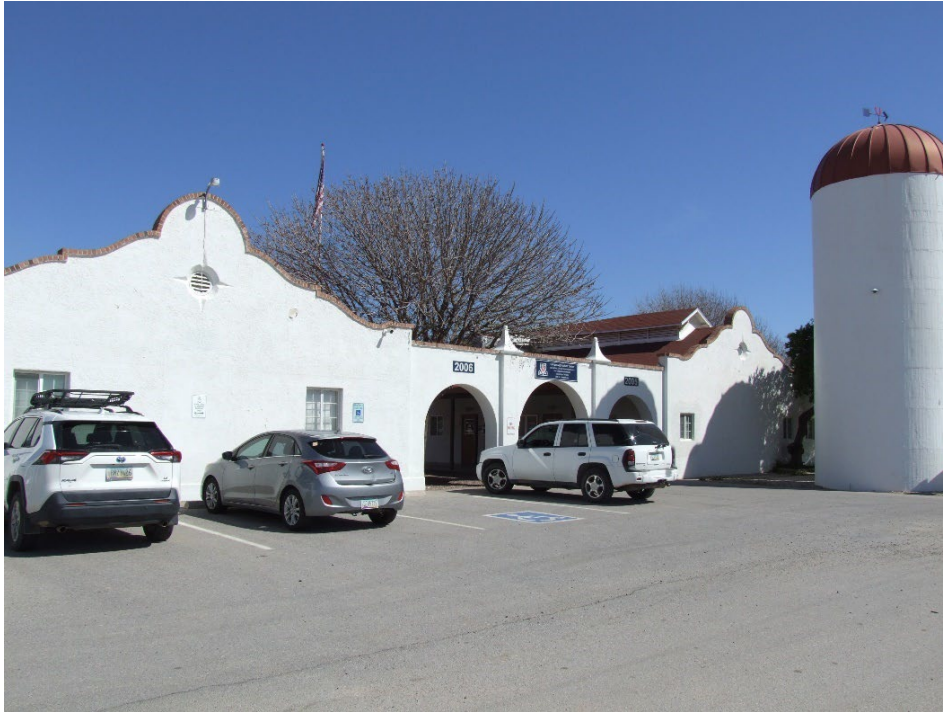
Photograph 16. South elevation of the Office Building and arched arcade openings; view facing northeast (AZ_Pima County_UA Campus Agricultural Center Historic District_0016)

The Office Building, also known as the former Dairy Barn, is a one-story building with a rectangular footprint. Its exterior walls are constructed of brick masonry and are sheathed in stucco resting on a poured concrete foundation. The walls are topped by a medium-pitch asphalt shingle gable roof with a north/south axis, with shallow overhanging eaves. A large monitor runs the length of the roof and once served as ventilation inside the Dairy Barn. There is a Mission-style arched parapet on the north and south elevations with brick coping and quatrefoils around the attic vents. The walls are punctuated with aluminum and vinyl sliding sash windows with ornamental grilles that replaced the original steel casements. The building also has a mix of original solid wood doors and modern doors with glass panels (**Photograph 16**).

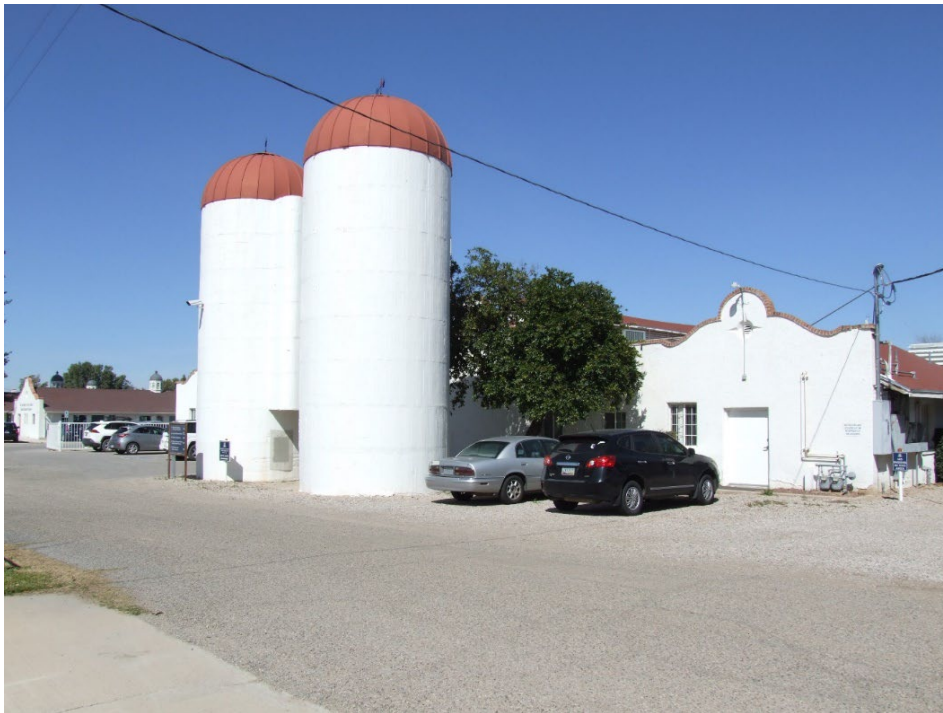
Photograph 17. East and south elevations of the Office Building with silos; view facing northwest (AZ_Pima County_UA Campus Agricultural Center Historic District_0017)

There is a central courtyard between the Office Building and the Classroom Building connected by a brick and stucco open arcade of three arches in line with the south elevation, that together enclose the central courtyard along the south elevation of the Office Building and Classroom Building uniting them into a single composition. Former openings in the west gable of the south elevation have been filled in. This building has additions to the west and north sides, with historic aerial imagery indicating these additions were constructed sometime after 1980 (**Photograph 17**).

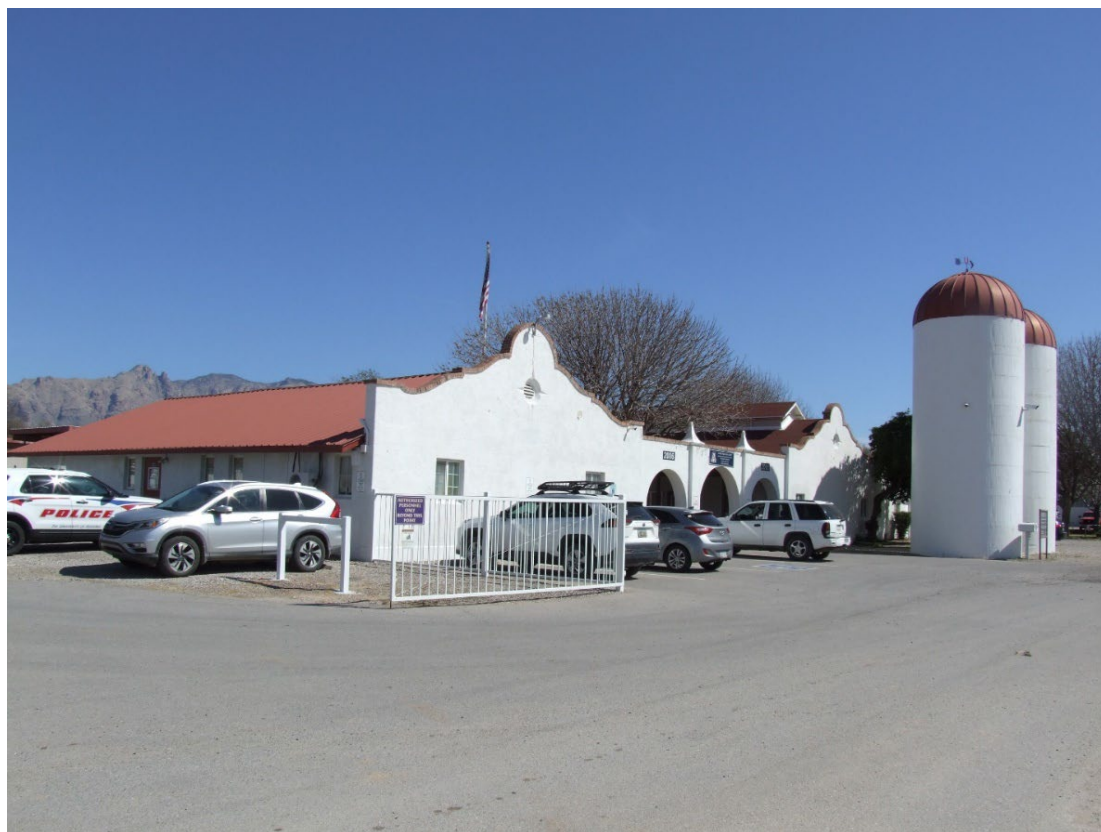
The Classroom Building is a one-story building with a rectangular footprint. The exterior walls are constructed of brick masonry covered in stucco on a poured concrete foundation. The walls are topped by a medium-pitch gable roof with a north-south axis with slightly overhanging eaves, with the roof constructed of galvanized steel over wood frame. There is a Mission-style parapet on the north and south elevations. There are attic vents near the gable ends that are surrounded by decorative stucco quatrefoils. The exterior walls are punctuated with fixed vinyl and steel casement windows along the south, west, and east elevations. The building has original solid wood doors and replacement modern doors with glass panels located on the east, west, and north elevations.

Photograph 18. West and south elevations of the Classroom Building; view facing northeast (AZ_Pima County_UA Campus Agricultural Center Historic District_0018)

As noted in the previous description for the Office Building, there is a central courtyard between the Classroom Building and the Office Building uniting them into a single composition. A modern fence encloses the courtyard along the north elevation, connecting the Classroom Building and the Office Building, and a steel stairway is located along the north (back) elevation for access to the attic. A former doorway on the south elevation has been filled in (**Photograph 18**).

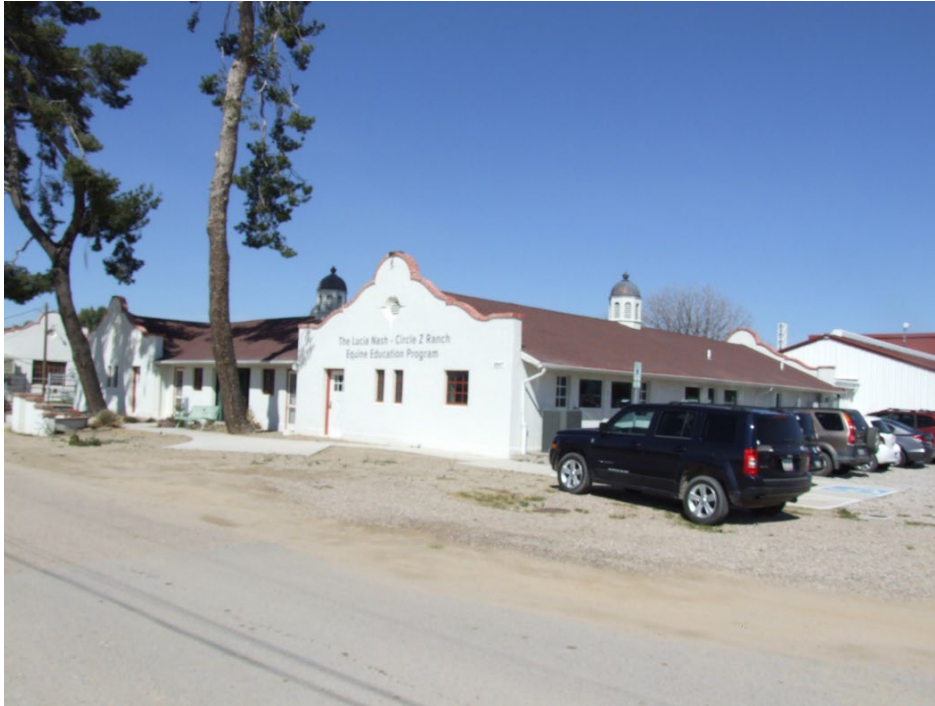
Photograph 19. East and south elevations of the Equine Education Building; view facing northwest (AZ_Pima County_UA Campus Agricultural Center Historic District_0019)

The Equine Education Building, formerly known as the Horse/Equine Barn, is a one-story building with a U-shaped footprint. The exterior walls are constructed of brick masonry and are covered in stucco on a poured concrete foundation. The walls are topped by a medium pitch gable and cross-gable roof with asphalt shingles and shallow overhanging eaves. There is a Mission-style parapet on the north and south elevations with quatrefoils surrounding attic vents on the gable ends. Two decorative copulas with copper domes are located in the center of the east gable and the middle cross gable portions of the roof (**Photograph 19**).

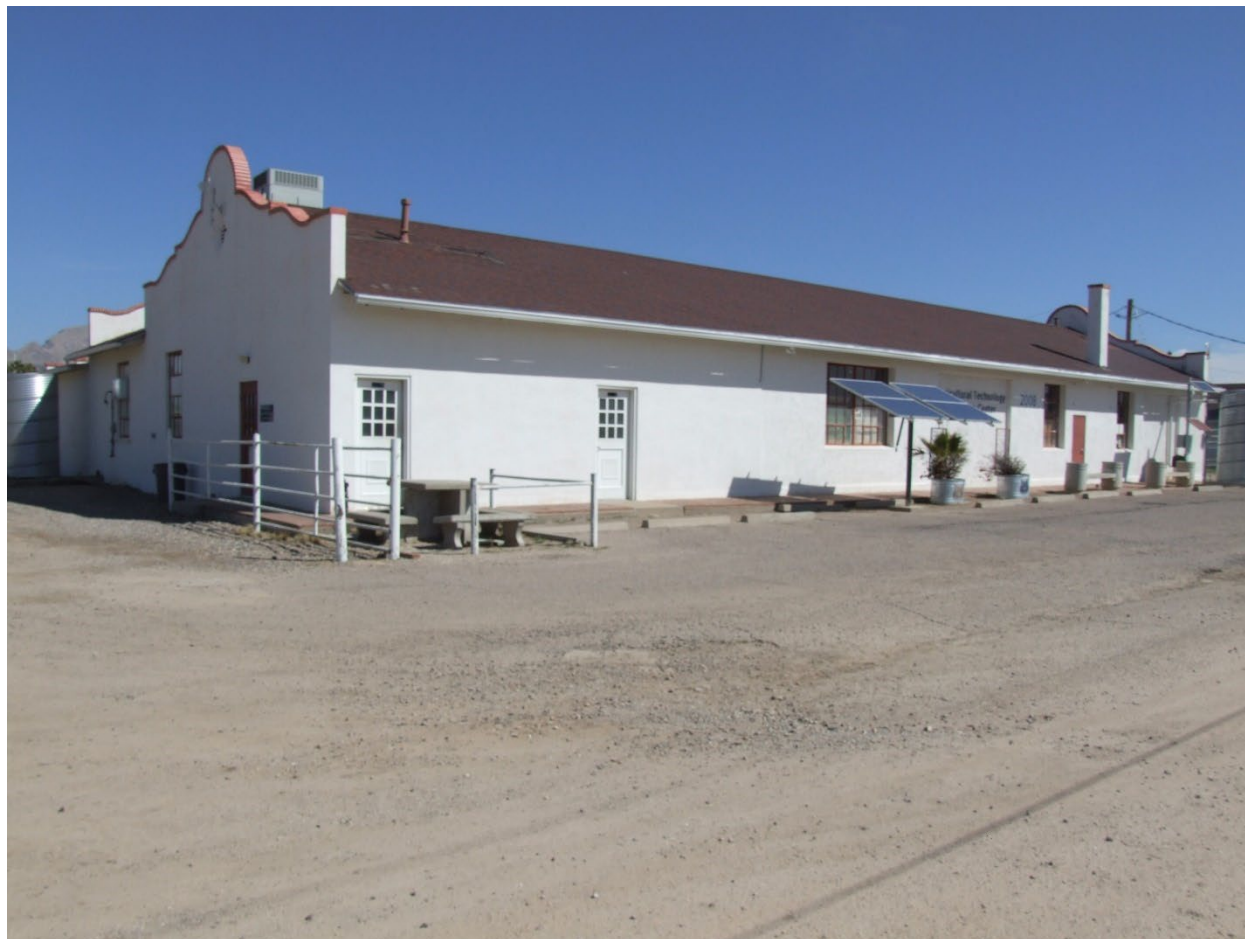
The brick and stucco Agricultural Education Facility is a single-story Mission Revival style building with a rectangular plan. The building is constructed of brick masonry walls covered in stucco that are set on a poured concrete foundation. The building's walls are topped by a medium-pitch asphalt shingle gable roof with shallow overhanging eaves. There is a Mission-style parapet on the east and west elevations, in addition to attic vents near the gable ends that are surrounded by quatrefoils. The chimney is flush with the south elevation (**Photograph 21**).

Photograph 21. West and south elevations of Agricultural Education Facility; view facing northeast (AZ_Pima County_UA Campus Agricultural Center Historic District_0021)

The building's exterior walls are punctuated by original steel casement windows along all elevations. The building's 1930s-era exterior doors have been replaced with modern steel doors along the south and west elevations. Americans with Disabilities Act (ADA)-compliant ramps are located along the main entryway on the west elevation and are constructed of concrete and brick pavers.

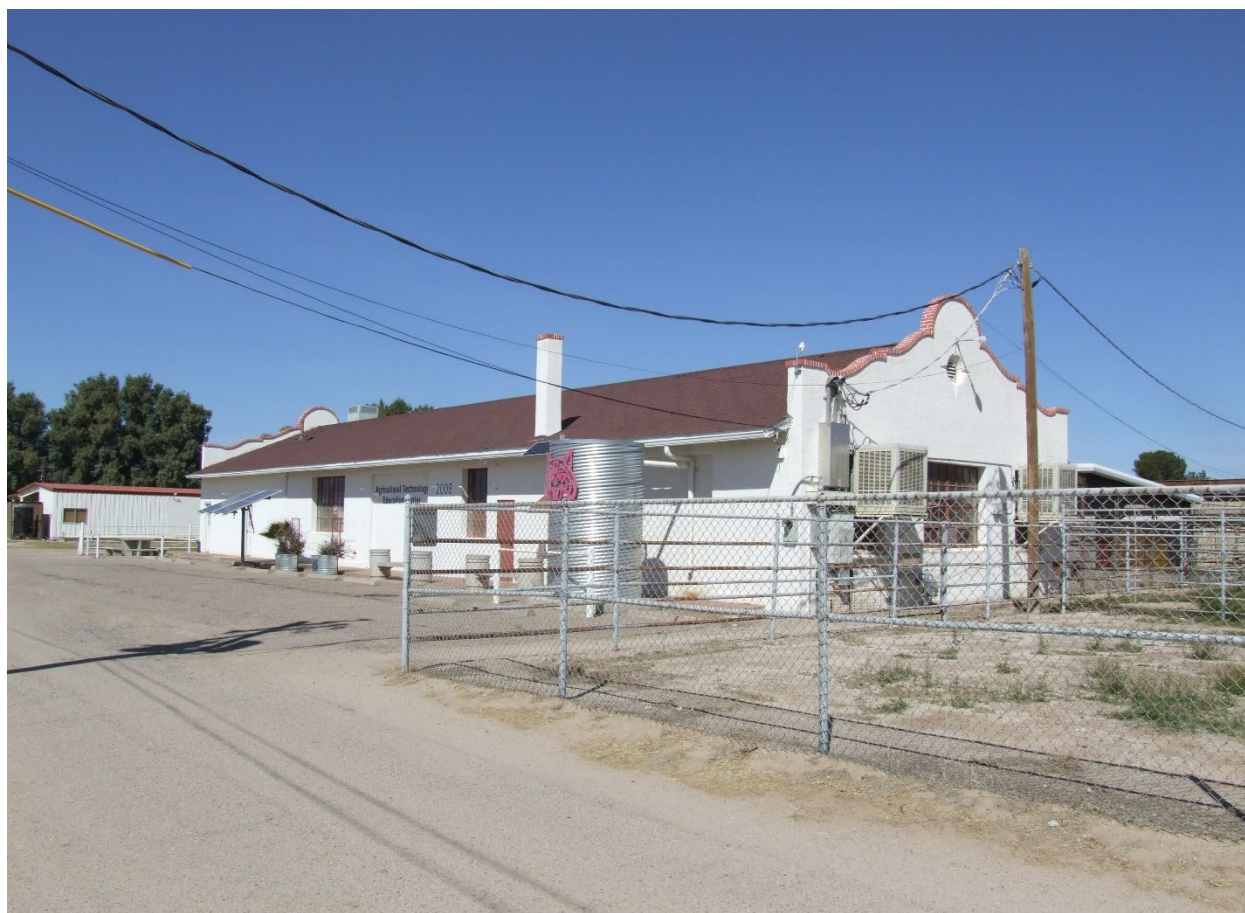
Photograph 22. East and south elevations of Agricultural Education Facility; view facing northwest (AZ_Pima County_UA Campus Agricultural Center Historic District_0022)

The eastern portion of the building is the original building; historic aerial imagery indicates that two additions were added to the building sometime after 1984. There is a shed roof overhang on the north elevation addition, and the exterior walls are constructed of CMU brick, while an L-shaped addition on the northwest corner is covered in stucco with brick coping and shed roof overhang. Both roofs are sheathed in asphalt shingles (**Photograph 22**).
