National Register of Historic Places Registration Form

Historic name: University of Arizona Campus Agricultural Center
 Other names/site number: Campus Farm, Campbell Avenue Farm, University Farm; University Campus Farm Complex
 Name of related multiple property listing:
N/A
 (Enter "N/A" if property is not part of a multiple property listing)

Street & number: 4101 N. Campbell Avenue
 City or town: Tucson State: Arizona County: Pima County
 Not For Publication: Vicinity:

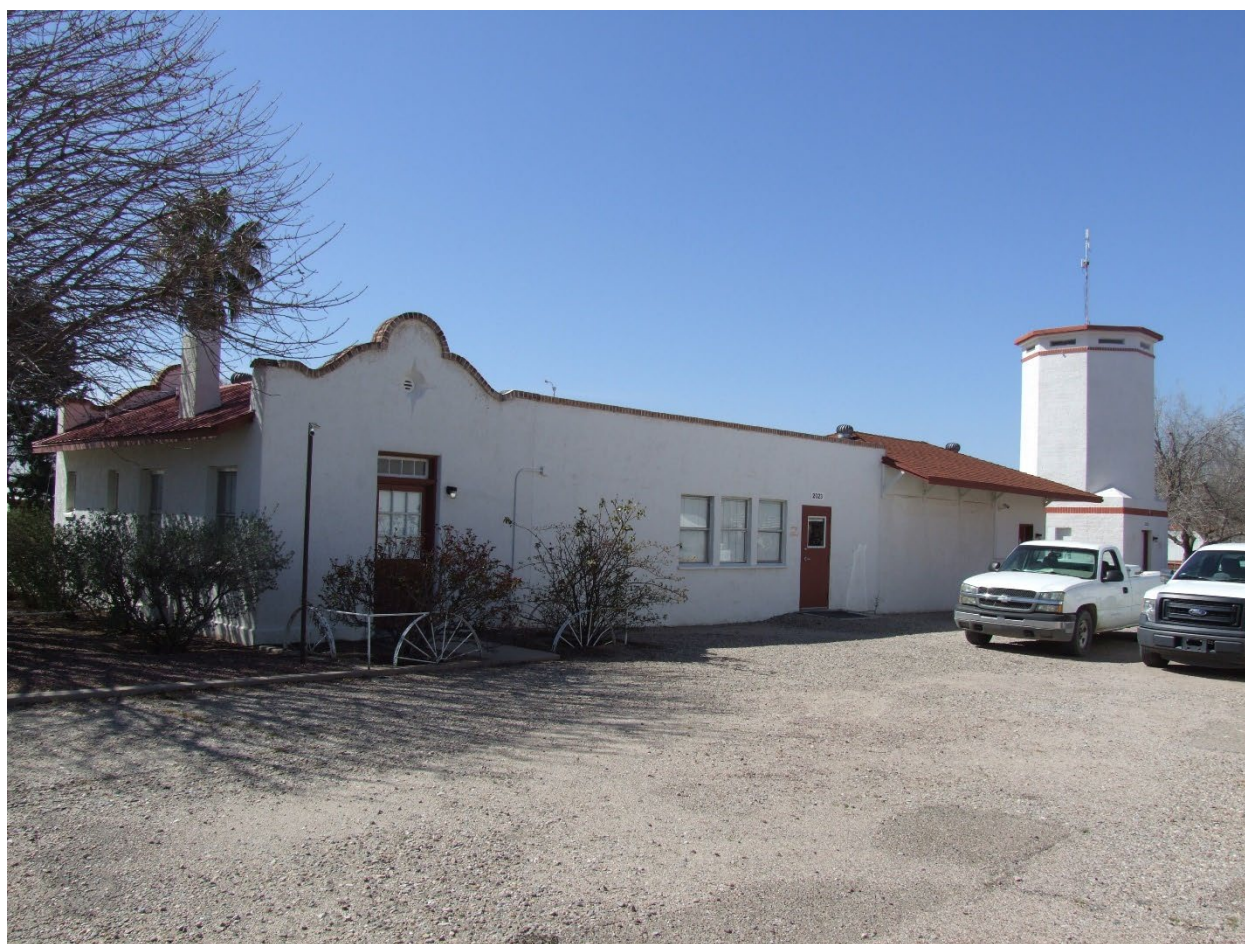
The exterior walls are pierced by steel casement and double-hung aluminum windows. The doors, except for the main entrance door at the northeast corner of the building, which is topped by a transom window, have been replaced. There is an L-shape addition that extends to the west that is constructed of frame and covered in stucco. Historically the addition in the center of the two ends of the building was built last, with the original farm office on the east, the second building on the west, both free-standing. The center of the building was a later added to connect the two buildings together. The westernmost end/addition is constructed of masonry walls that are covered in stucco with a painted wood veneer on the northwest corner (**Photograph 24**). Historic aerials indicate that the central and western most additions occurred sometime after 1980.

Photograph 23. East and north elevations of the Farm Office; view facing southwest (AZ_Pima County_UA Campus Agricultural Center Historic District_0023)

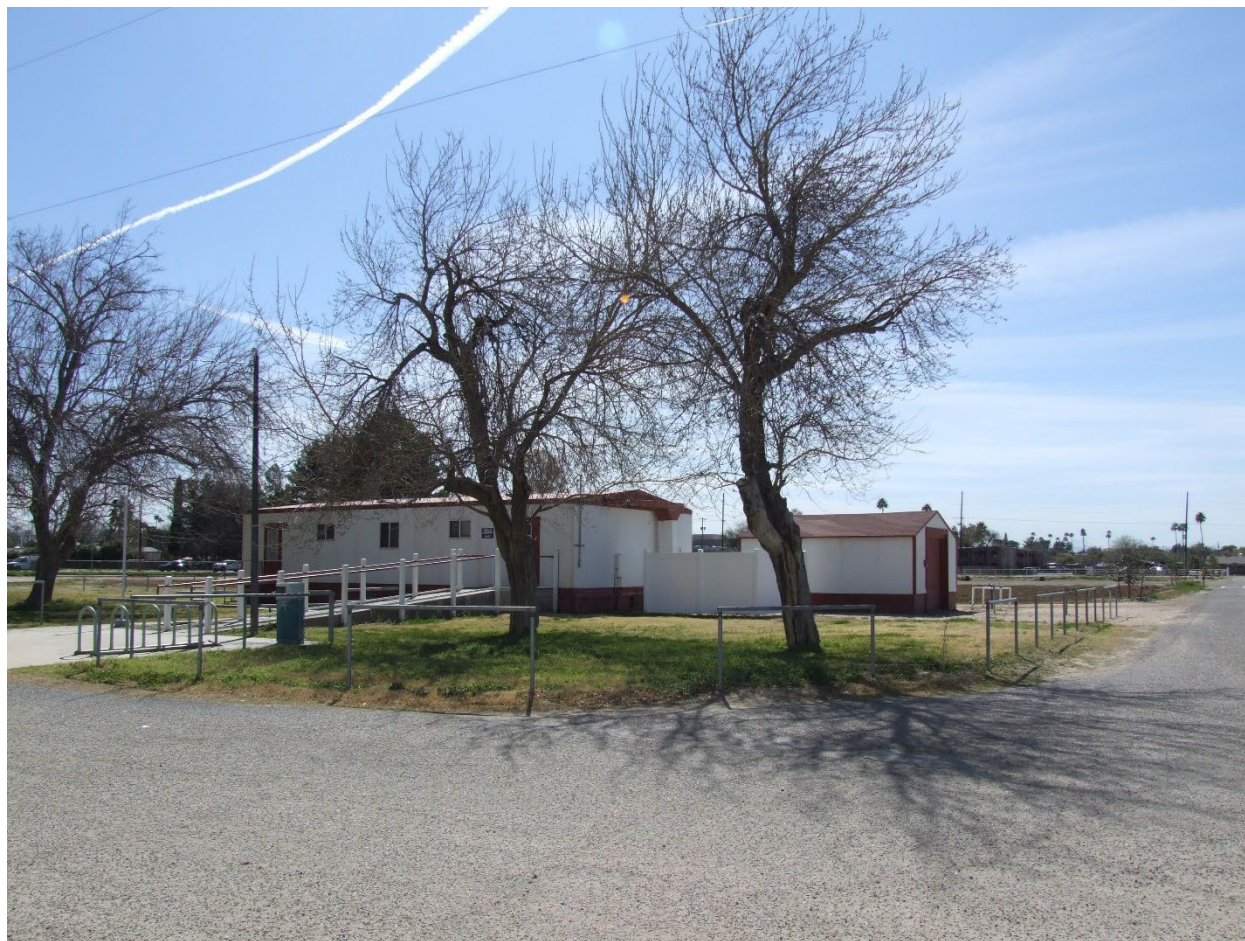
Photograph 28. West and north elevations of the modular Storage building, and storage shed; view facing southeast (UA_Pima County_UA Campus Agricultural Center Historic District_028)

The Storage Building is composed of two related buildings: a classroom and a storage shed. The classroom is a one-story Vernacular modular unit with a rectangular footprint. The walls are metal and topped by a metal gable roof. Fenestrations include aluminum sliding windows and solid metal core doors. There is a raised ADA ramp with a railing that leads to the main entrance near the west elevation and a set of metal stairs leading to the entrance near the east elevation. Behind the modular classroom is a small, one-story storage shed with a rectangular footprint. The walls are constructed with a brick base with wood frame above, topped by an asphalt shingle gable roof. There is a single, on-center, roll-up garage-style door on the west elevation (**Photograph 28**).

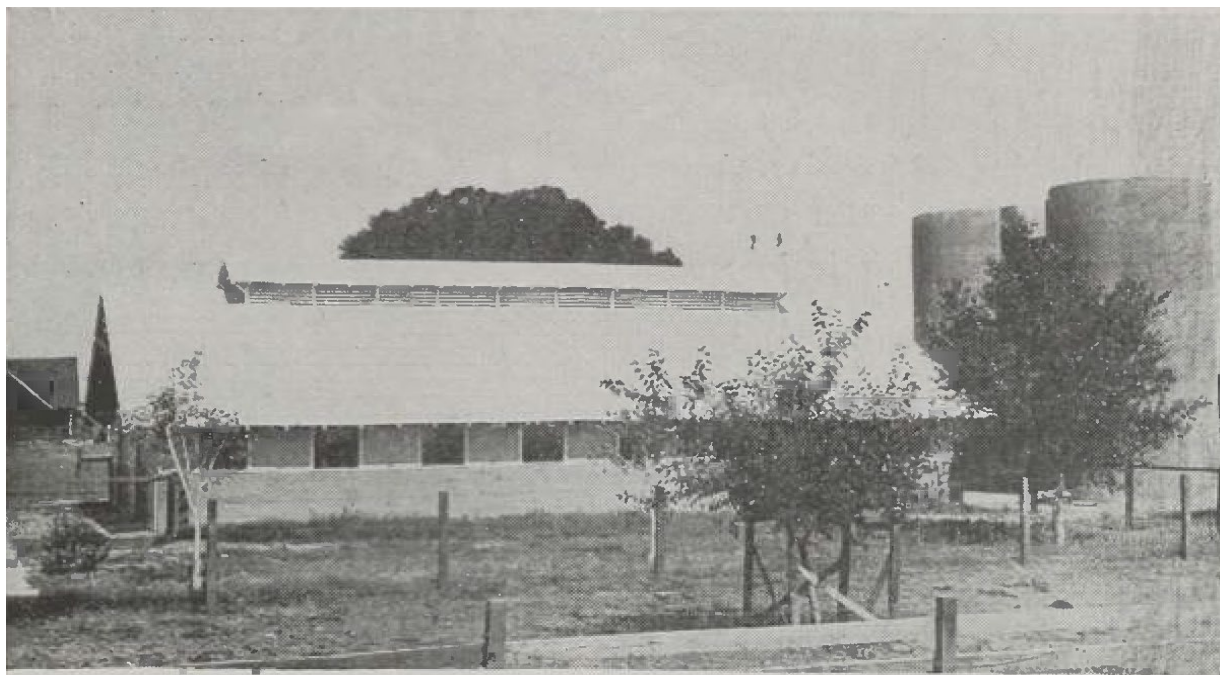
Figure 7. Historical image of silos and dairy barn (now part of the office/administration building), view facing southeast. Image from *The Arizona Agriculturist*, Vol II, No. 1, January 1925:15.

Construction continued apace through 1919. A new water tower was designed by California architect John B. Lyman, and a horse barn, a hay barn and milking barn, a sleep house, a hog house, a creamery and an unnamed building (where the current office/administrative building stands today) were constructed. In 1919, two silos were completed; following their completion, building activity at the CAC facility slowed until the 1930s (Giebner 1992) (**Figure 7**).

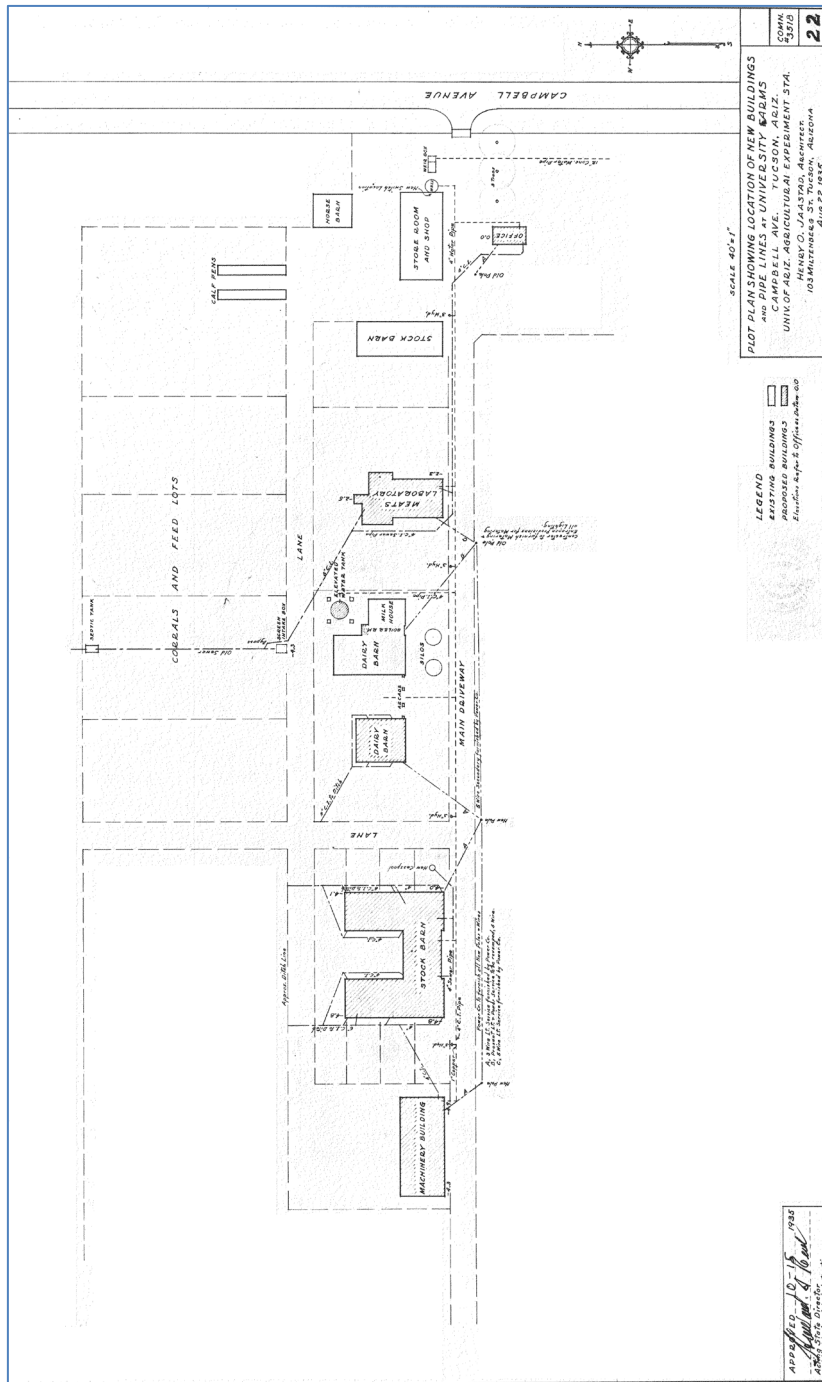
Figure 9. 1935 plot plan of new buildings and pipelines, as proposed by Henry O. Jaastad’s architectural firm. Note that the buildings east of the Meats Laboratory, except for the Storeroom, Shop and office, are no longer present. Additionally, the Water Tower next to the Storeroom and Shop is not depicted on this plot plan, though it was constructed in 1917 and enclosed in 1935. (Note, north is to the left.)

SCALE 40' = 1"
PLOT PLAN SHOWING LOCATION OF NEW BUILDINGS AND PIPE LINES AT UNIVERSITY FARMS CAMPBELL AVE. TUCSON, ARIZ. UNIV. OF ARIZ. AGRICULTURAL EXPERIMENT STA.
 HENRY O. JAASTAD, ARCHITECT.
 103 MILTENBERG ST. TUCSON, ARIZONA
 AUG. 22, 1935.

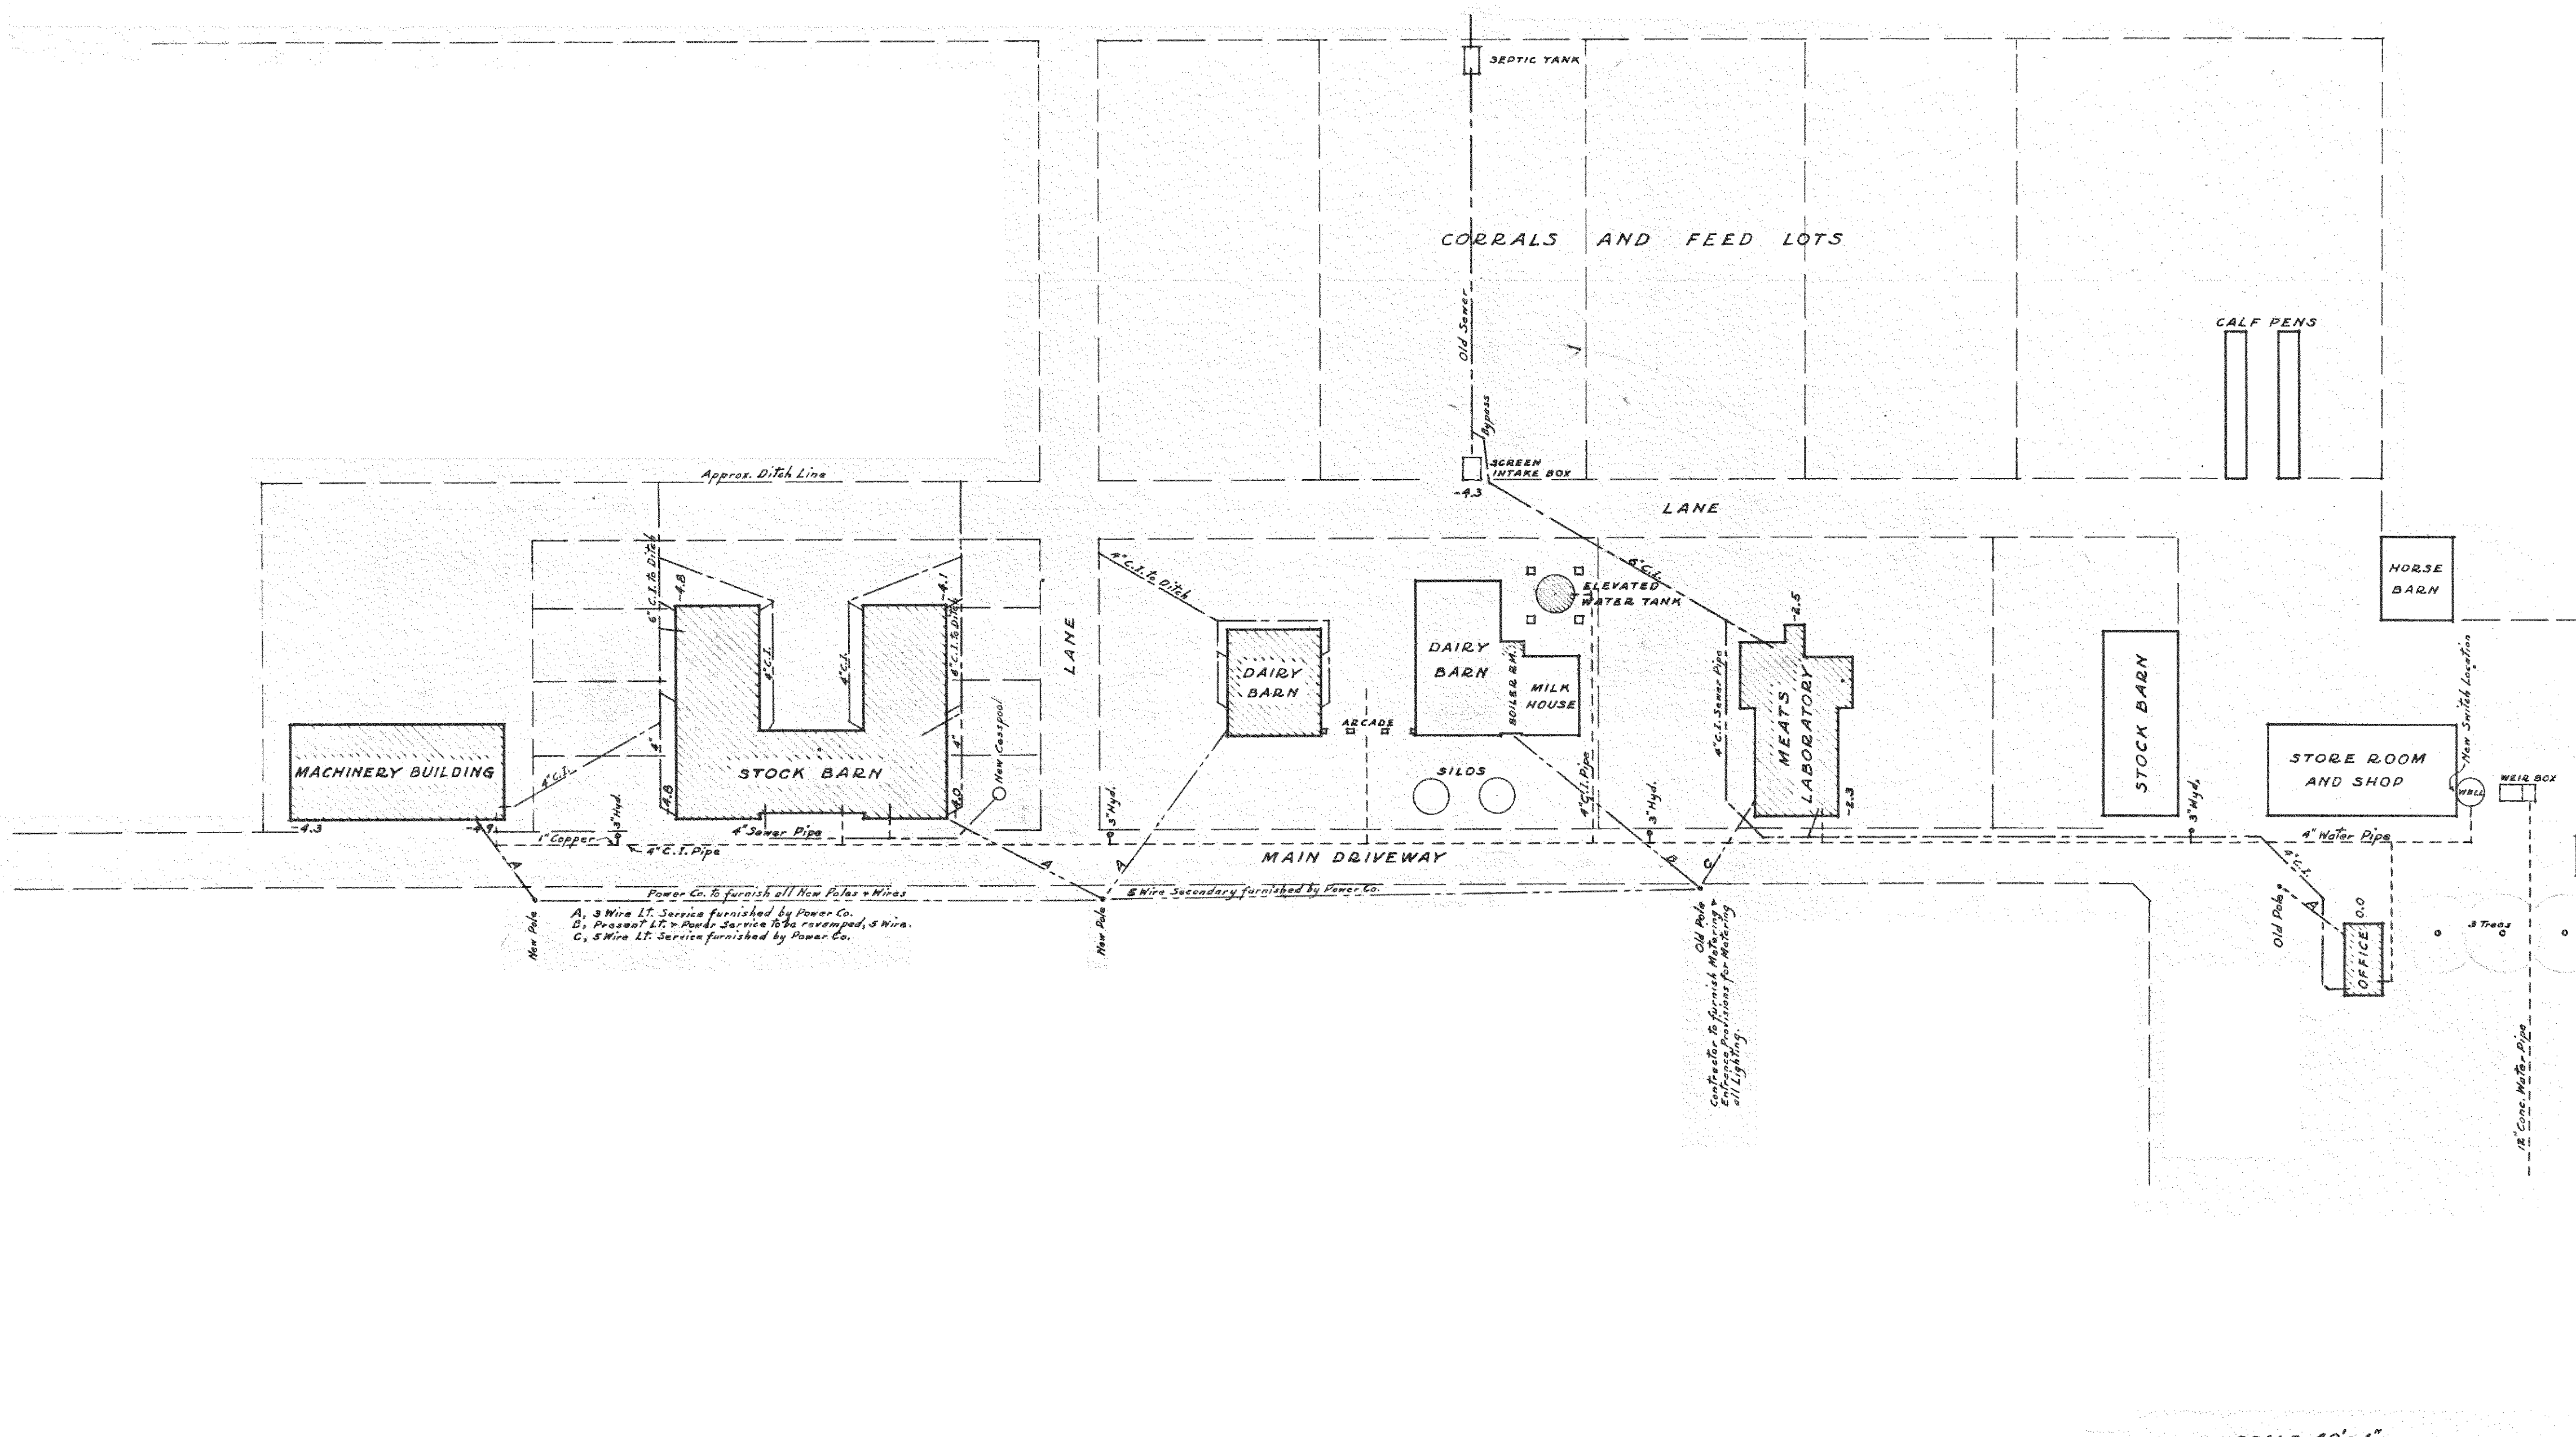
Power Co. to furnish all New Poles & Wires
 A, 3 Wire LT. Service furnished by Power Co.
 B, Present LT. & Power Service to be revamped, 5 Wire.
 C, 5 Wire LT. Service furnished by Power Co.

Old Pole
 Contractor to furnish repairing & all Lighting

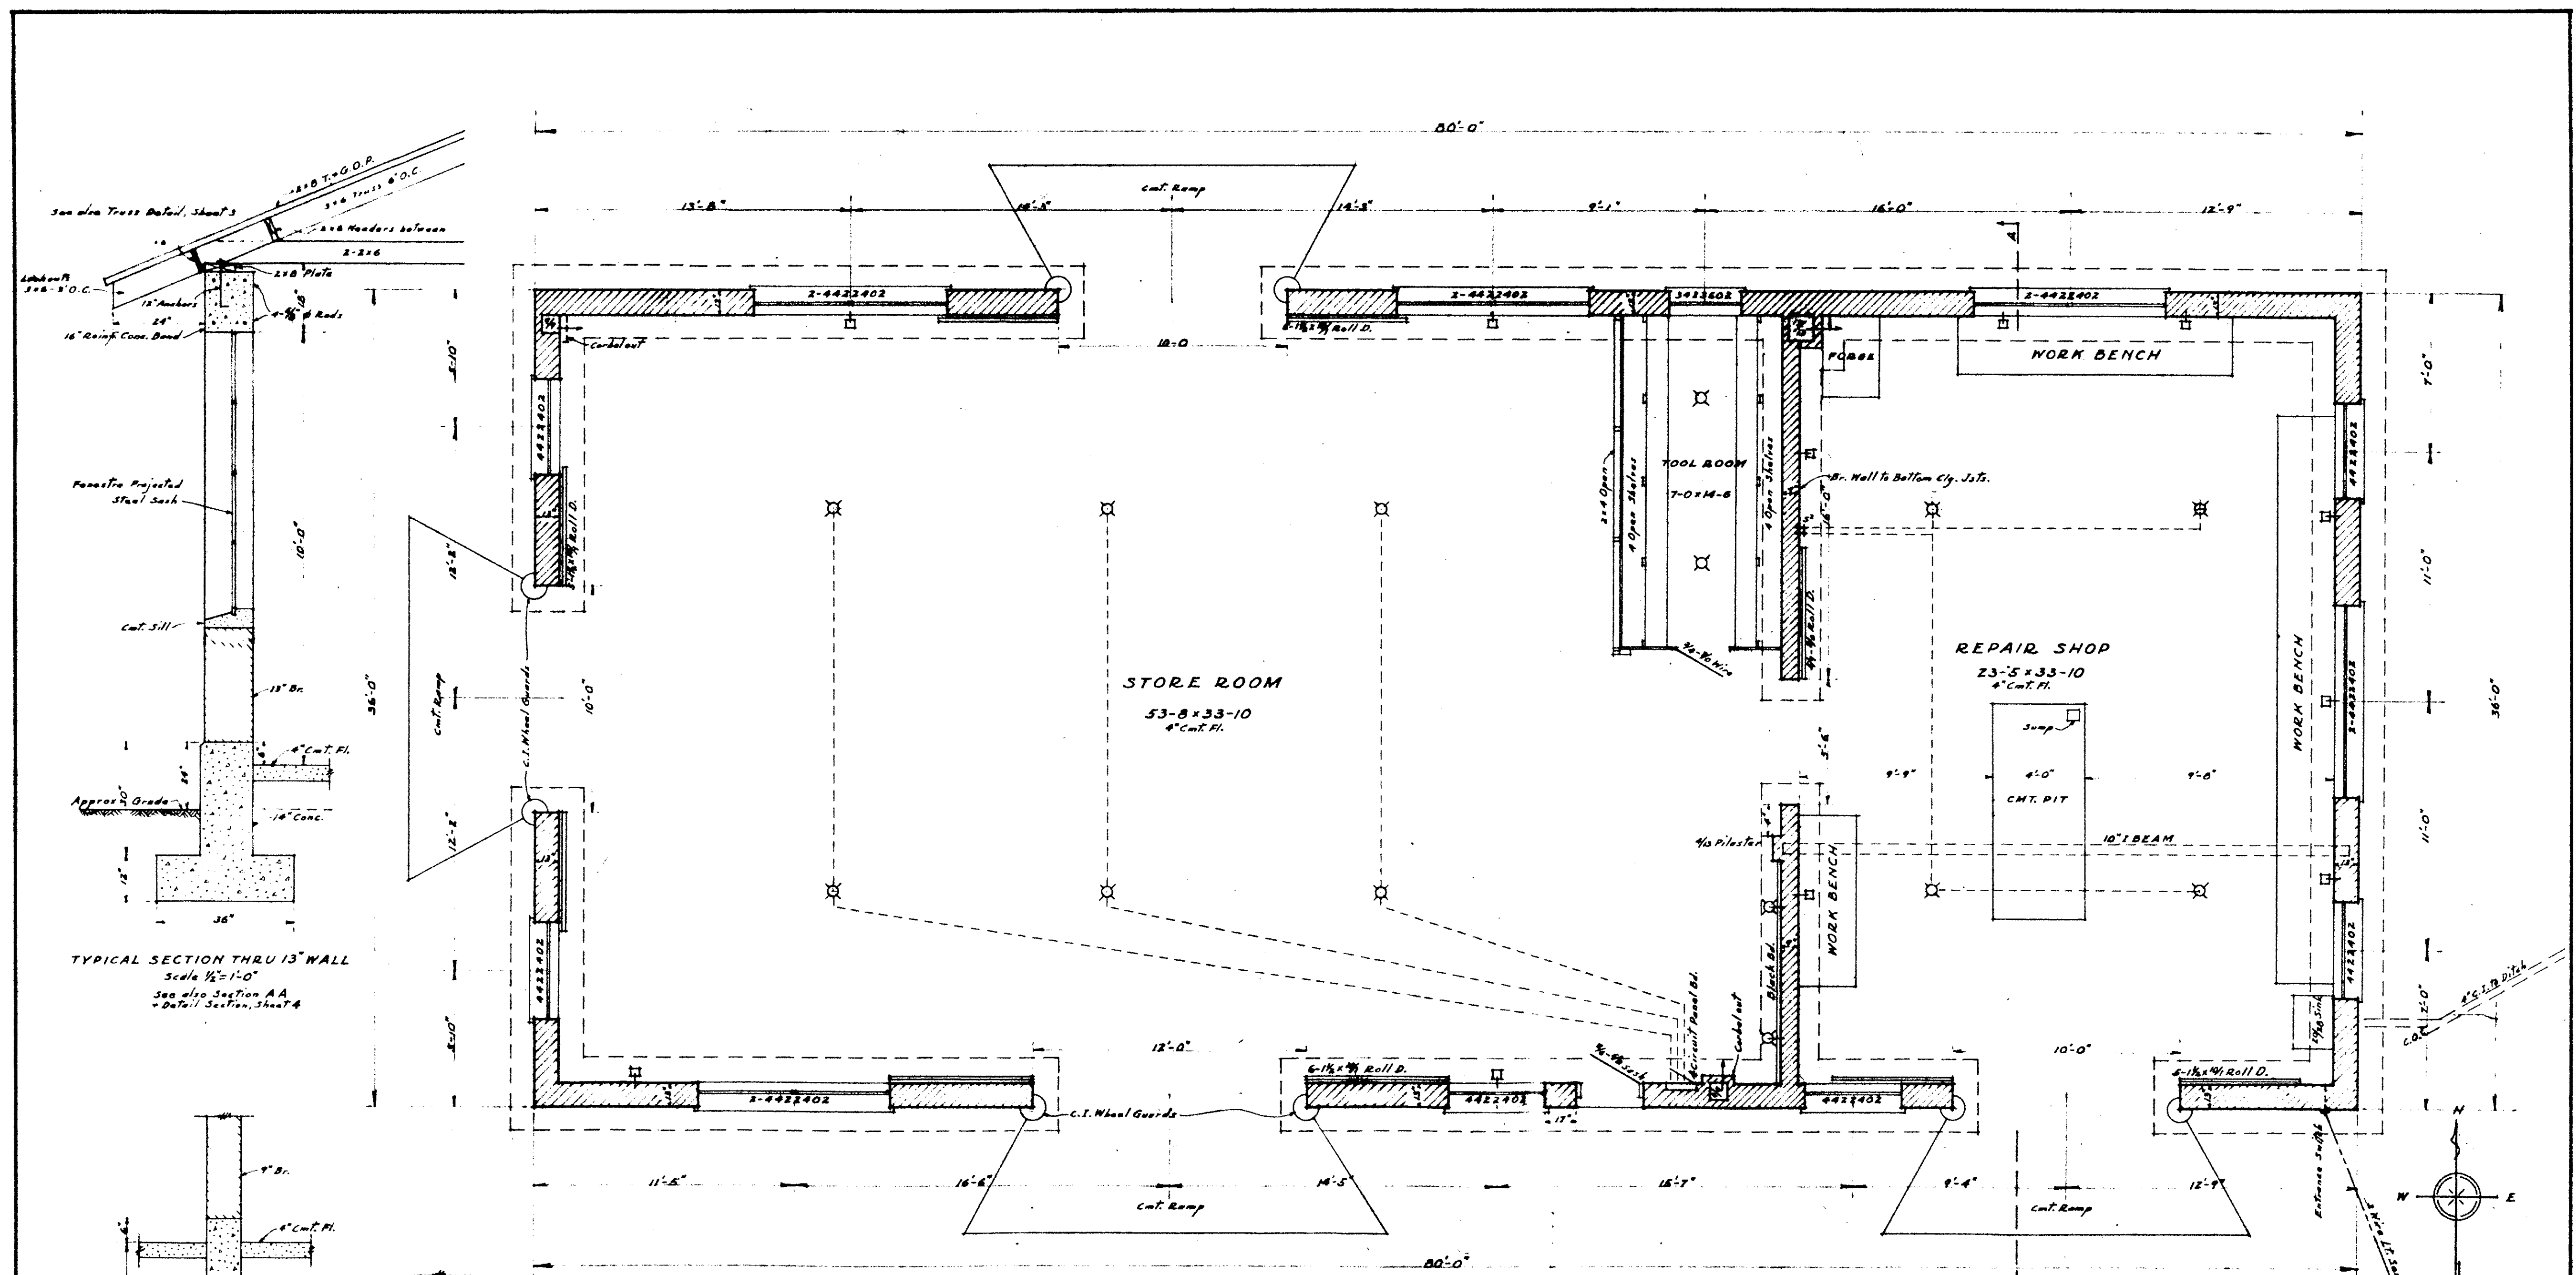
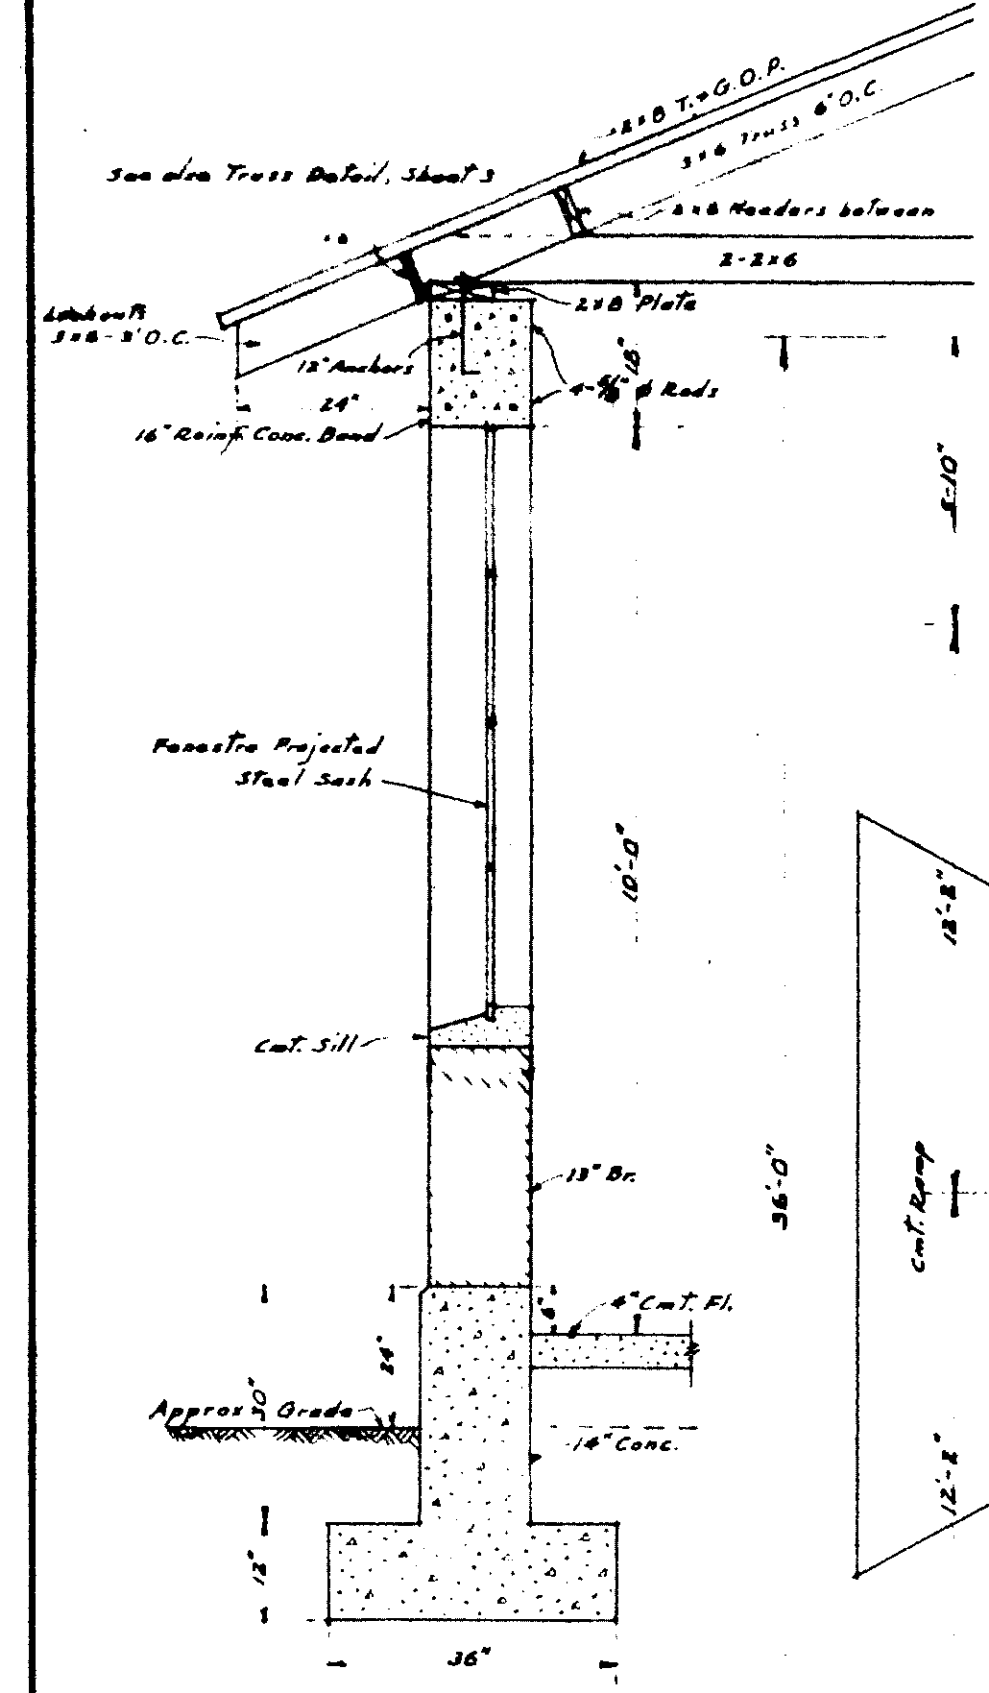
TYPICAL SECTION THRU 13" WALL
Scale 1/2"=1'-0"
See also Section AA
+ Detail Section, Sheet 4

TYPICAL SECTION THRU 9" WALL
Scale 1/2"=1'-0"

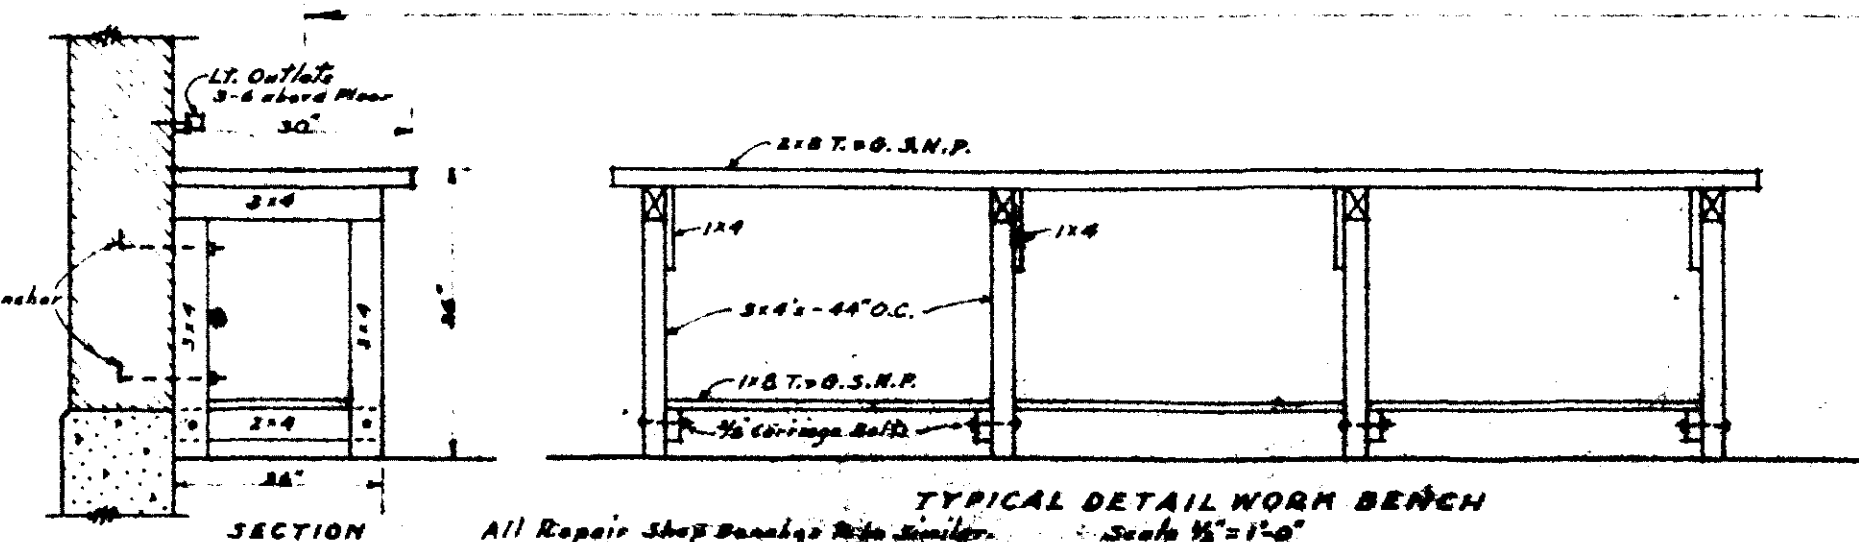
TYPICAL DETAIL WORK BENCH
Scale 1/2"=1'-0"
All Repair Shop Benches Like Similar

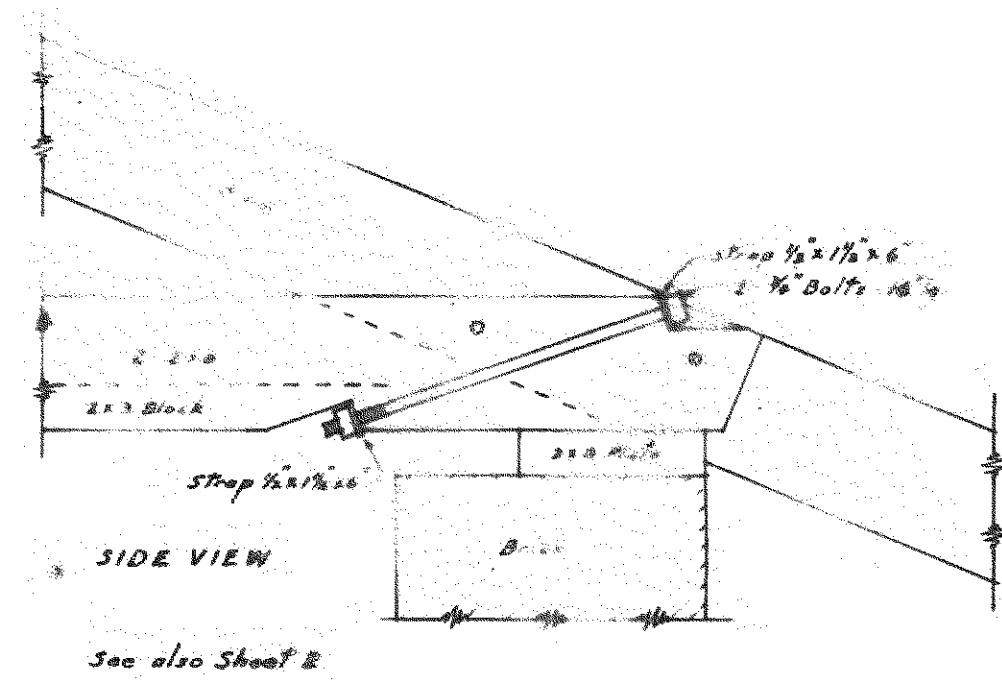
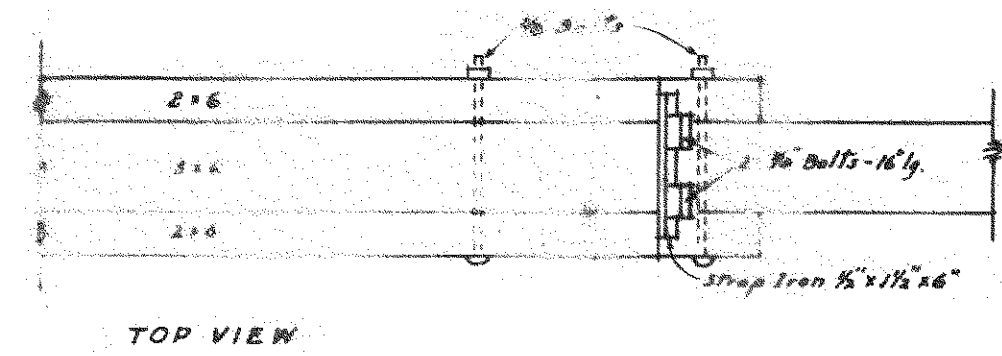
DETAIL ENDS OF TRUSSES
Scale 1/4" = 1'-0"
Typical for Trusses on Machinery Building at Maats Laboratory

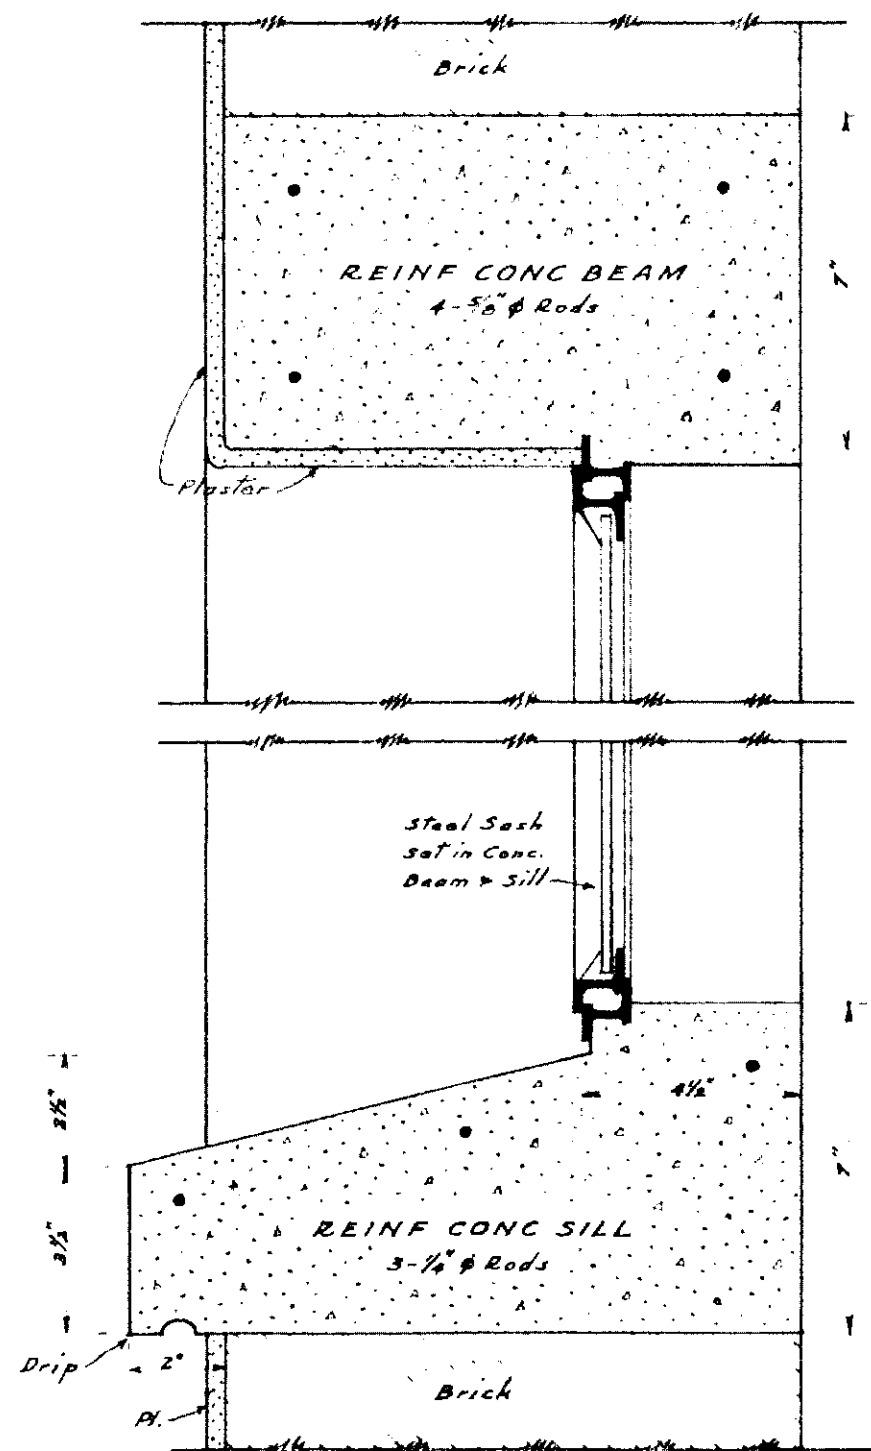
DETAIL WINDOW SECTION
Scale 3" = 1'-0"
TYPICAL FOR ALL FARM BLDGS.

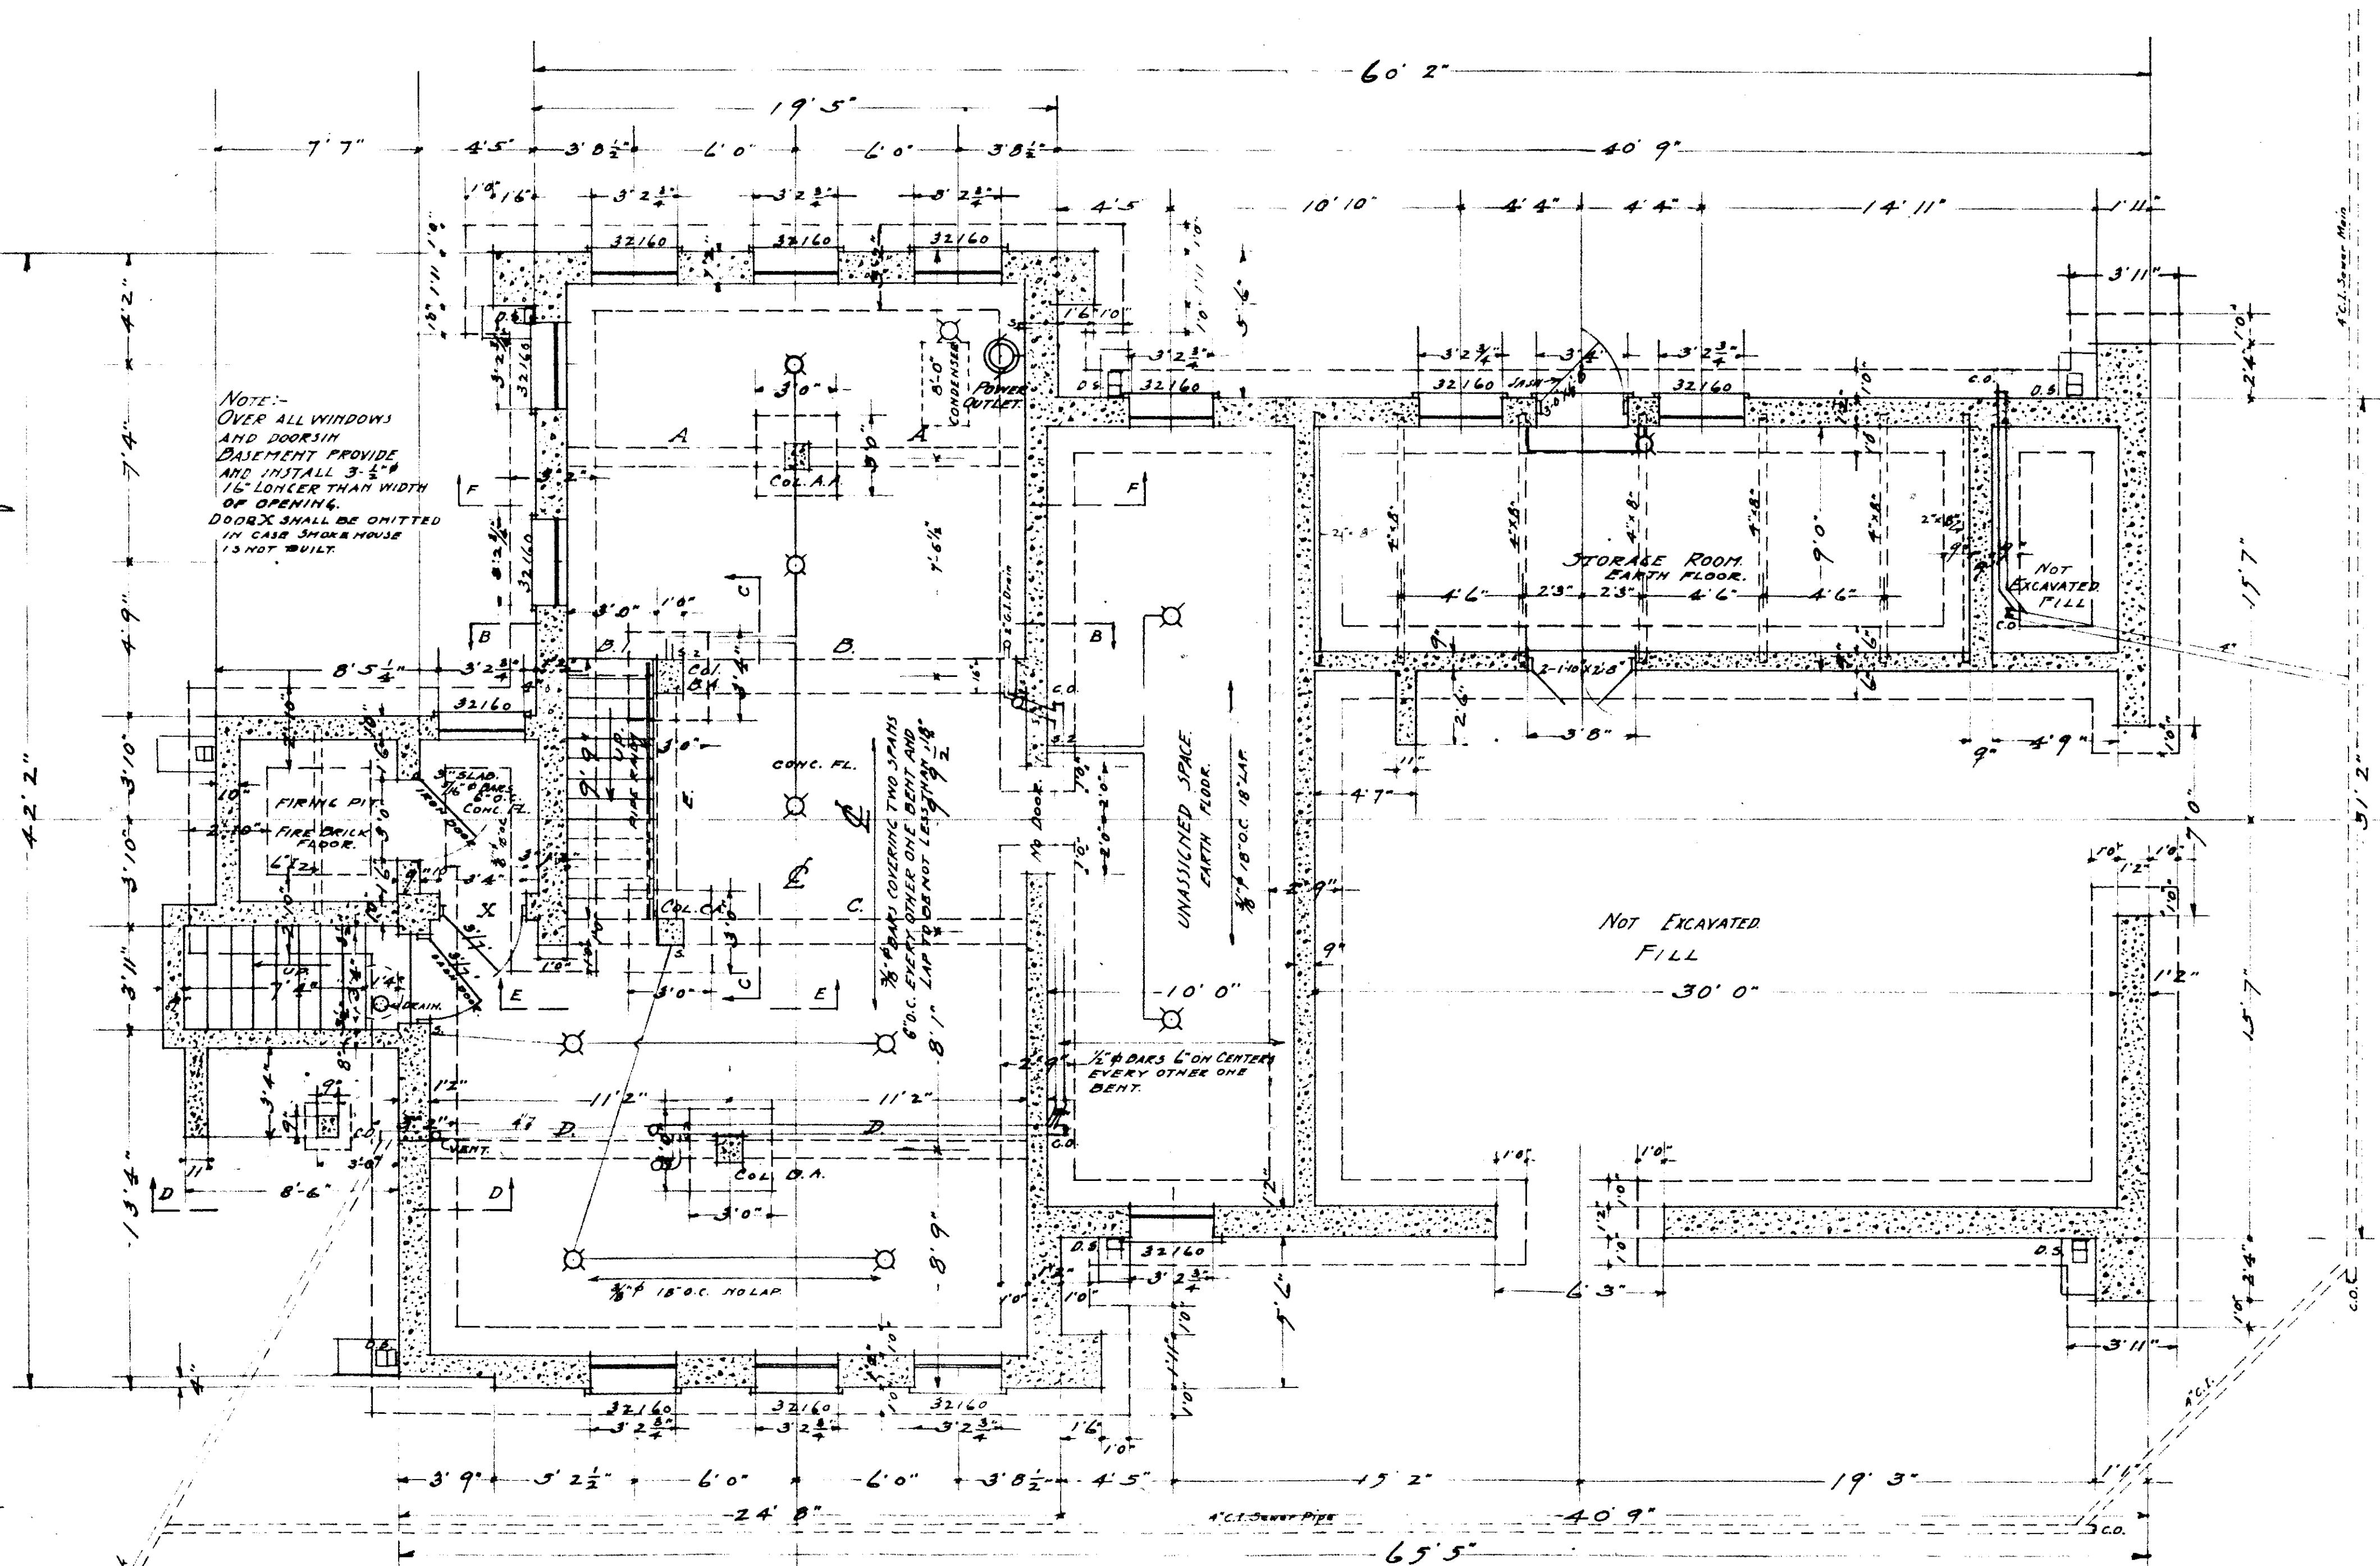
FOUNDATION PLAN
Scale 1/4" = 1'-0"
