National Register of Historic Places Registration Form

Historic name: University of Arizona Campus Agricultural Center
 Other names/site number: Campus Farm, Campbell Avenue Farm, University Farm; University Campus Farm Complex
 Name of related multiple property listing:
N/A
 (Enter "N/A" if property is not part of a multiple property listing)

Street & number: 4101 N. Campbell Avenue
 City or town: Tucson State: Arizona County: Pima County
 Not For Publication: Vicinity:

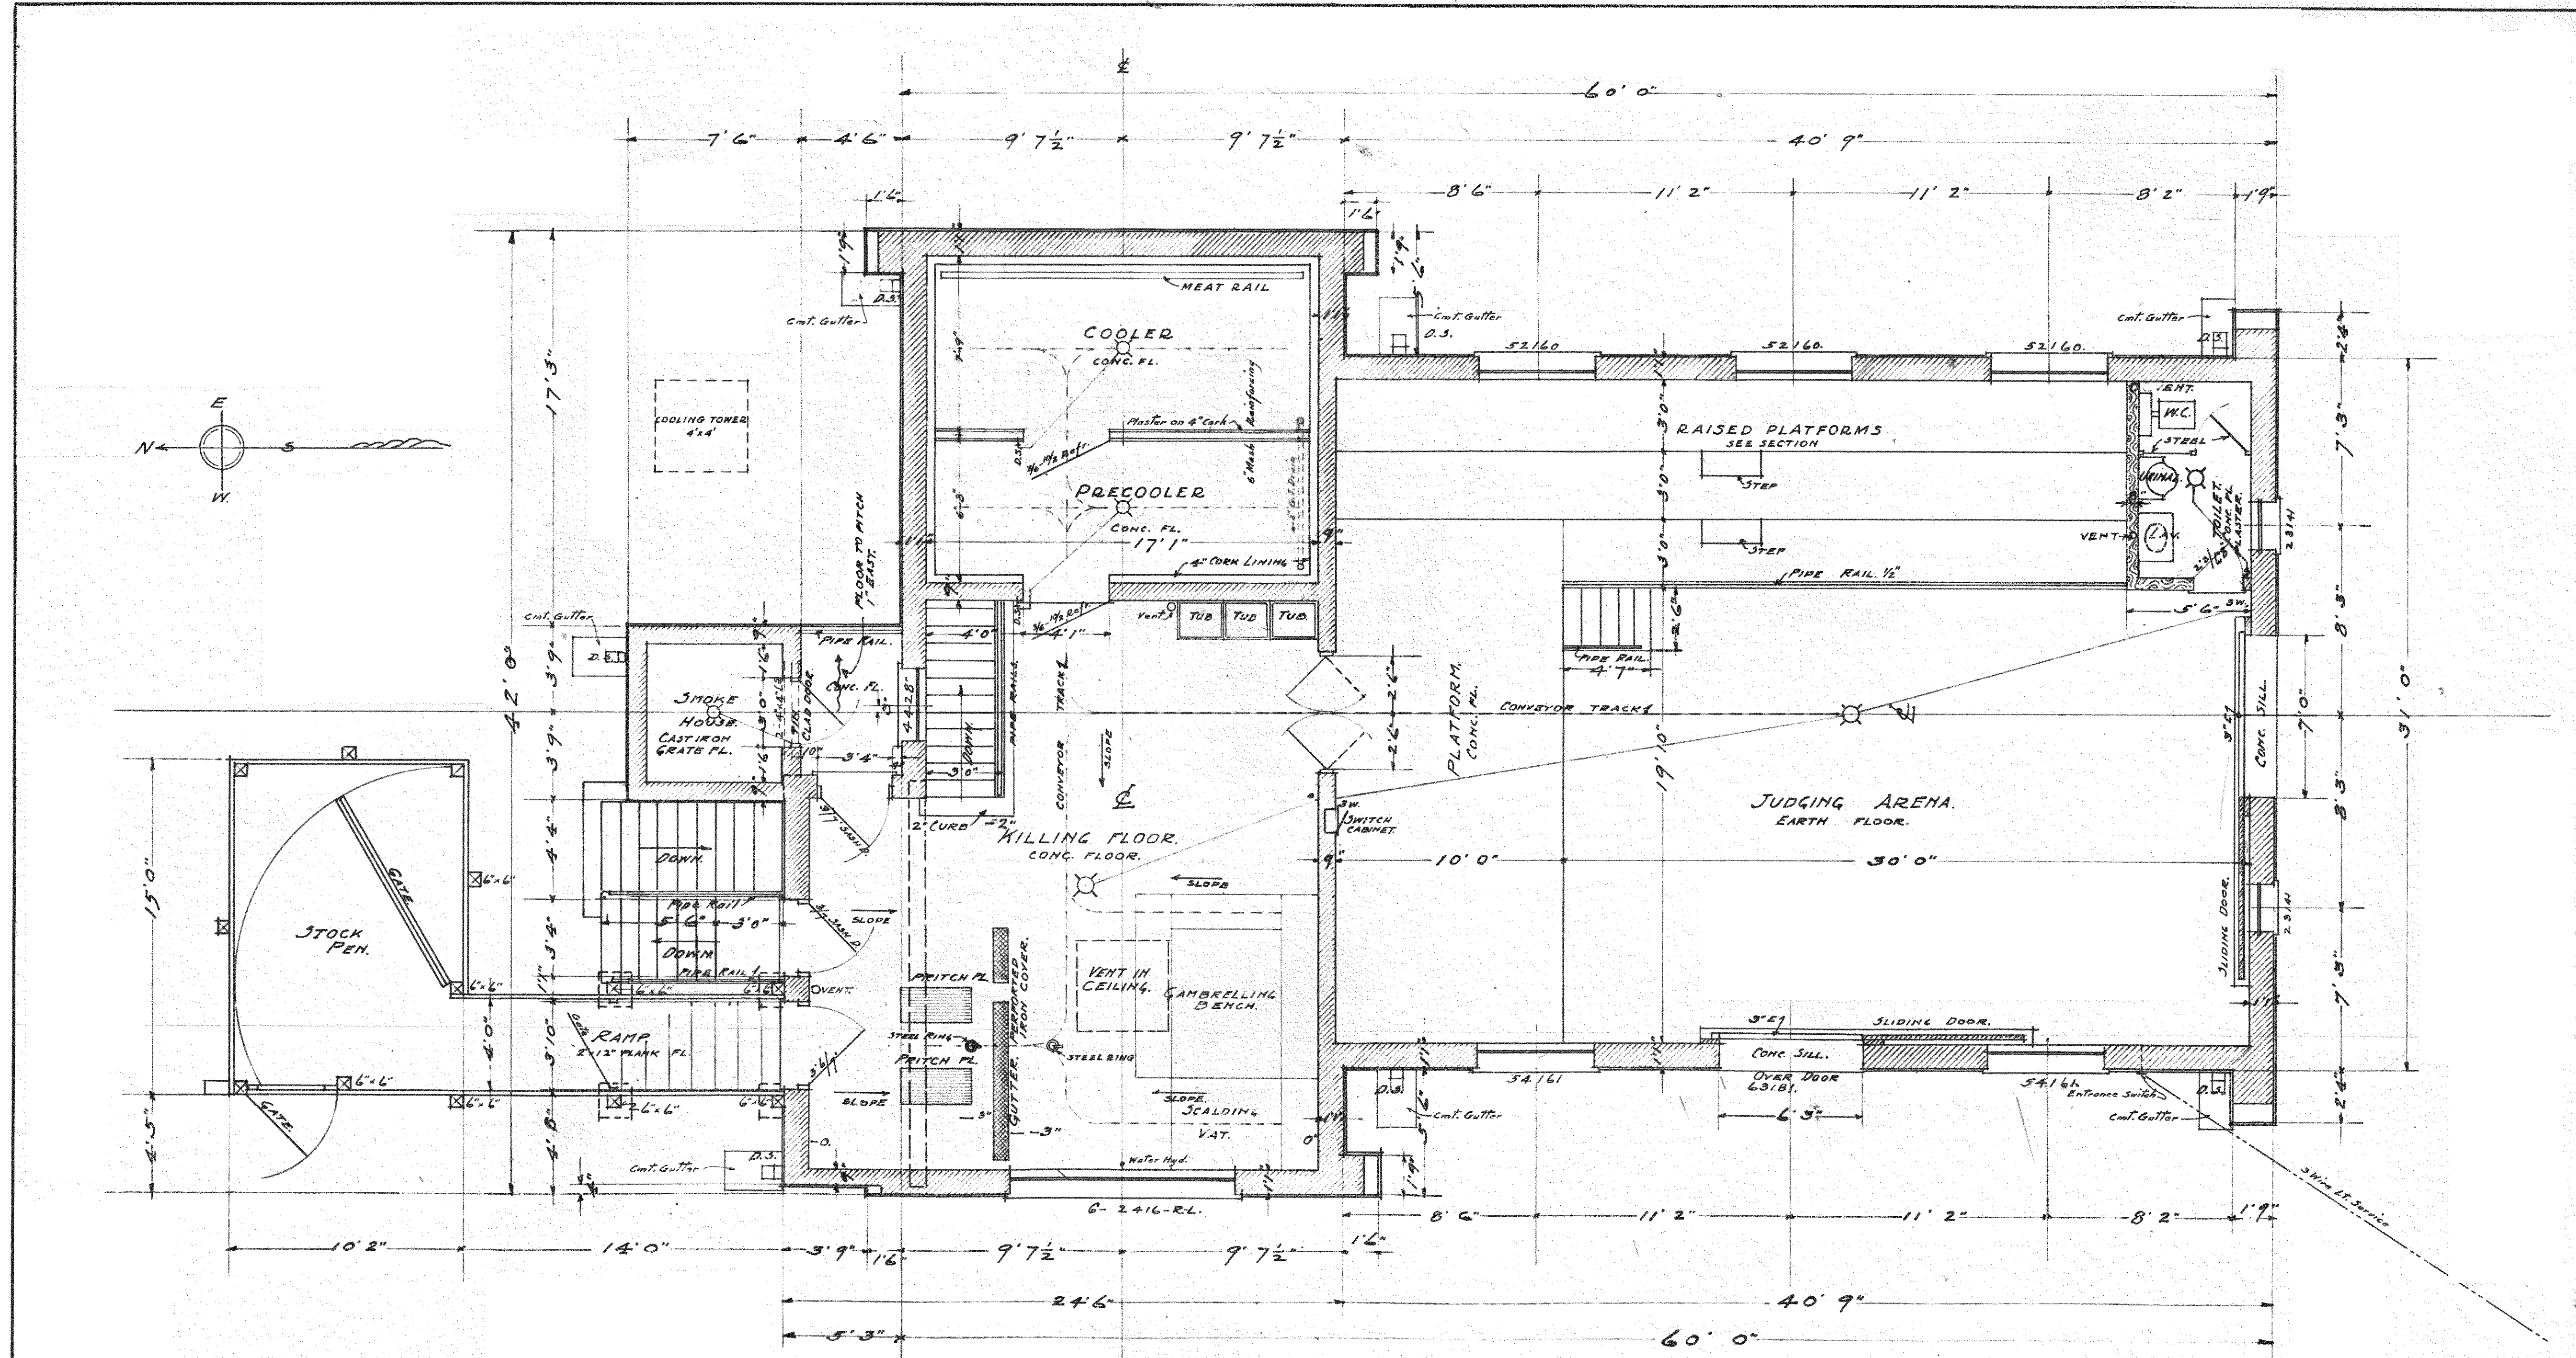
FLOOR PLAN
Scale 1/4" = 1'-0"

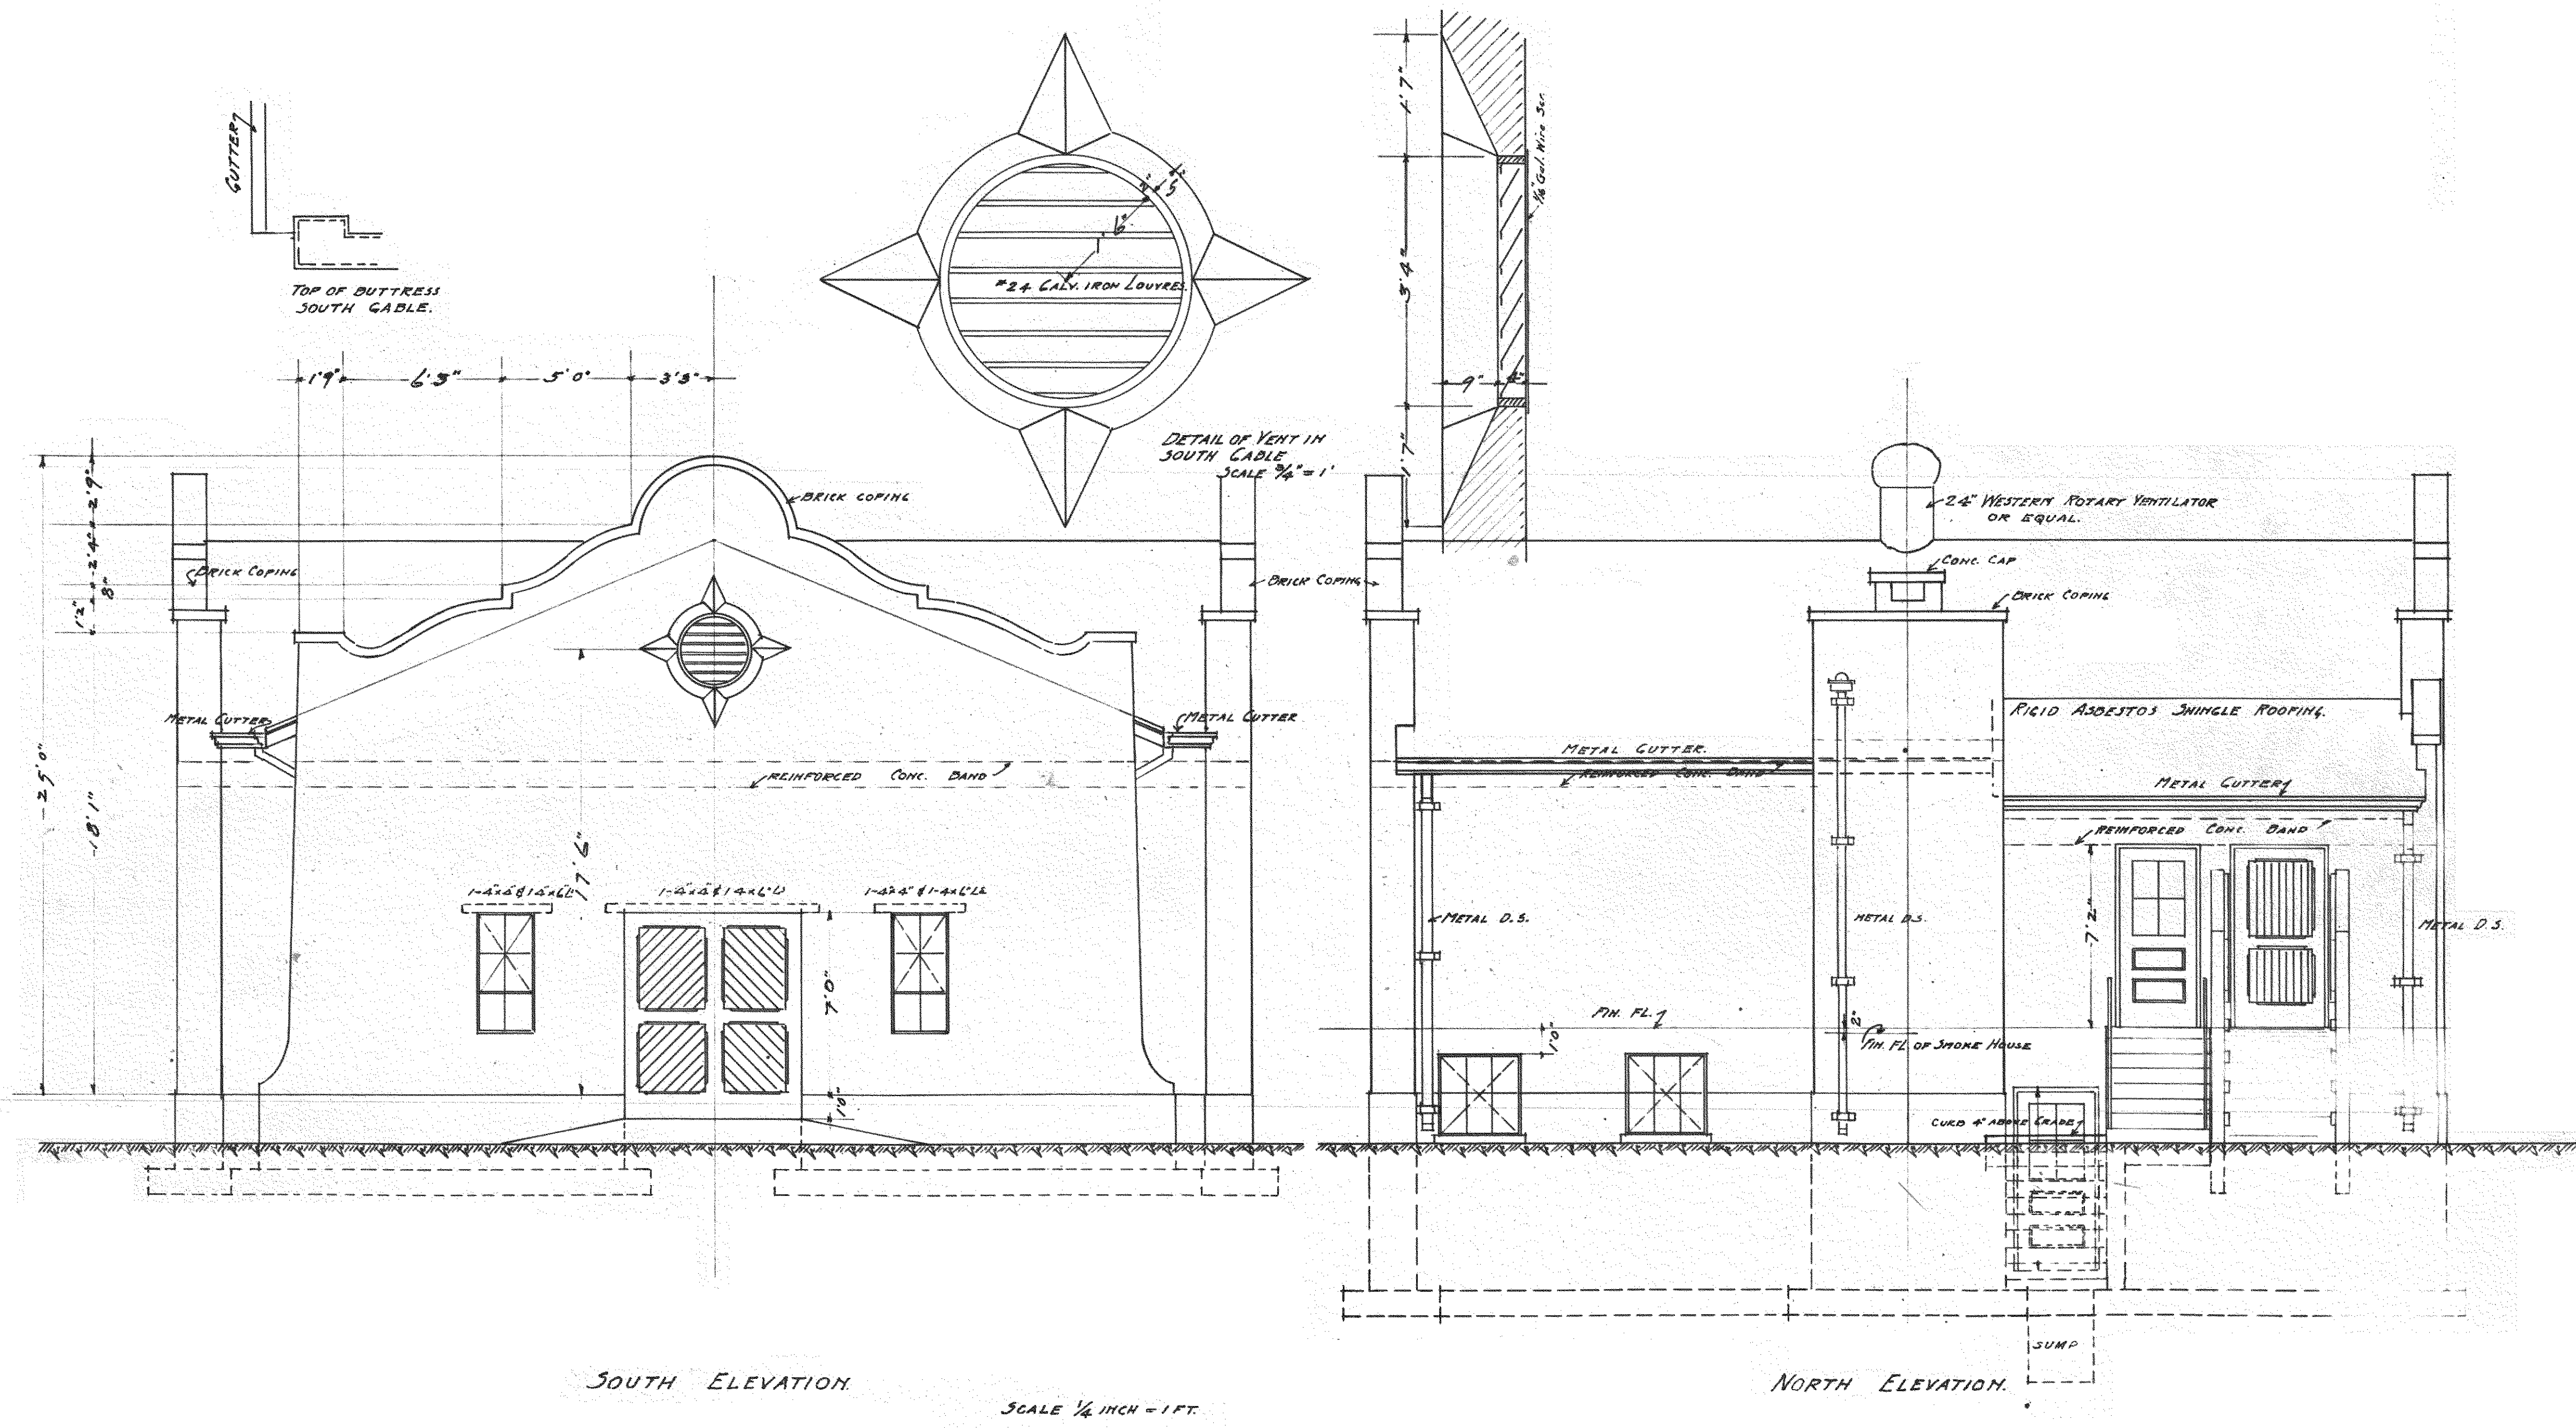
SOUTH ELEVATION
SCALE 1/4 INCH = 1 FT.

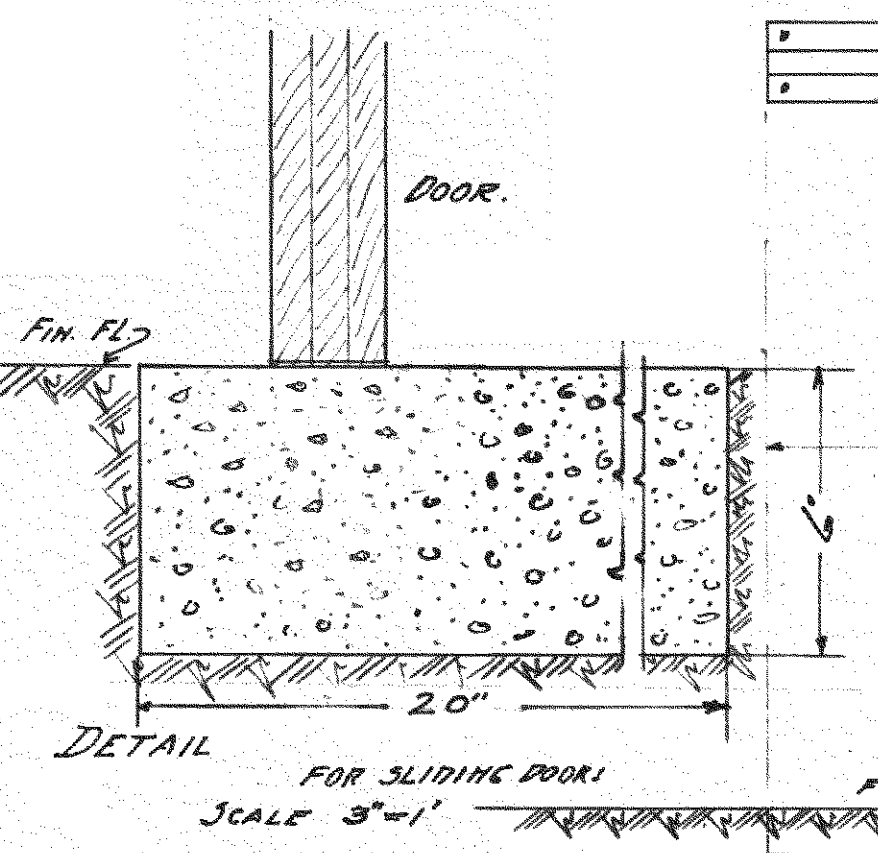
SLIDING DOOR FOR 6'3" x 7'0" BRICK OPENING.
SCALE 3/4"=1'

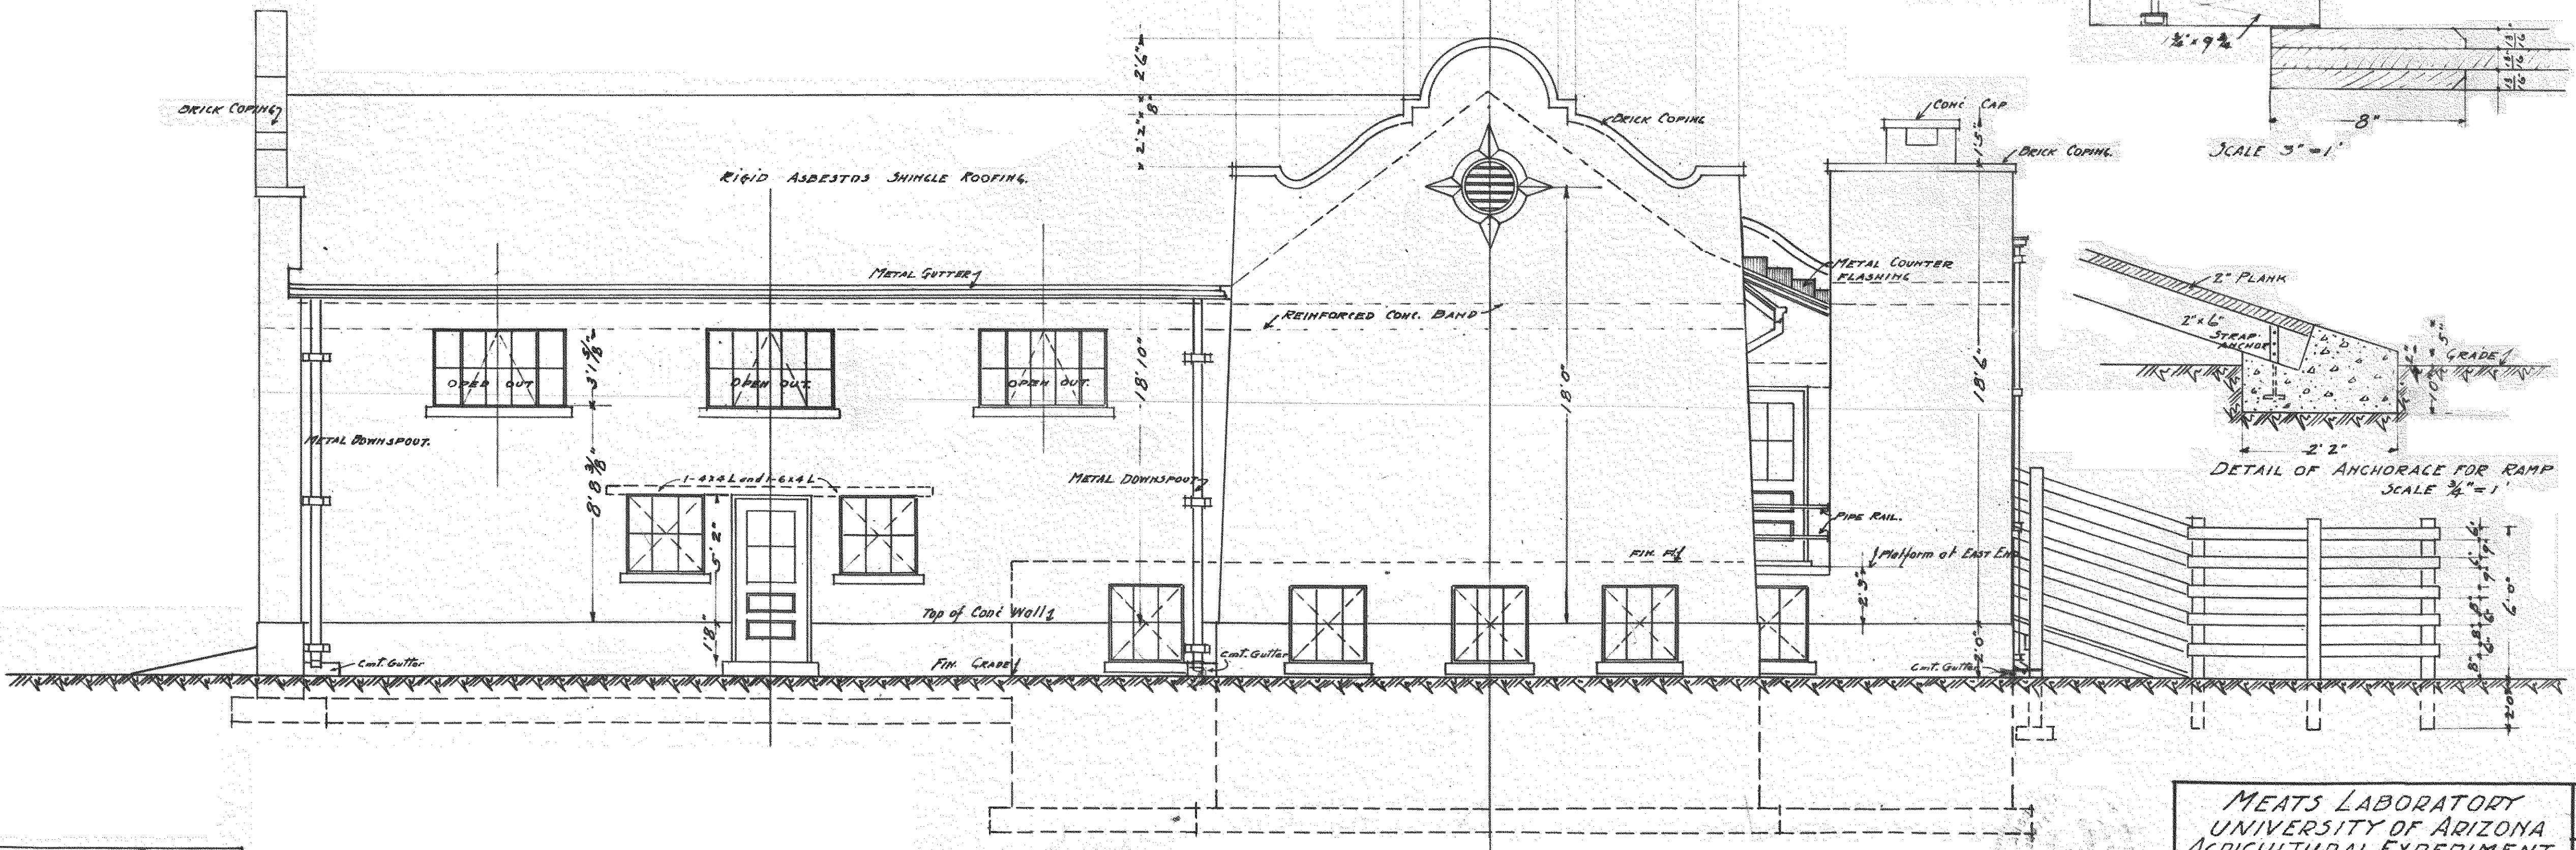
EAST ELEVATION
SCALE 1/2" INCH = 1 FOOT.

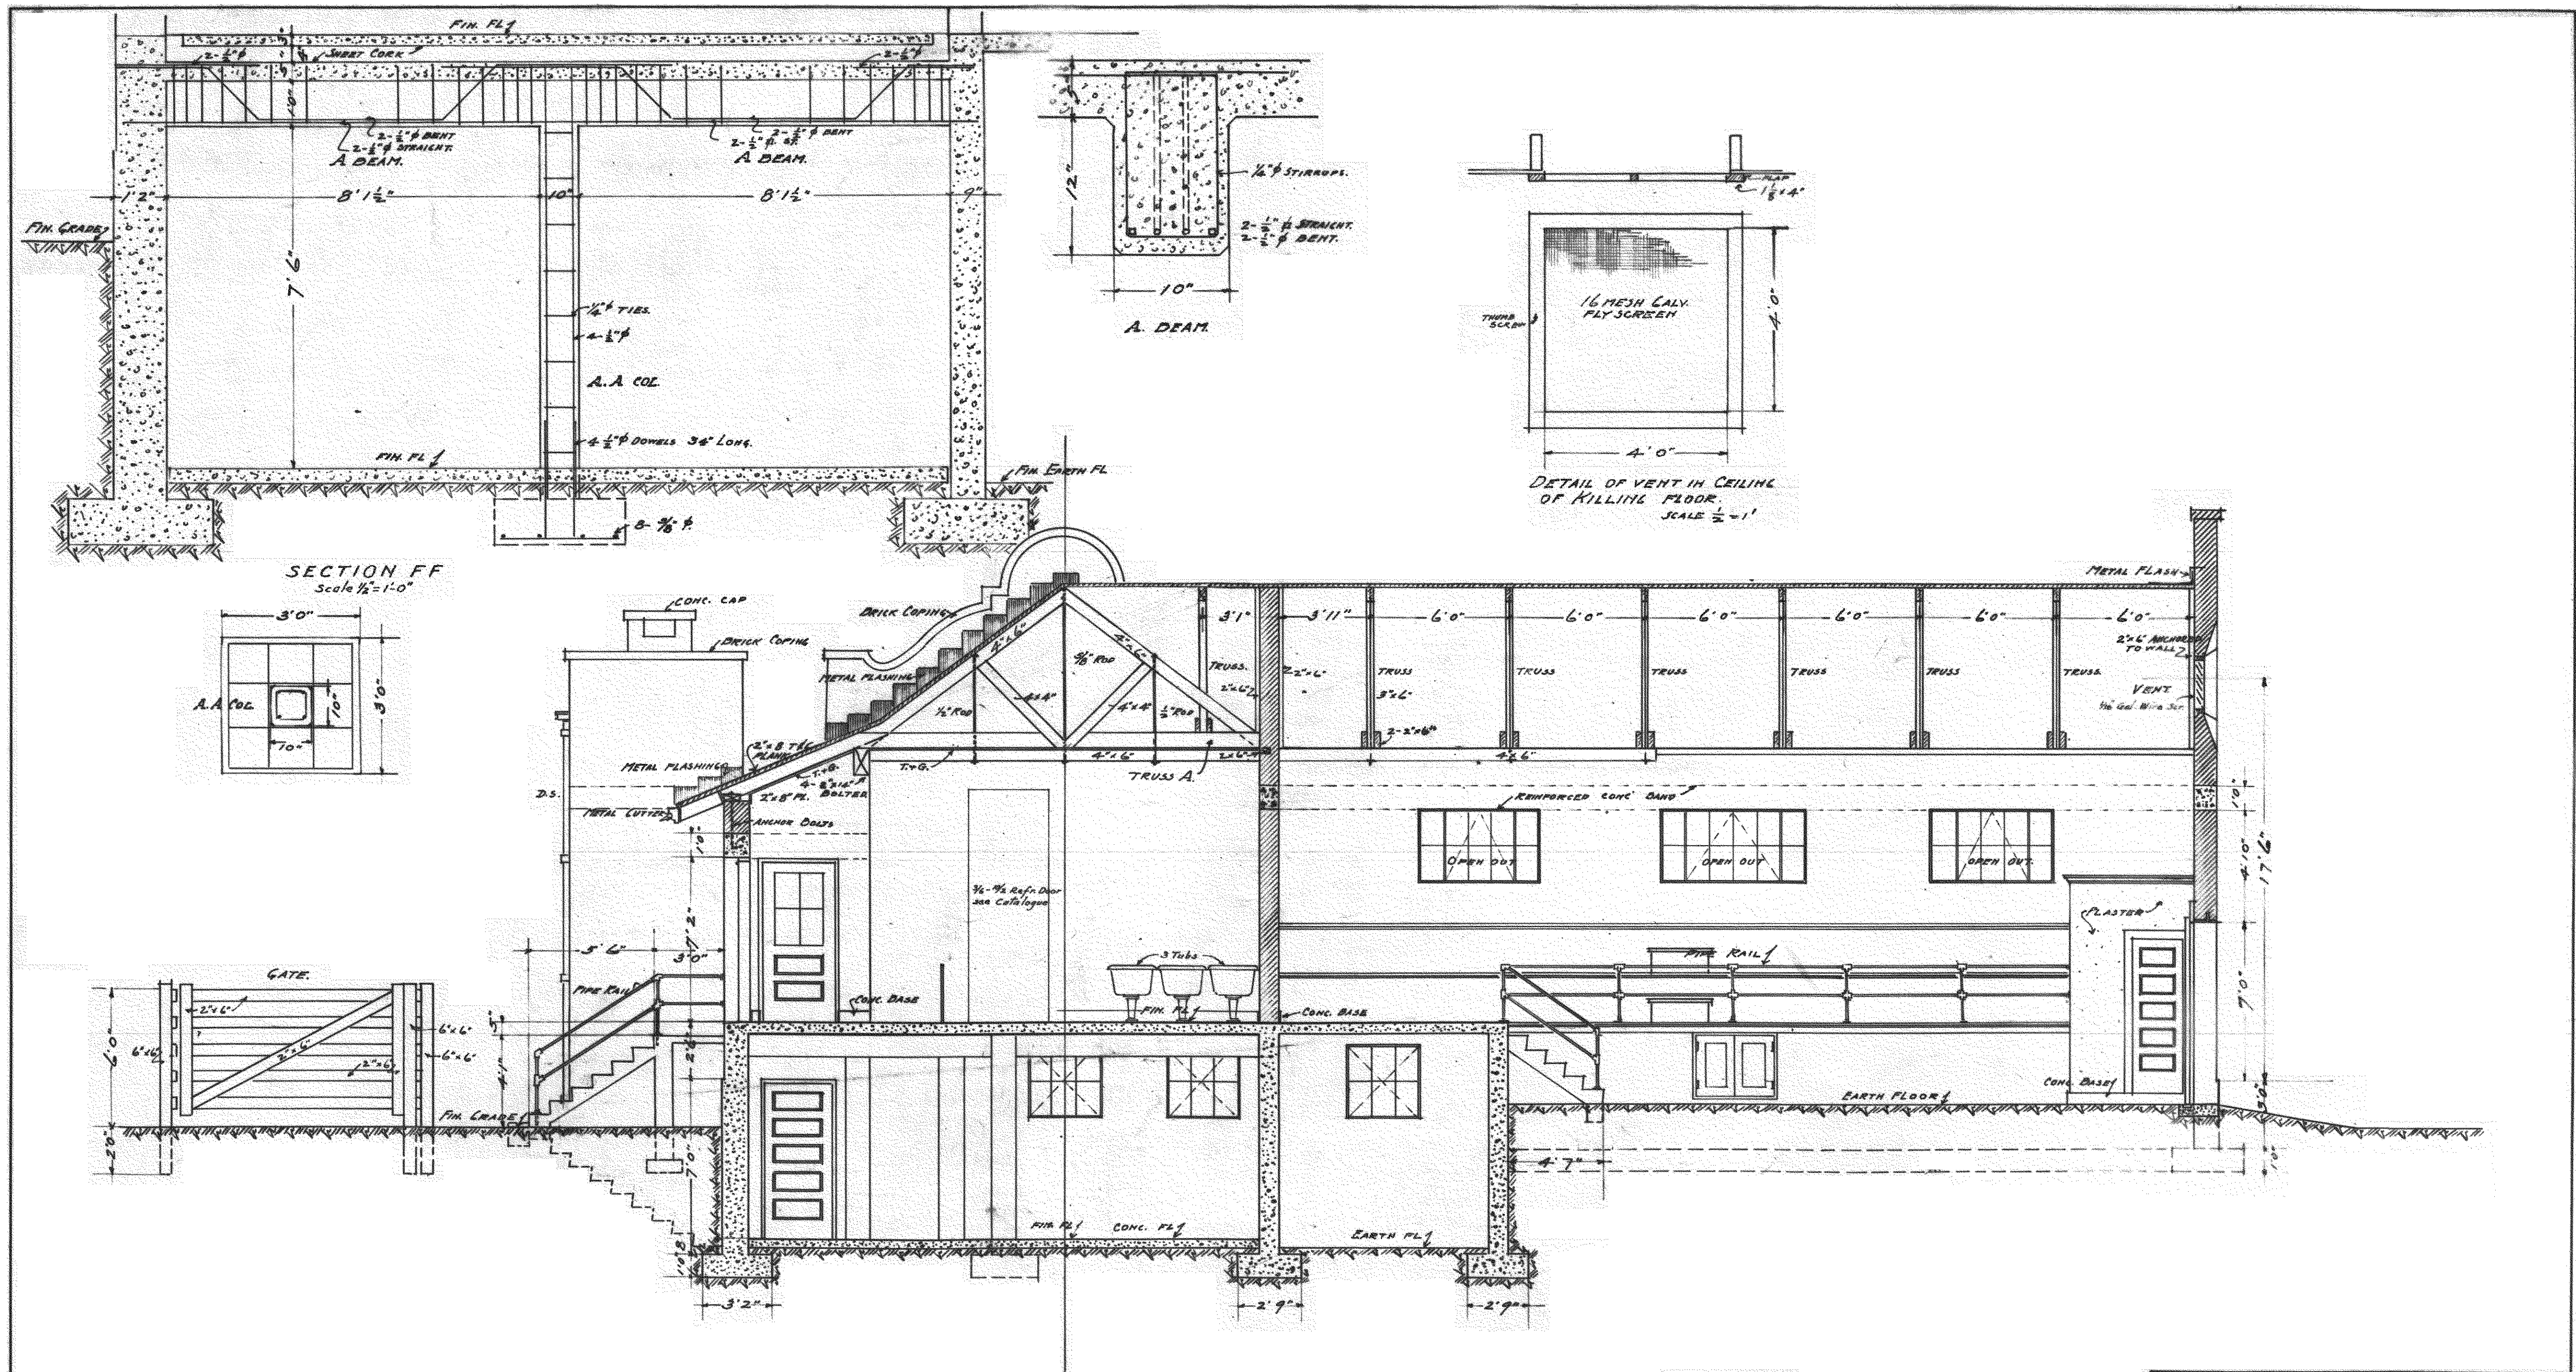
SECTION FF
Scale 1/2" = 1'-0"

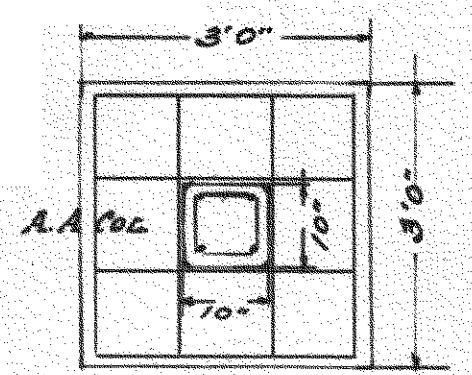
LONGITUDINAL SECTION
Scale 1/4" = 1 FT.

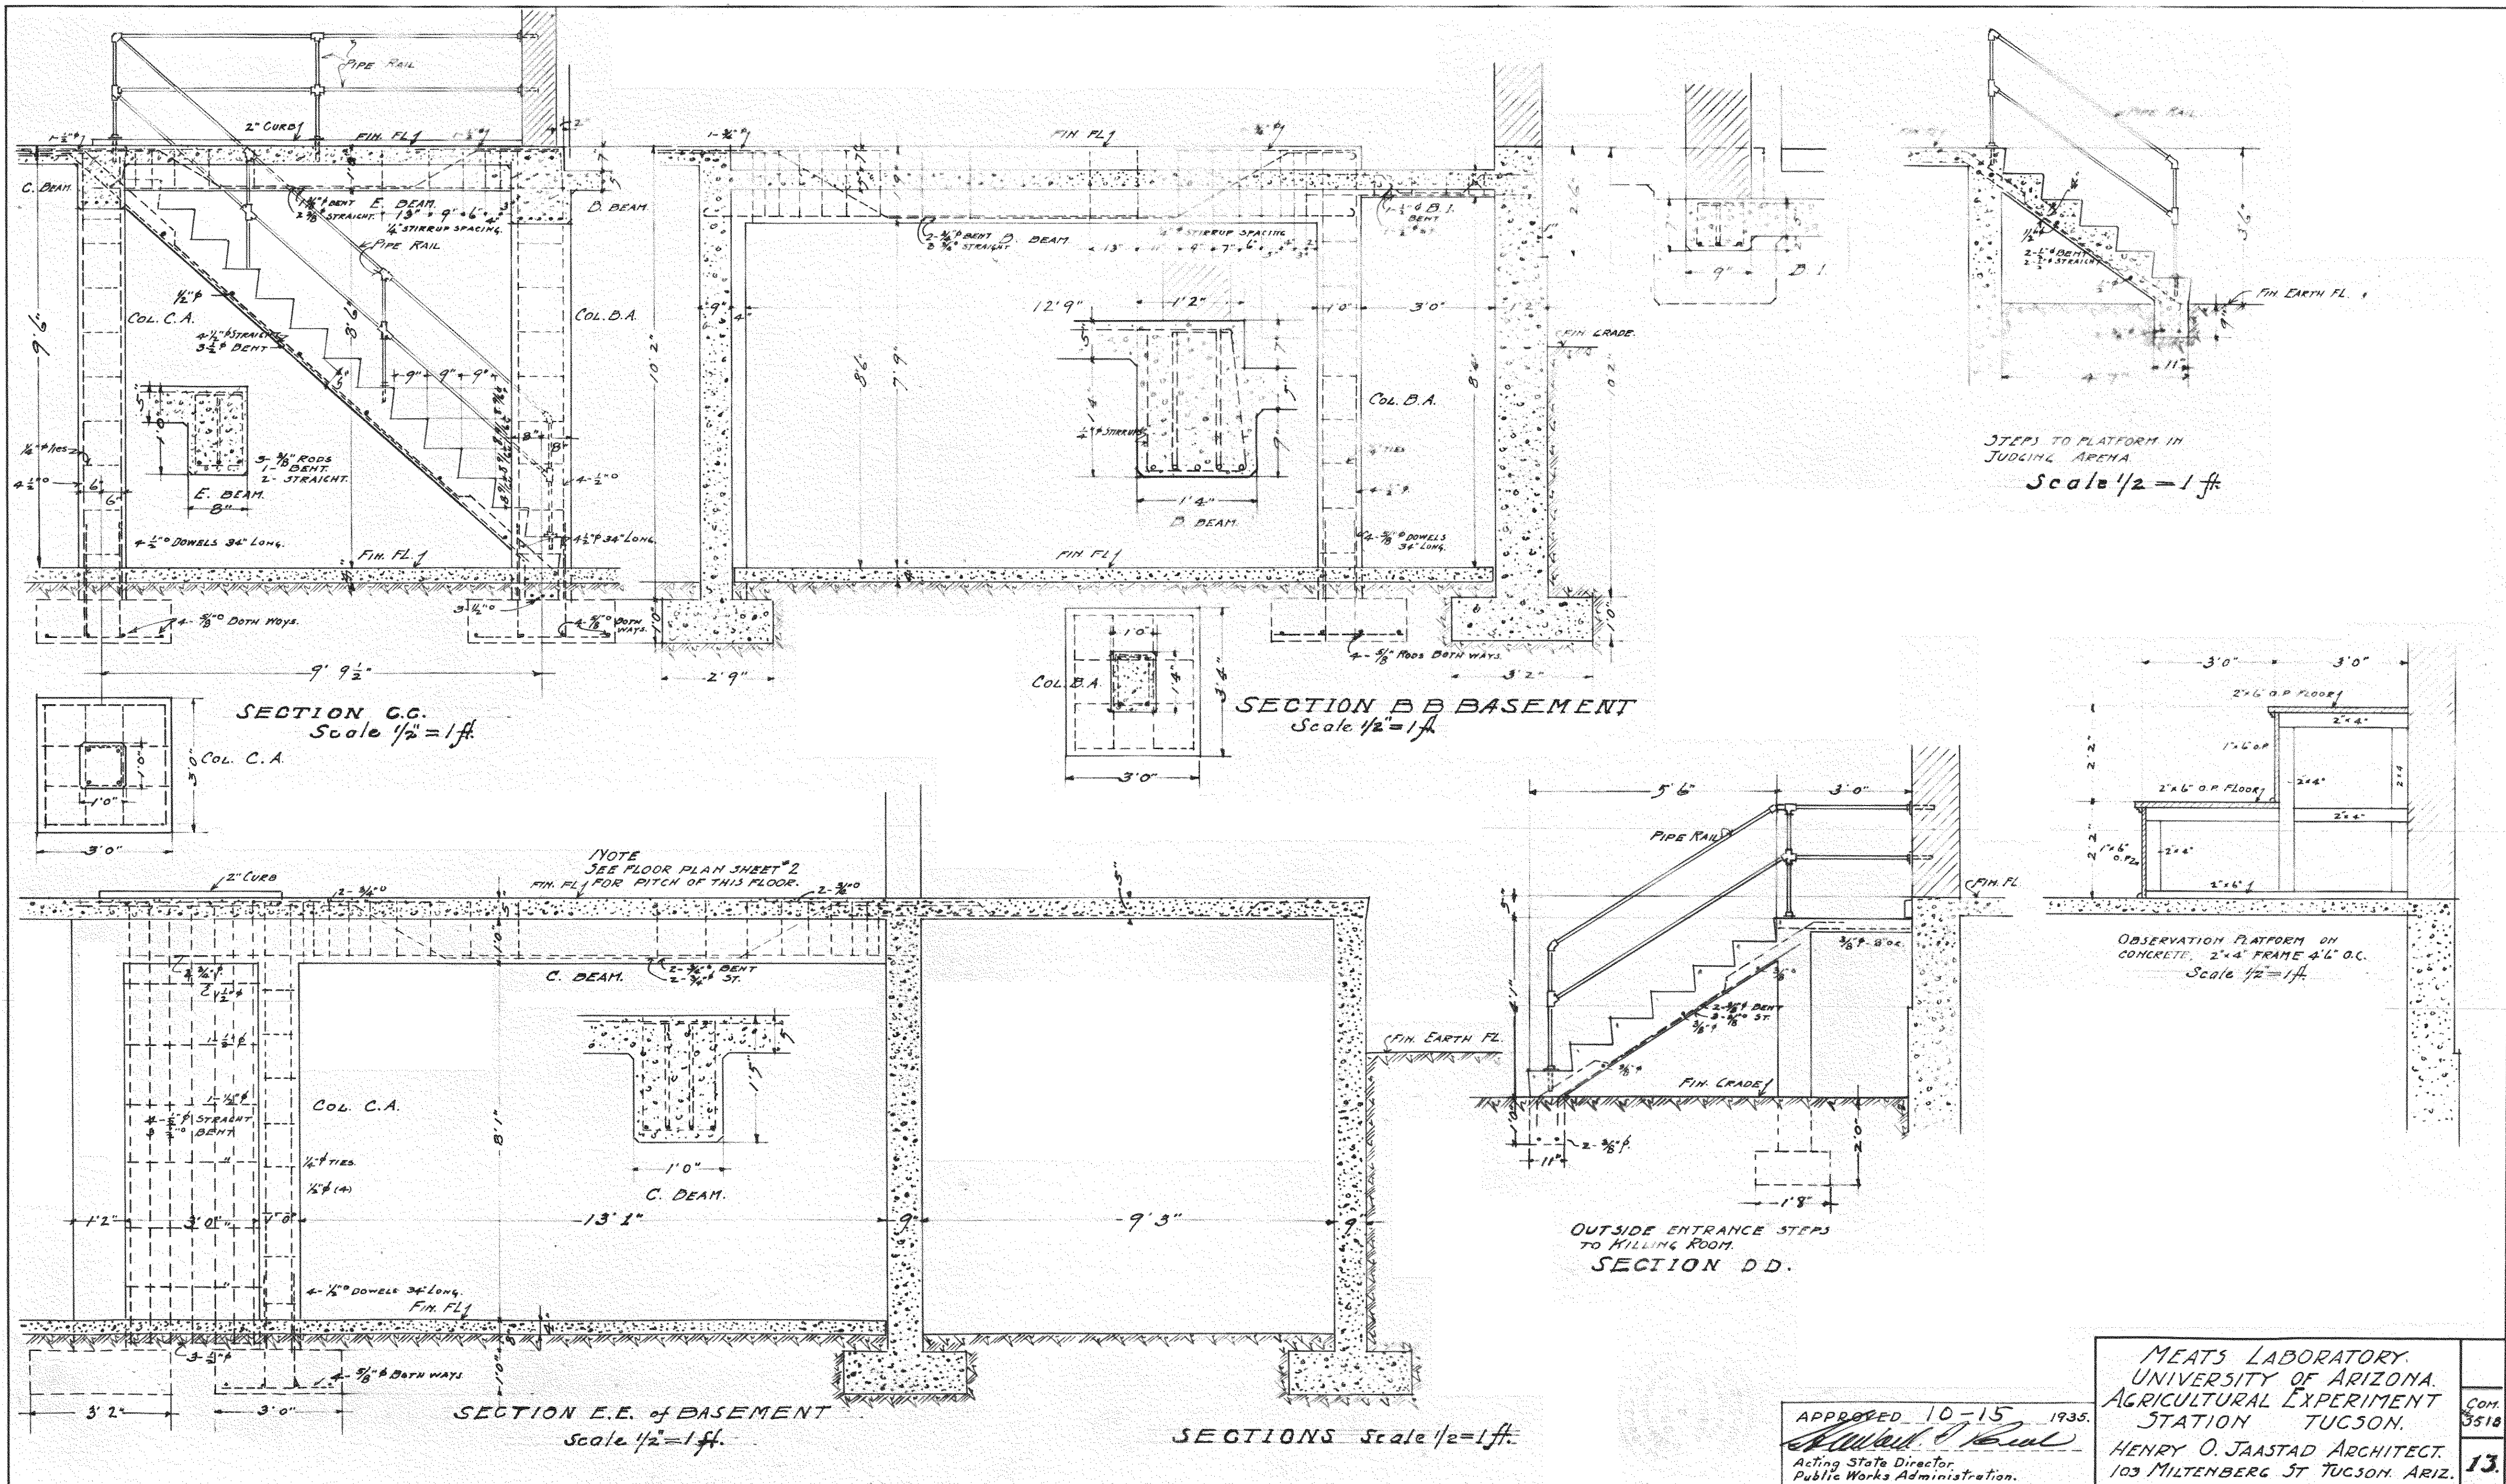
SECTION C.C.
Scale 1/2" = 1 ft.

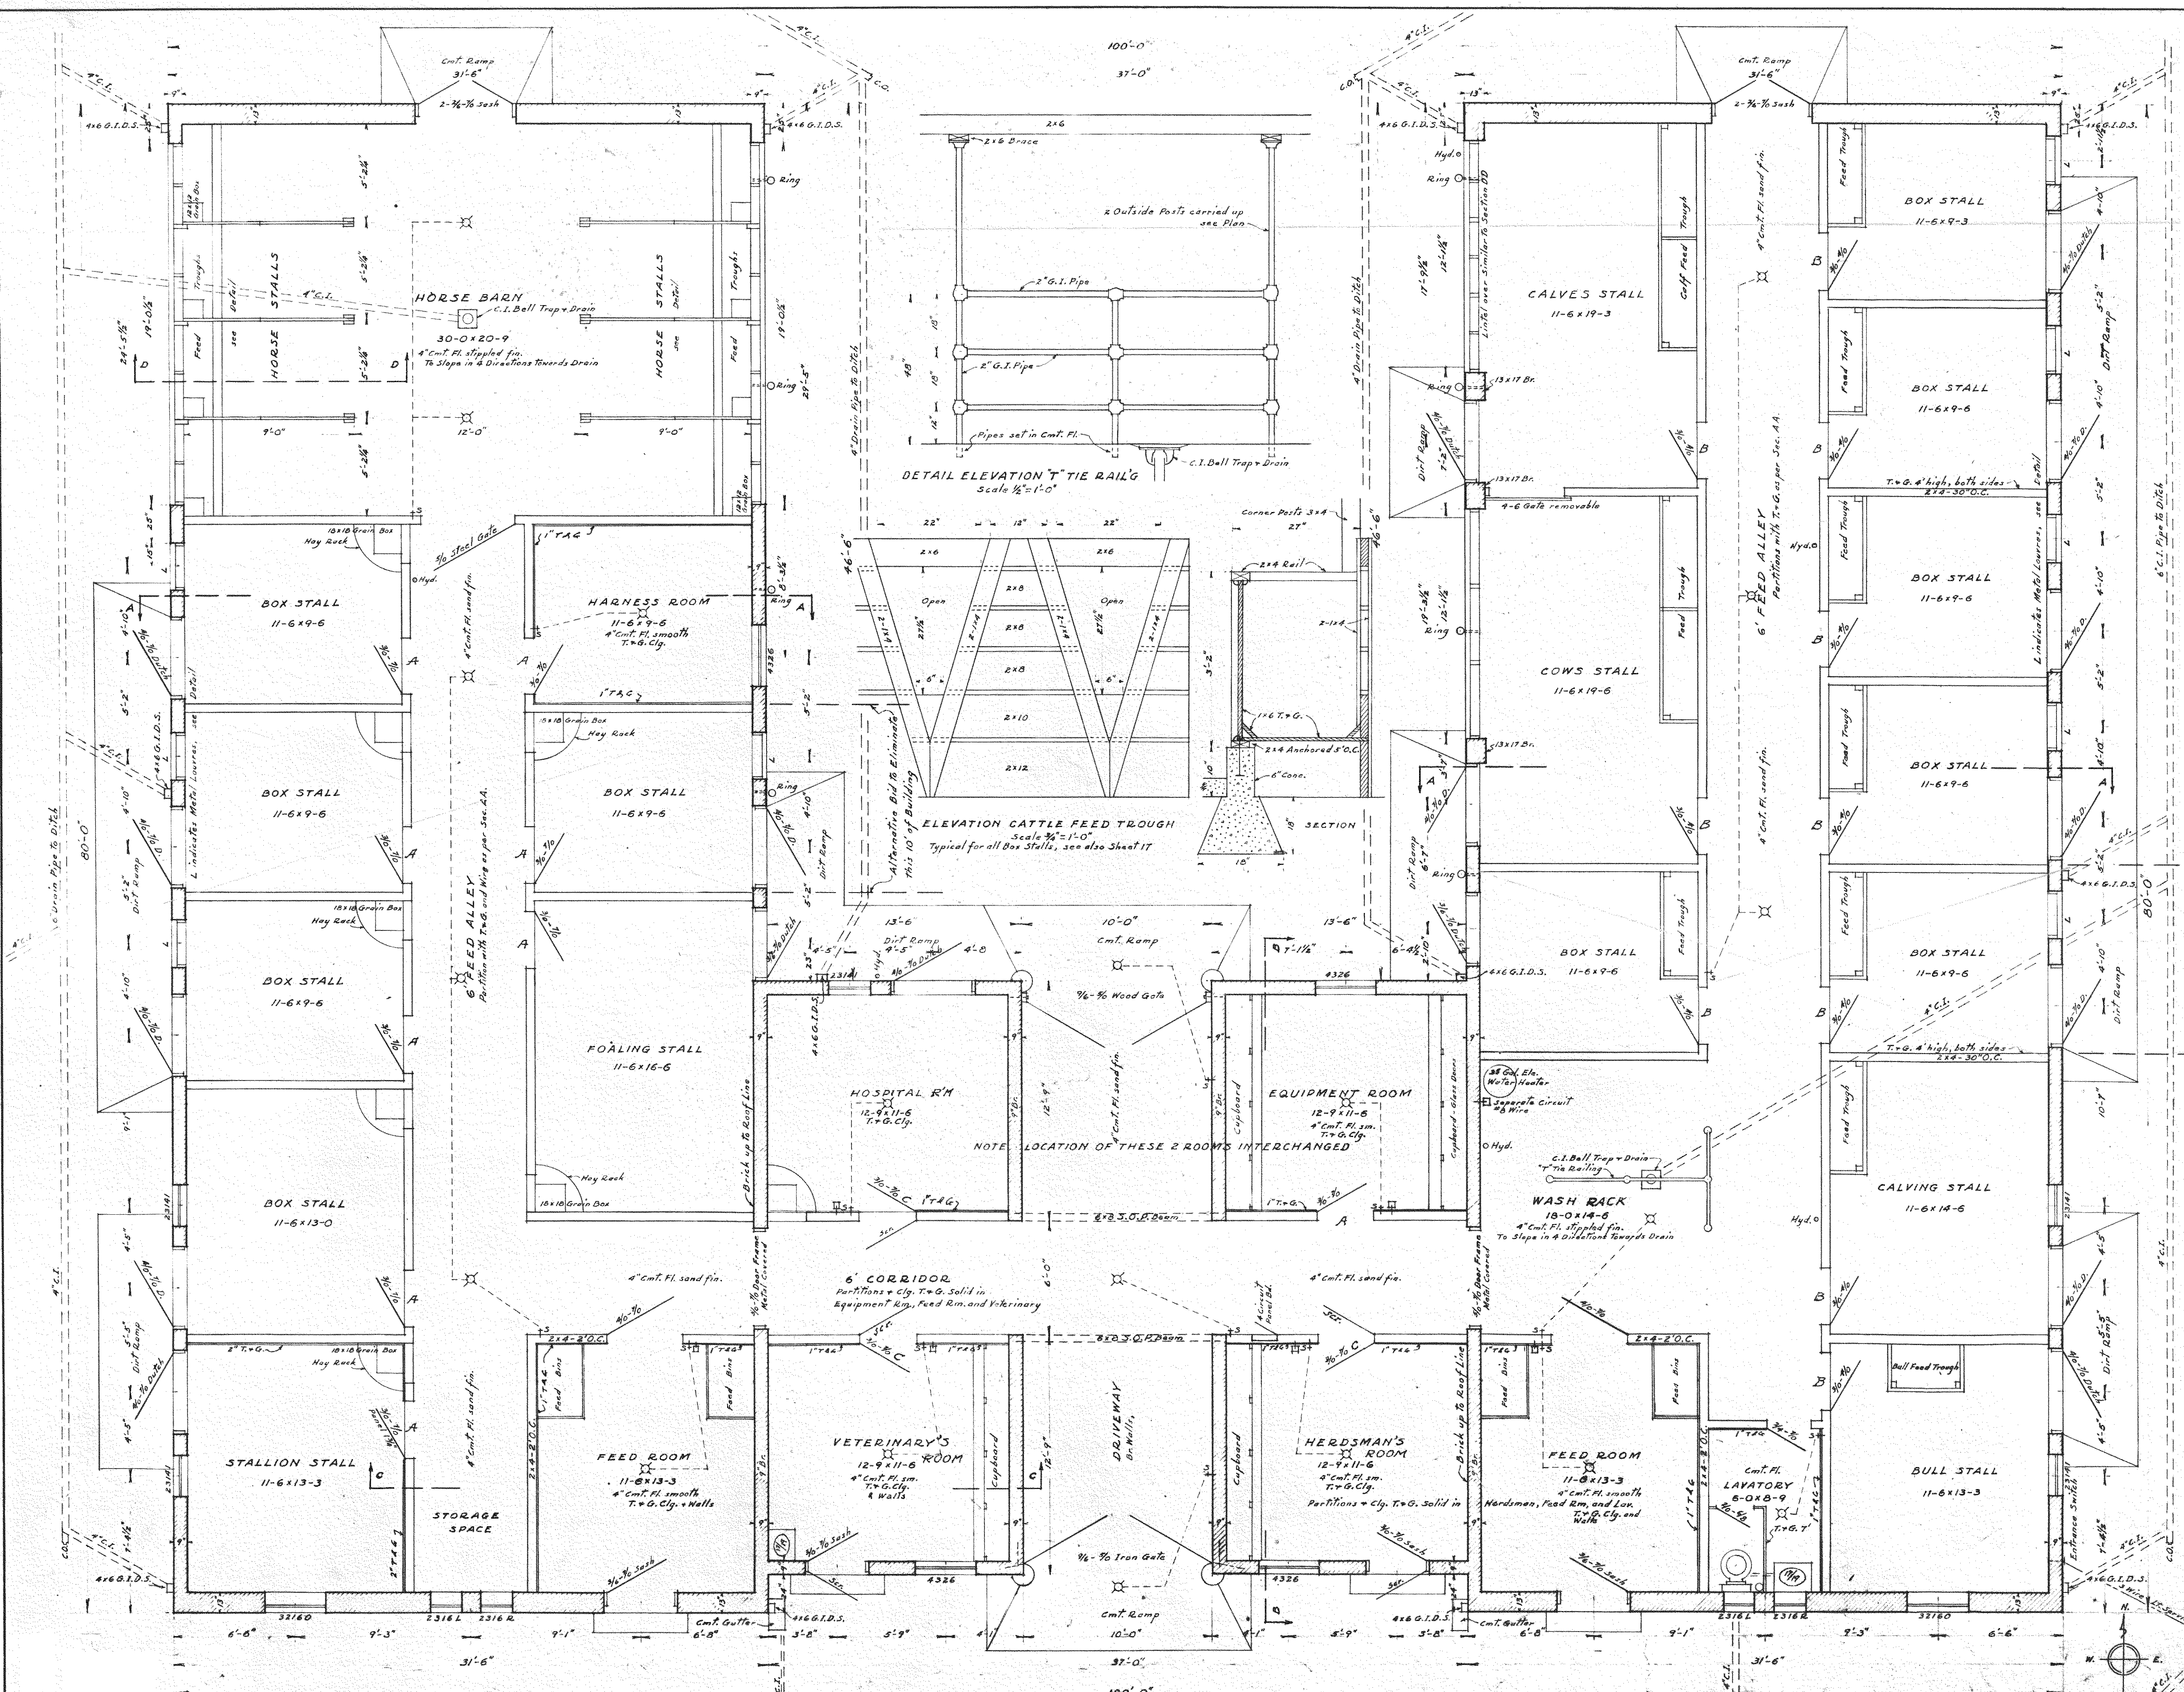
Notes: All Floors in Stalls etc. to be Dirt except as indicated on Plan or Section.
 All Partition Studs to be 2" x 4" except in 2 Feed Rooms.
 All Roof Trusses to be 4" x 6" and Rafters 2" x 4".
 All Ceiling Joists to be 2" x 4" where supporting Trusses.
 All Inside Bevel Joints to be neatly struck.

FLOOR PLAN
 SCALE 1/8" = 1'-0"

The Equine Education Building, formerly known as the Horse/Equine Barn, is a one-story building with a U-shaped footprint. The exterior walls are constructed of brick masonry and are covered in stucco on a poured concrete foundation. The walls are topped by a medium pitch gable and cross-gable roof with asphalt shingles and shallow overhanging eaves. There is a Mission-style parapet on the north and south elevations with quatrefoils surrounding attic vents on the gable ends. Two decorative copulas with copper domes are located in the center of the east gable and the middle cross gable portions of the roof (**Photograph 19**).

Fenestrations include vinyl windows and modern doors. The east and west wings previously had Dutch door openings for each of the horse stalls, but all of these have been filled in and the windows have been replaced. There is a metal fence connecting the east and west wings, creating an open space/courtyard between each wing (**Photograph 20**). More recently the building was rehabilitated from a stable to a classroom and office space.

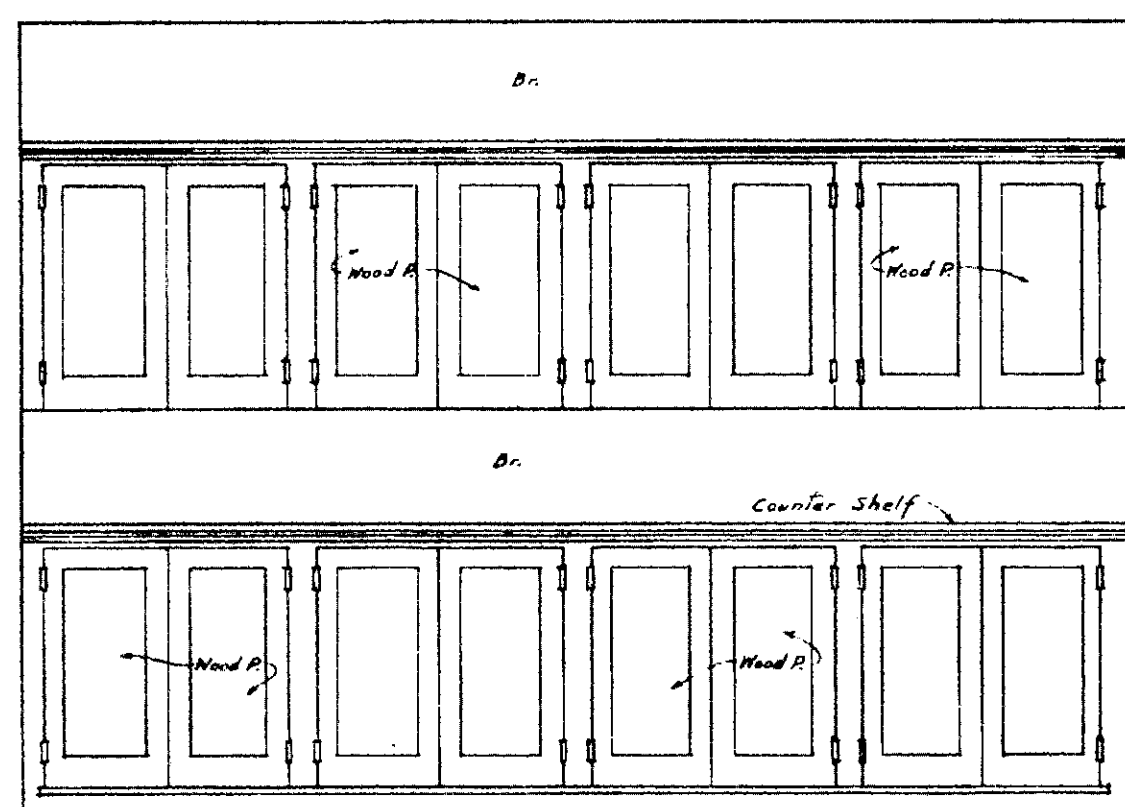
CUPBOARDS IN VETERINARY, HERDSMAN & EQUIPMENT ROOMS scale 1/2"=1'-0" SECTION
