National Register of Historic Places Registration Form

Historic name: University of Arizona Campus Agricultural Center
 Other names/site number: Campus Farm, Campbell Avenue Farm, University Farm; University Campus Farm Complex
 Name of related multiple property listing:
N/A
 (Enter "N/A" if property is not part of a multiple property listing)

Street & number: 4101 N. Campbell Avenue
 City or town: Tucson State: Arizona County: Pima County
 Not For Publication: Vicinity:

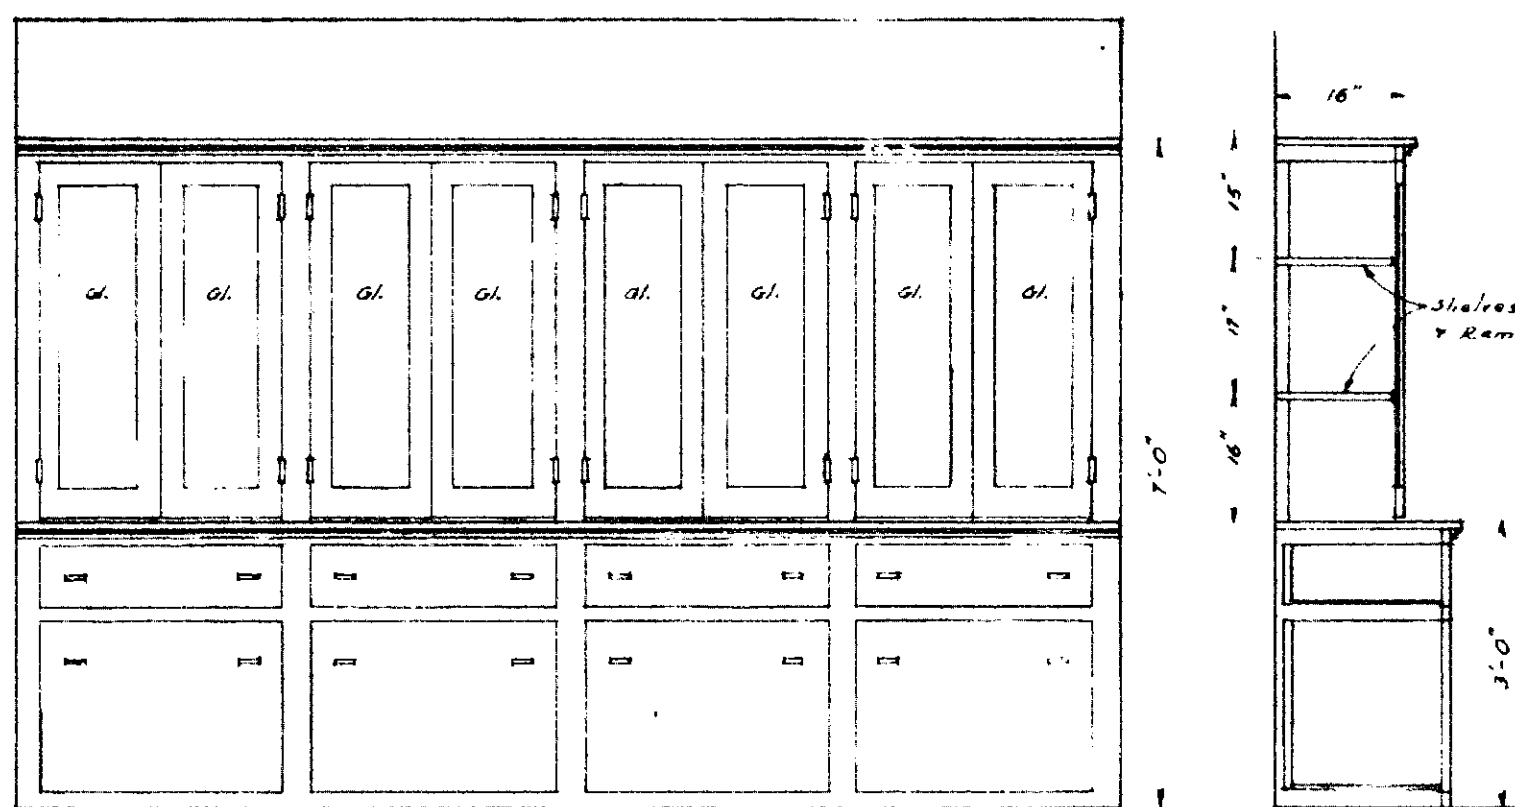
EAST IN EQUIPMENT ROOM scale 1/2"=1'-0" SECTION

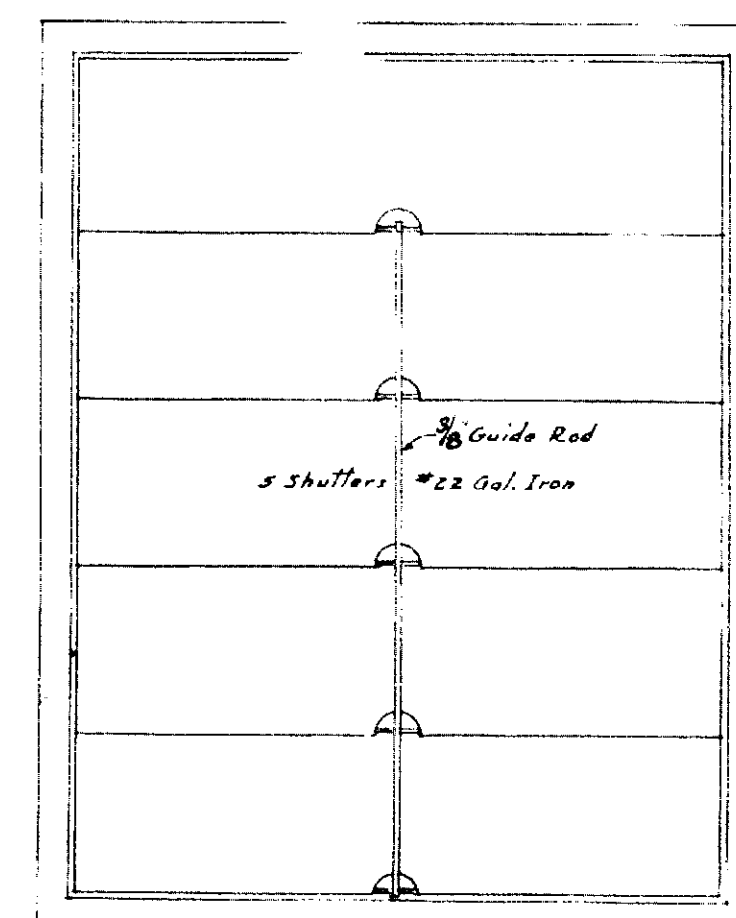
ELEVATION 2'-6" SECTION
PLAN 9 of these in Box Stalls as indicated by L on Floor Plan, Sheet No. 15
DETAIL OF METAL LOUVRES Scale 1 1/2"=1'-0"

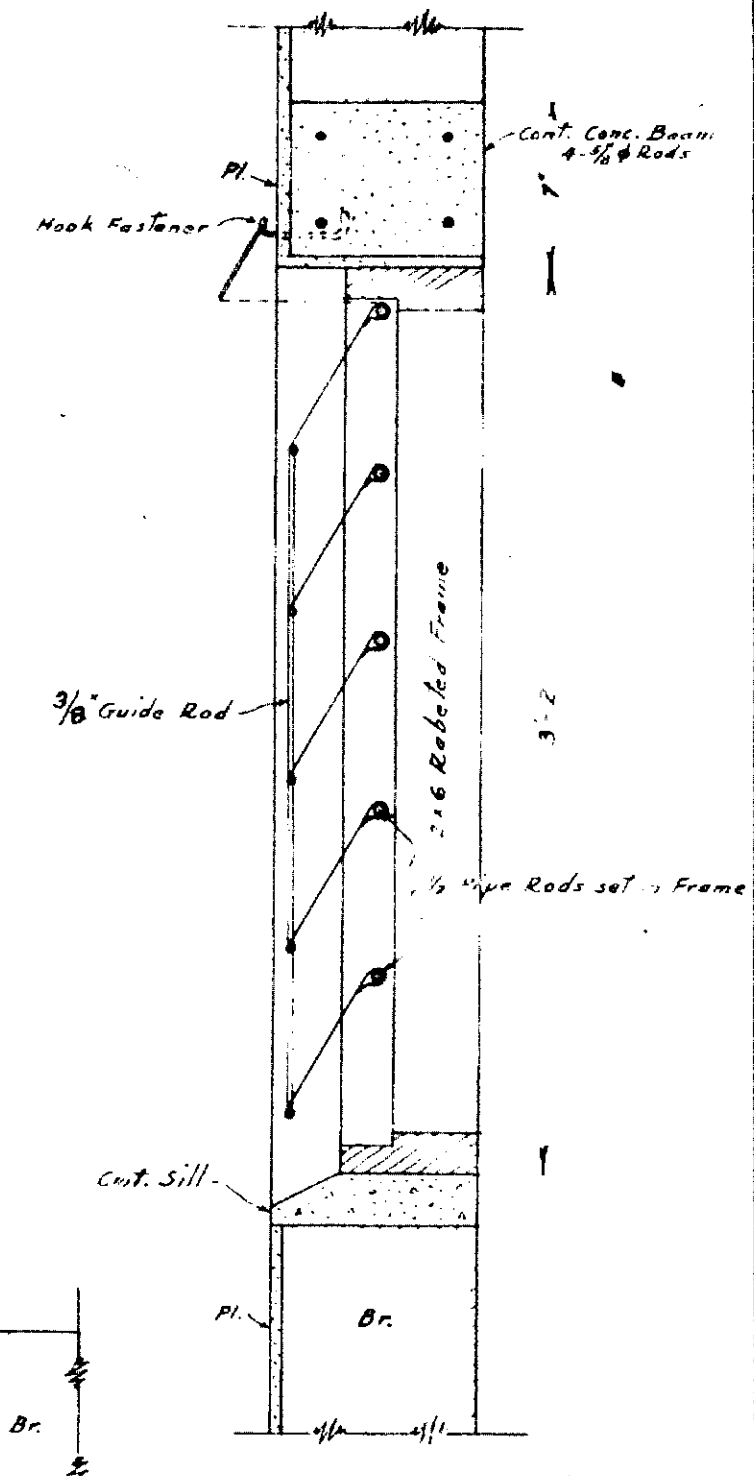
SECTION
SECTION CATTLE KINGS IN WALL 9 of these in Open Court, 3/4"=1'-0"

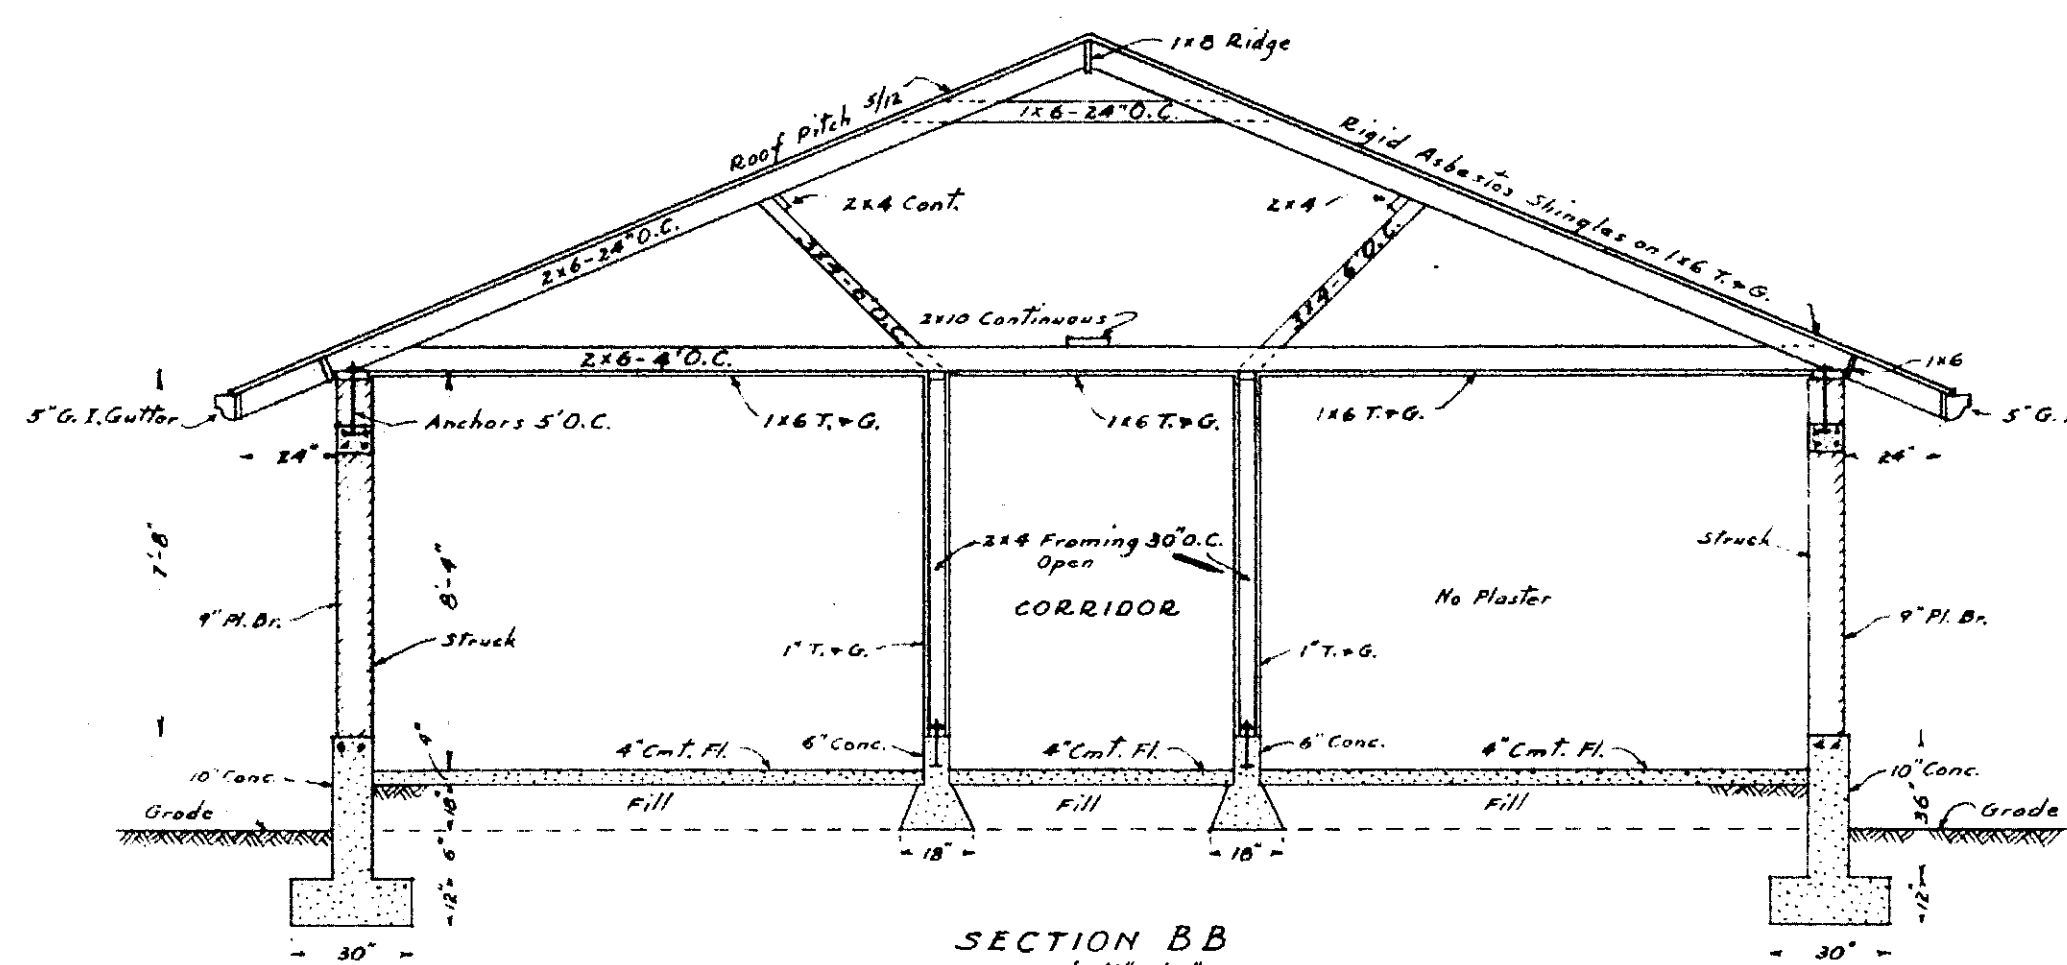
SECTION BB Scale 1/2"=1'-0" Framing similar to Sec AA See also Sec CC and Truss Detail

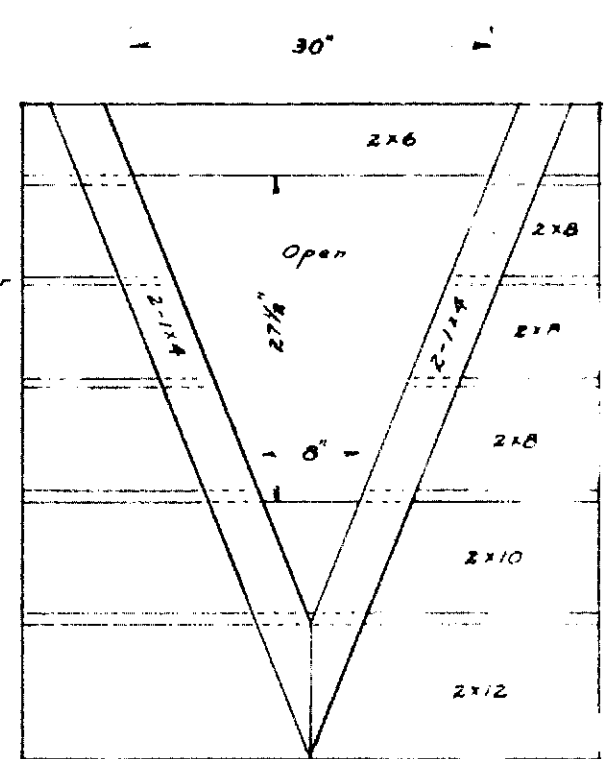
ELEVATION BULL FEED TROUGH Scale 3/4"=1'-0"

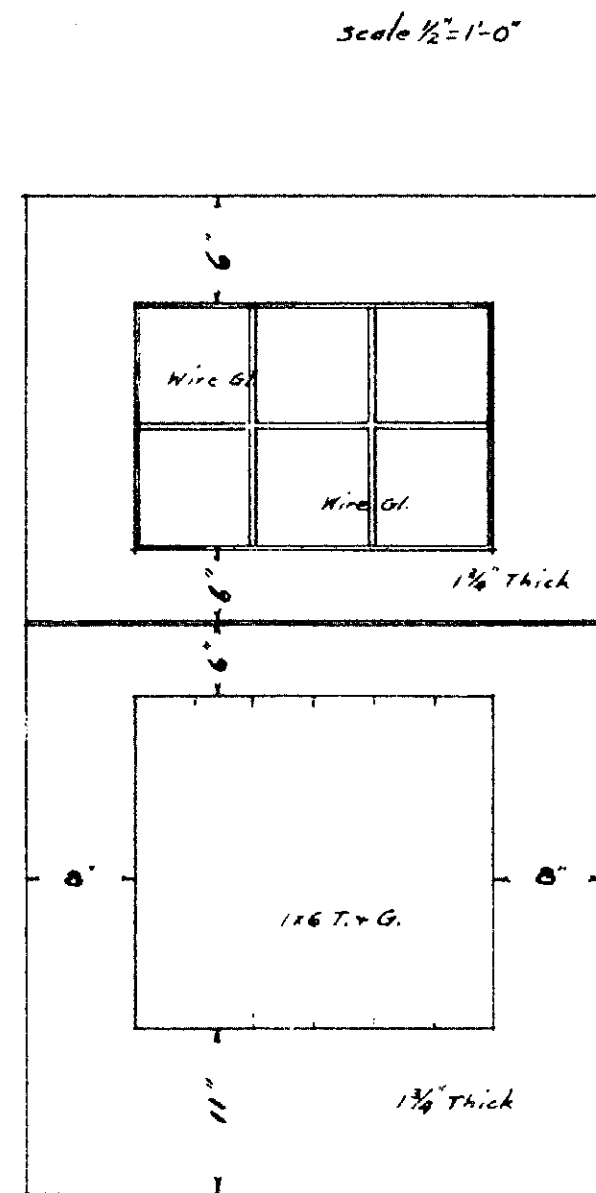
TYPICAL DETAIL DUTCH DOORS Scale 3/4"=1'-0"

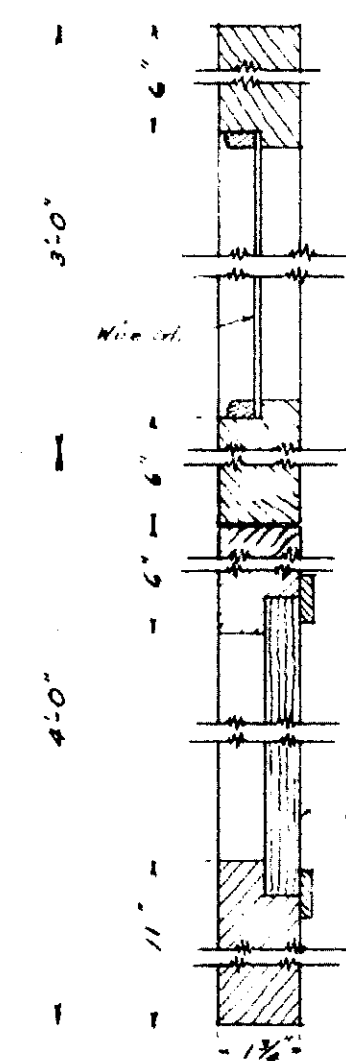
SECTION 3"=1'-0"

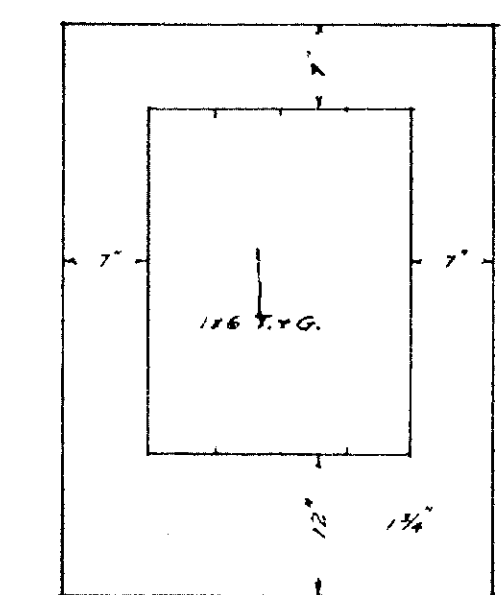
INSIDE DOOR IN ALL CATTLE STALLS Scale 3/4"=1'-0"

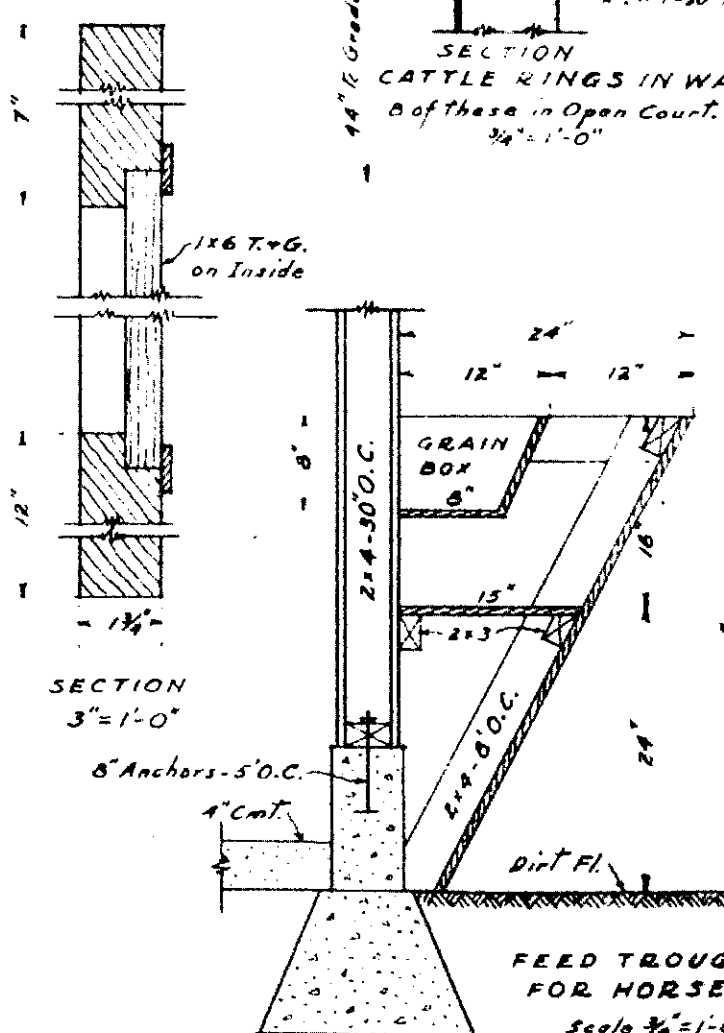
FEED TROUGH FOR HORSES Scale 3/4"=1'-0"

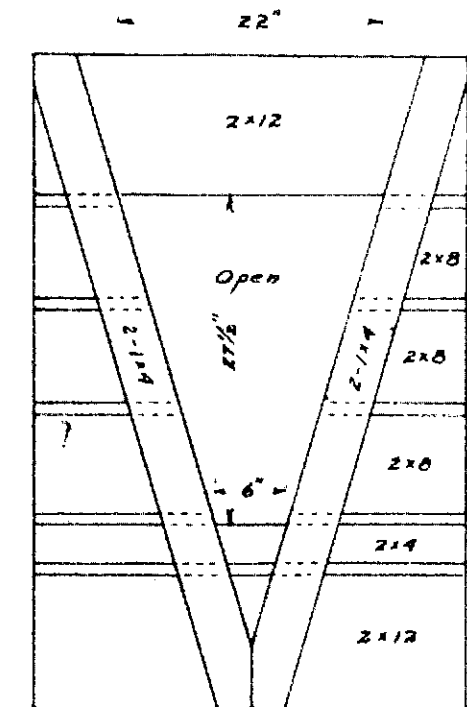
CALF FEED TROUGH Scale 3/4"=1'-0"

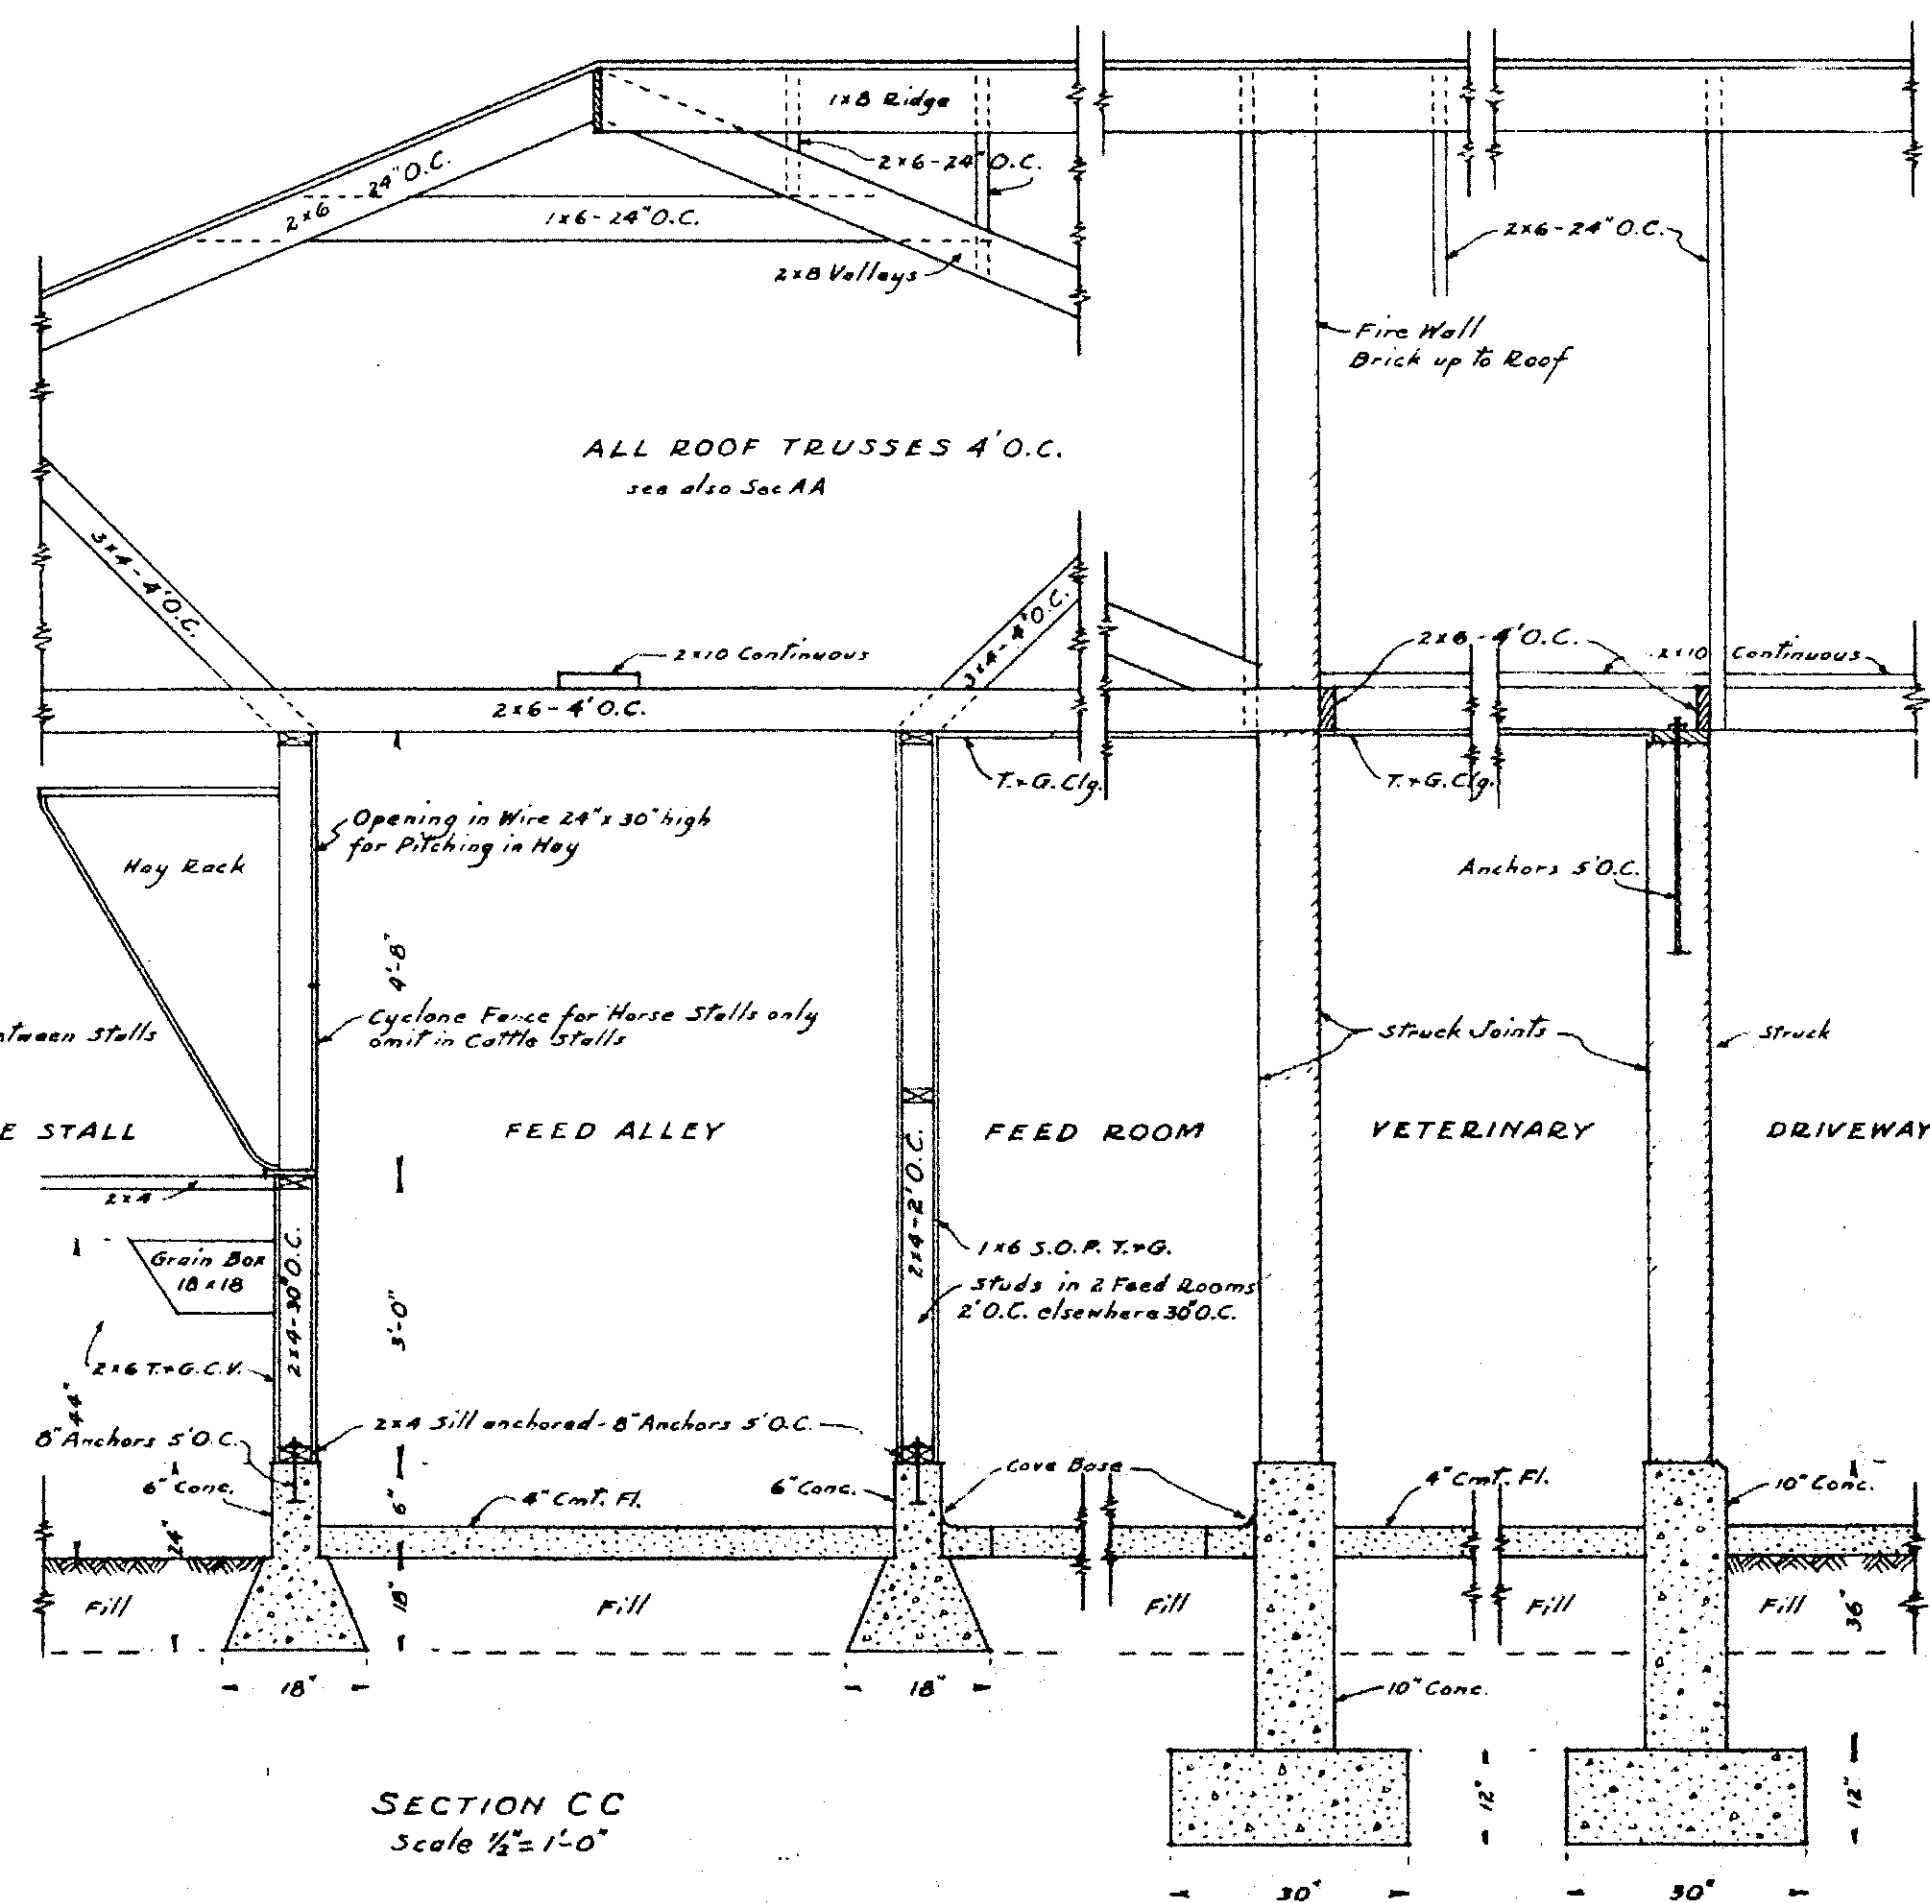
SECTION CC Scale 1/2"=1'-0"

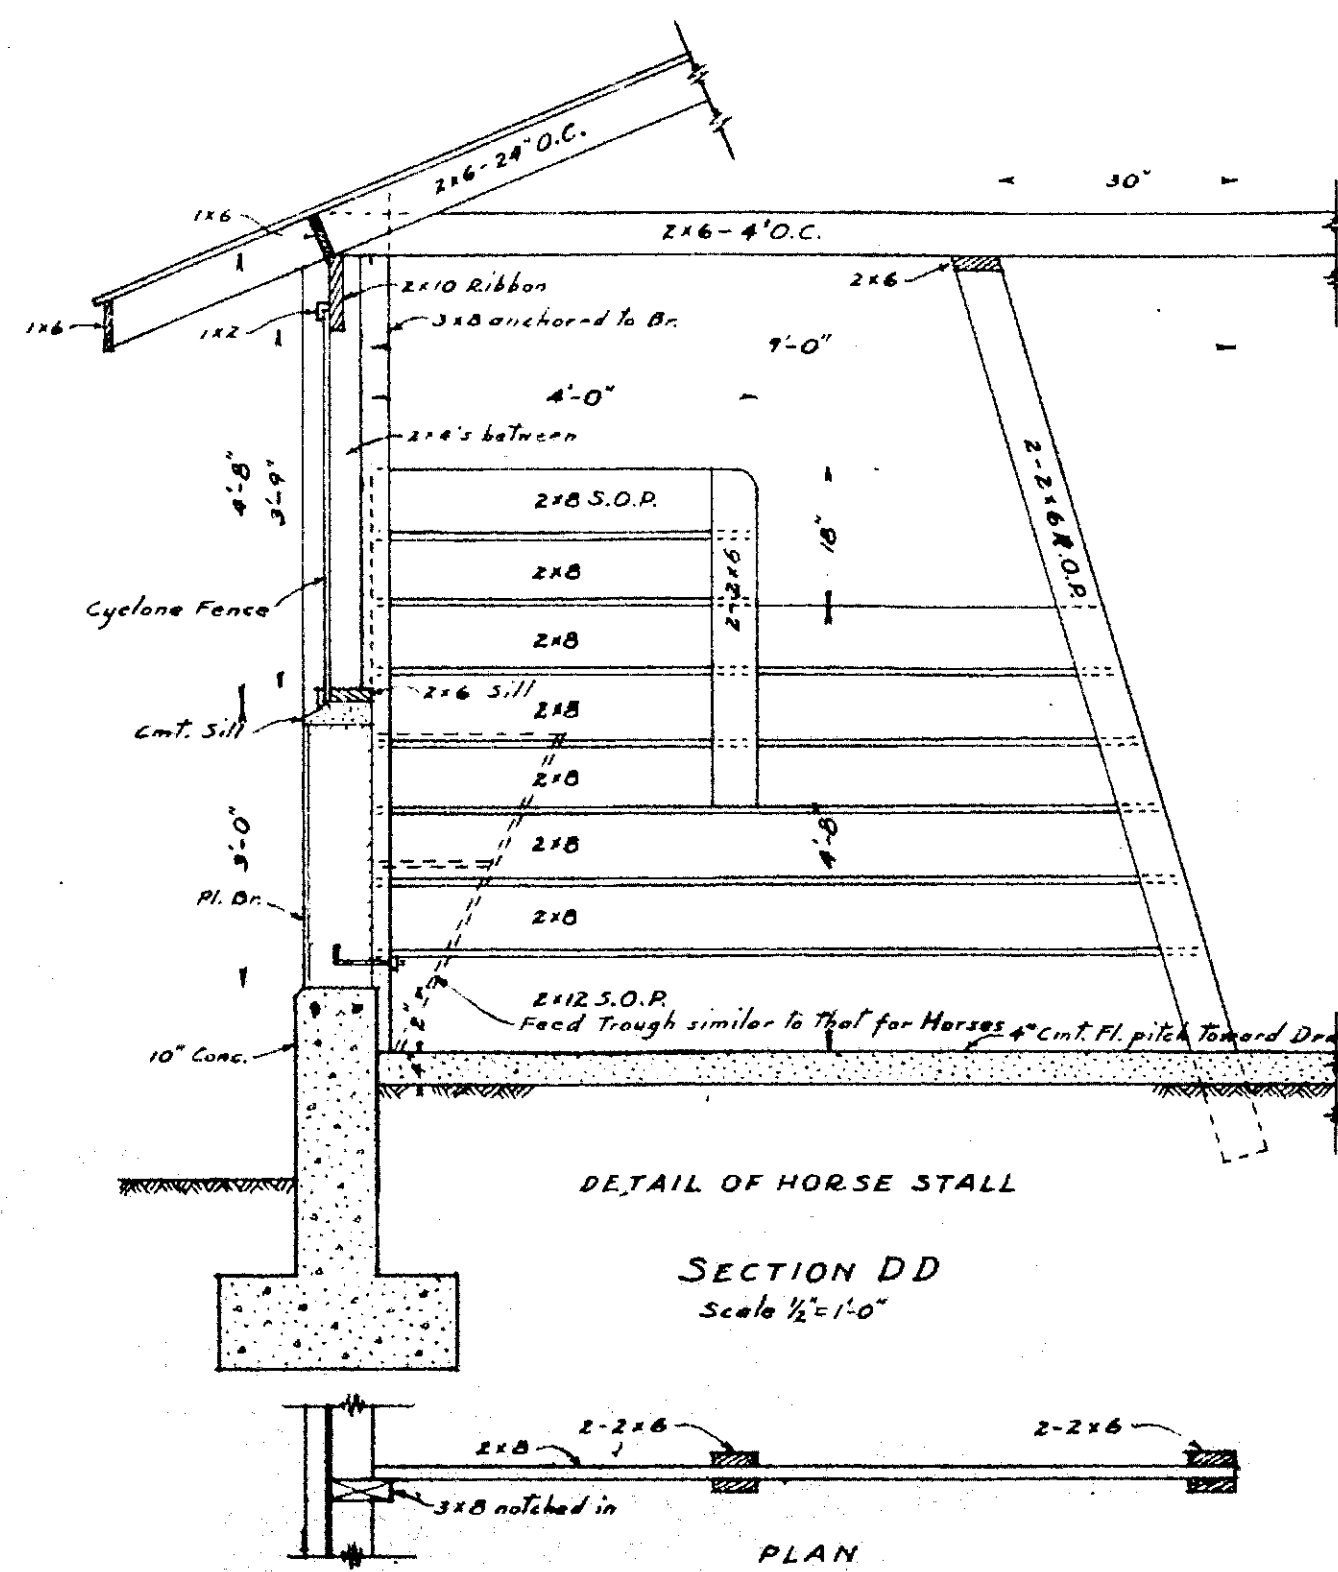
SECTION DD Scale 1/2"=1'-0"

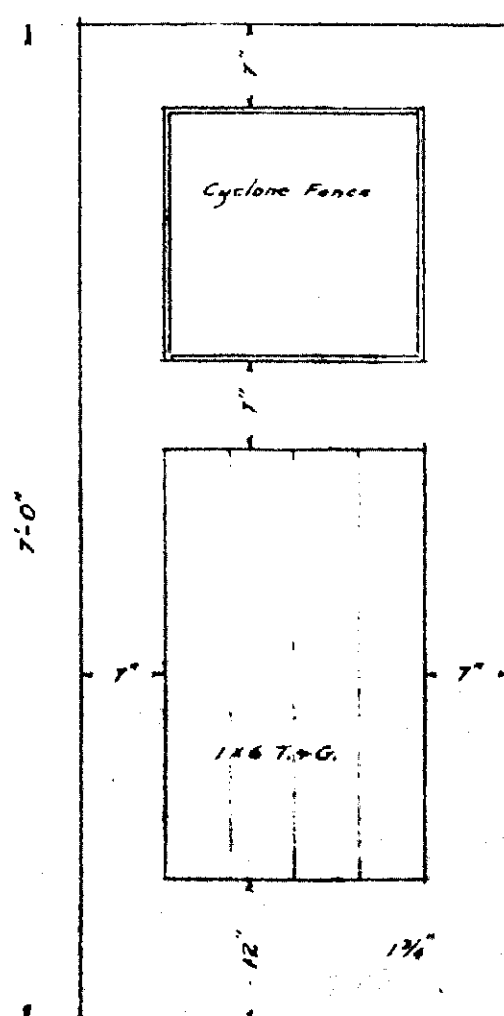
INSIDE DOOR IN ALL HORSE STALLS Scale 3/4"=1'-0" Doors designated C to be similar with Wire Glass instead of Cyclone Fence.

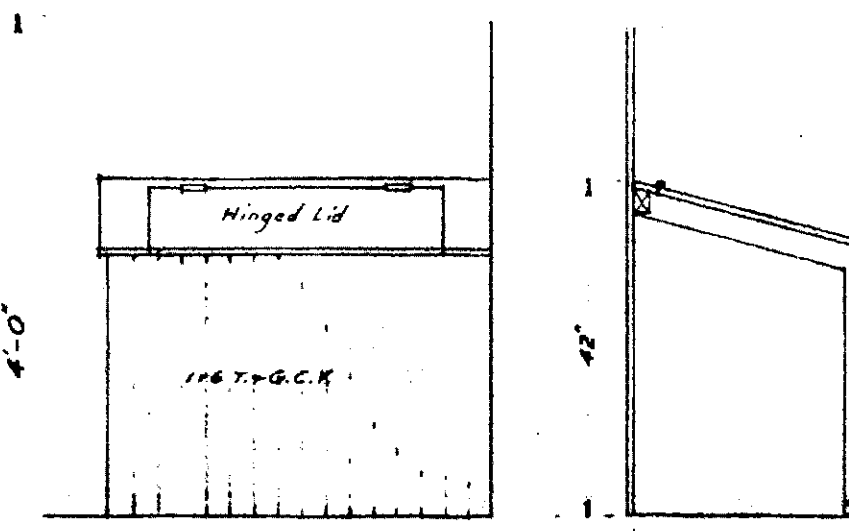
FEED BINS IN FEED ROOMS Scale 1/2"=1'-0"

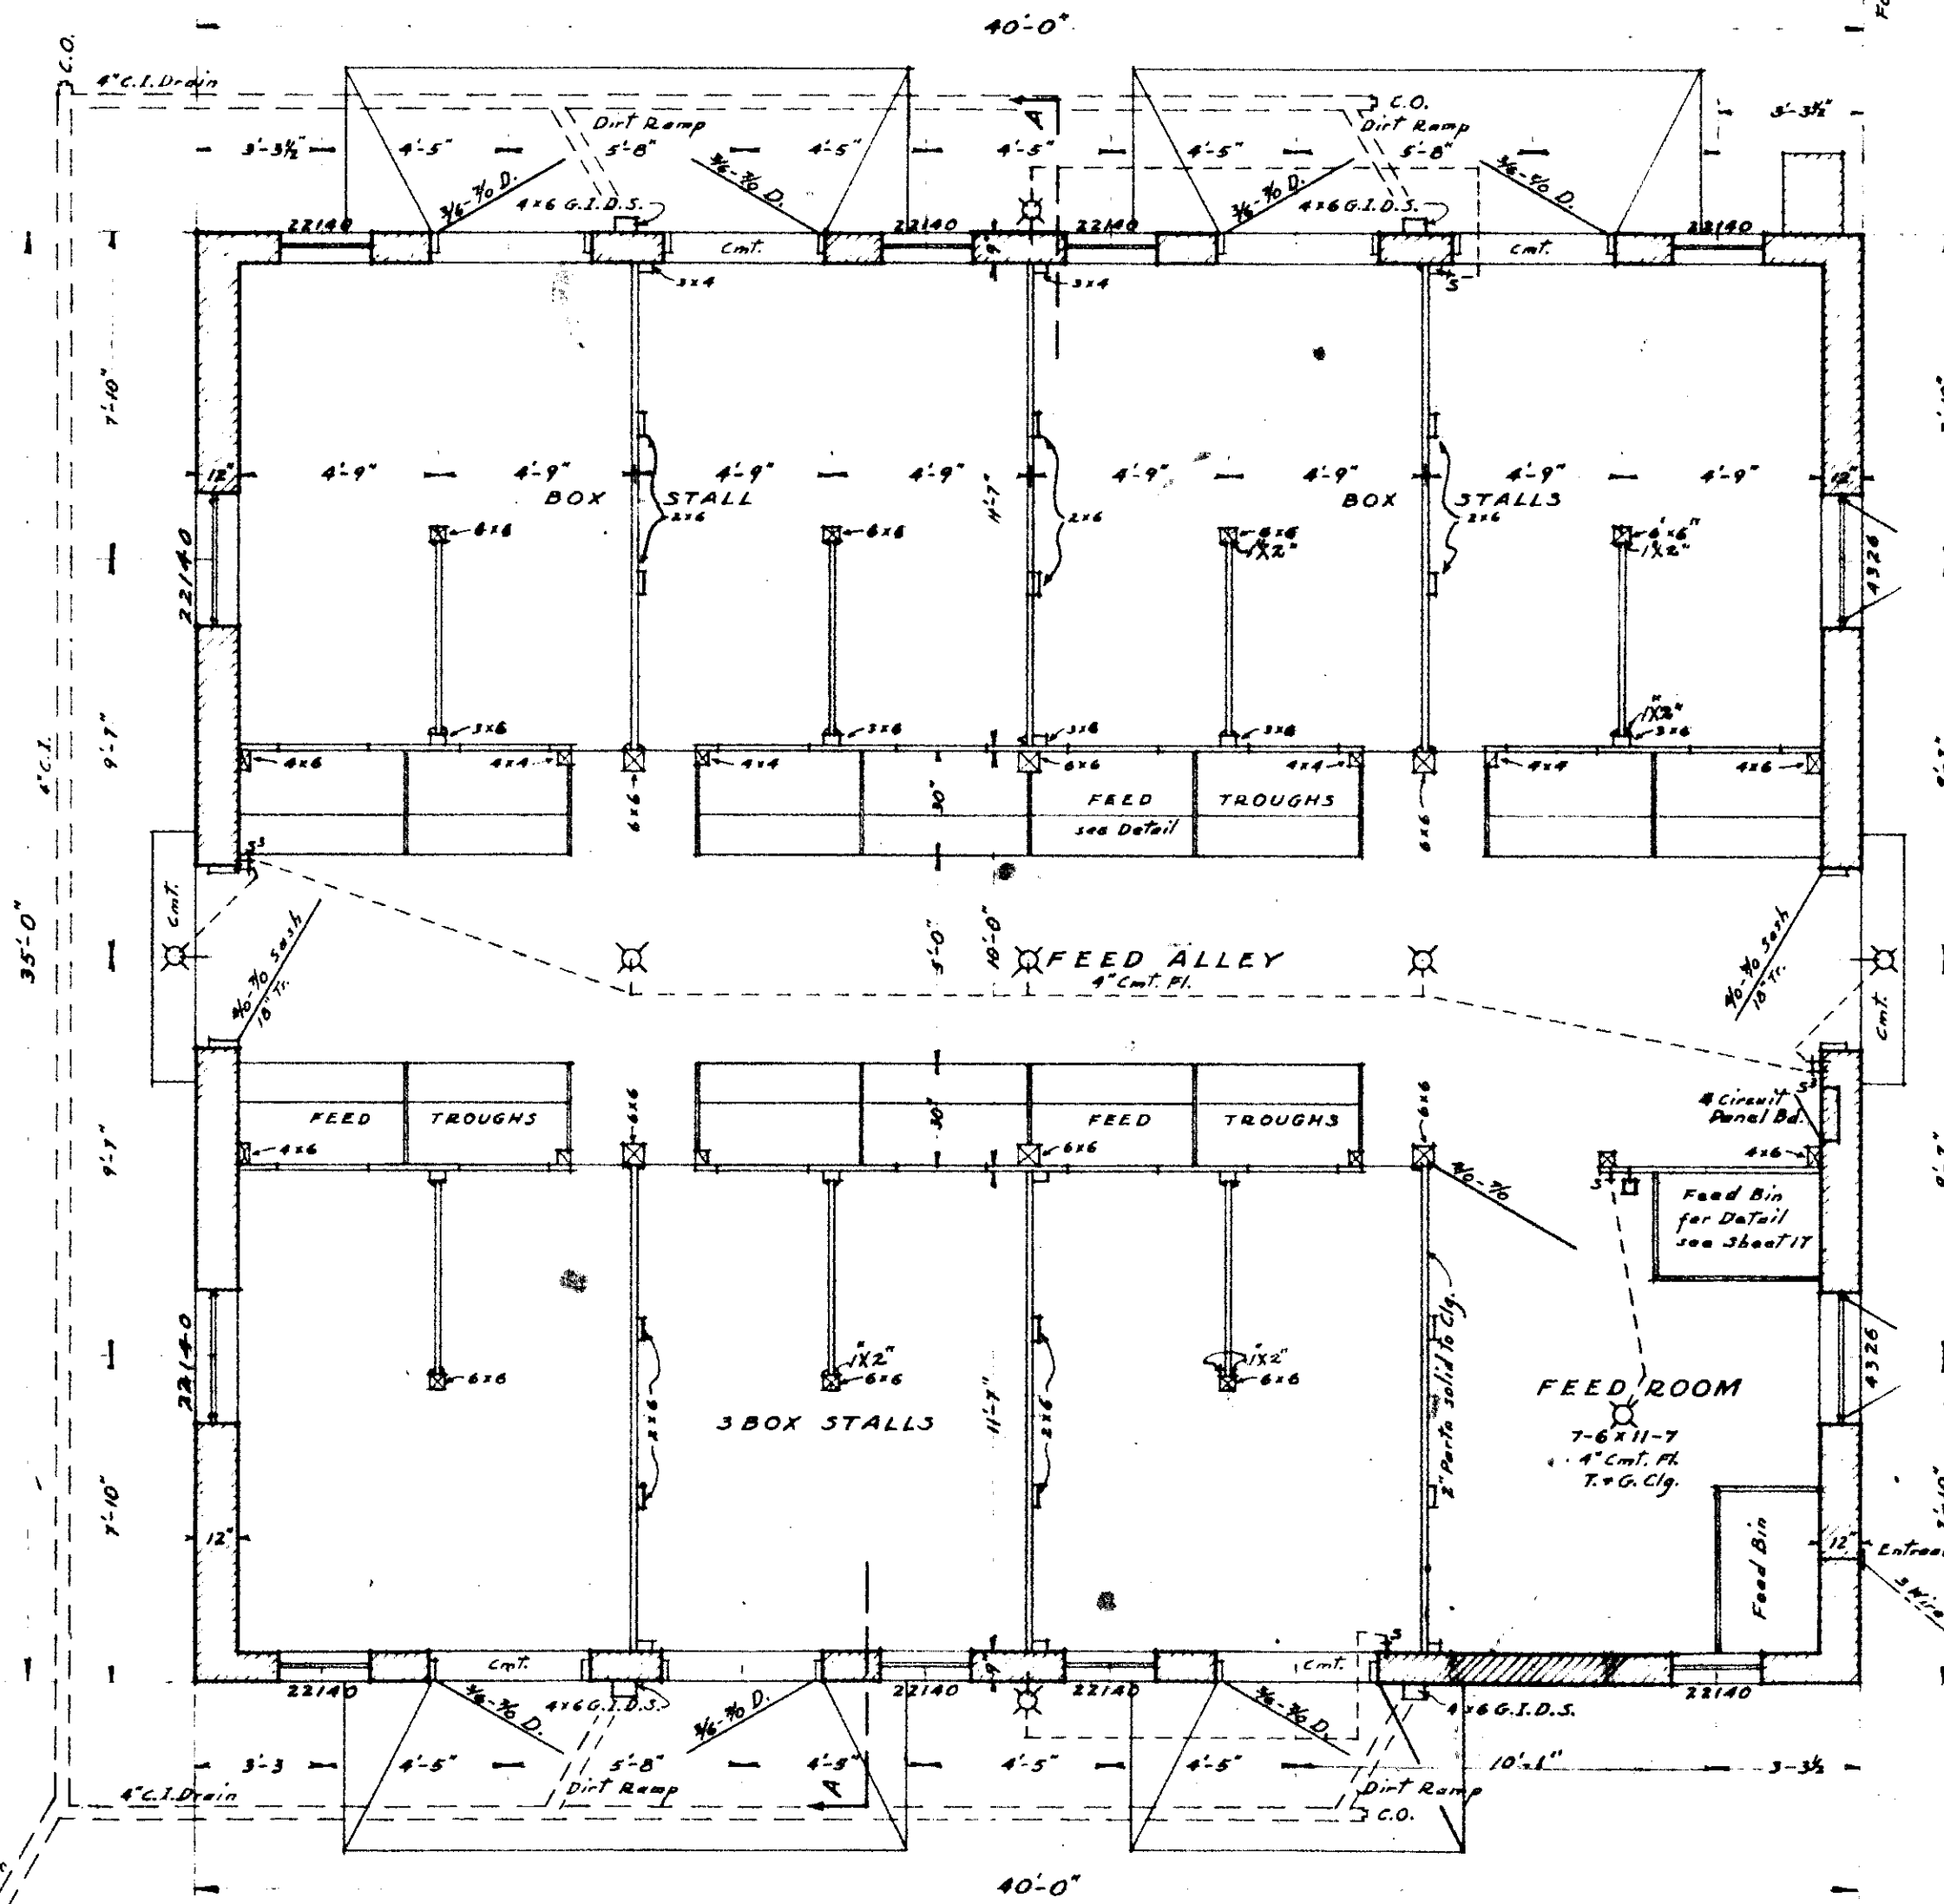
FLOOR PLAN
SCALE 1/4"=1'-0"

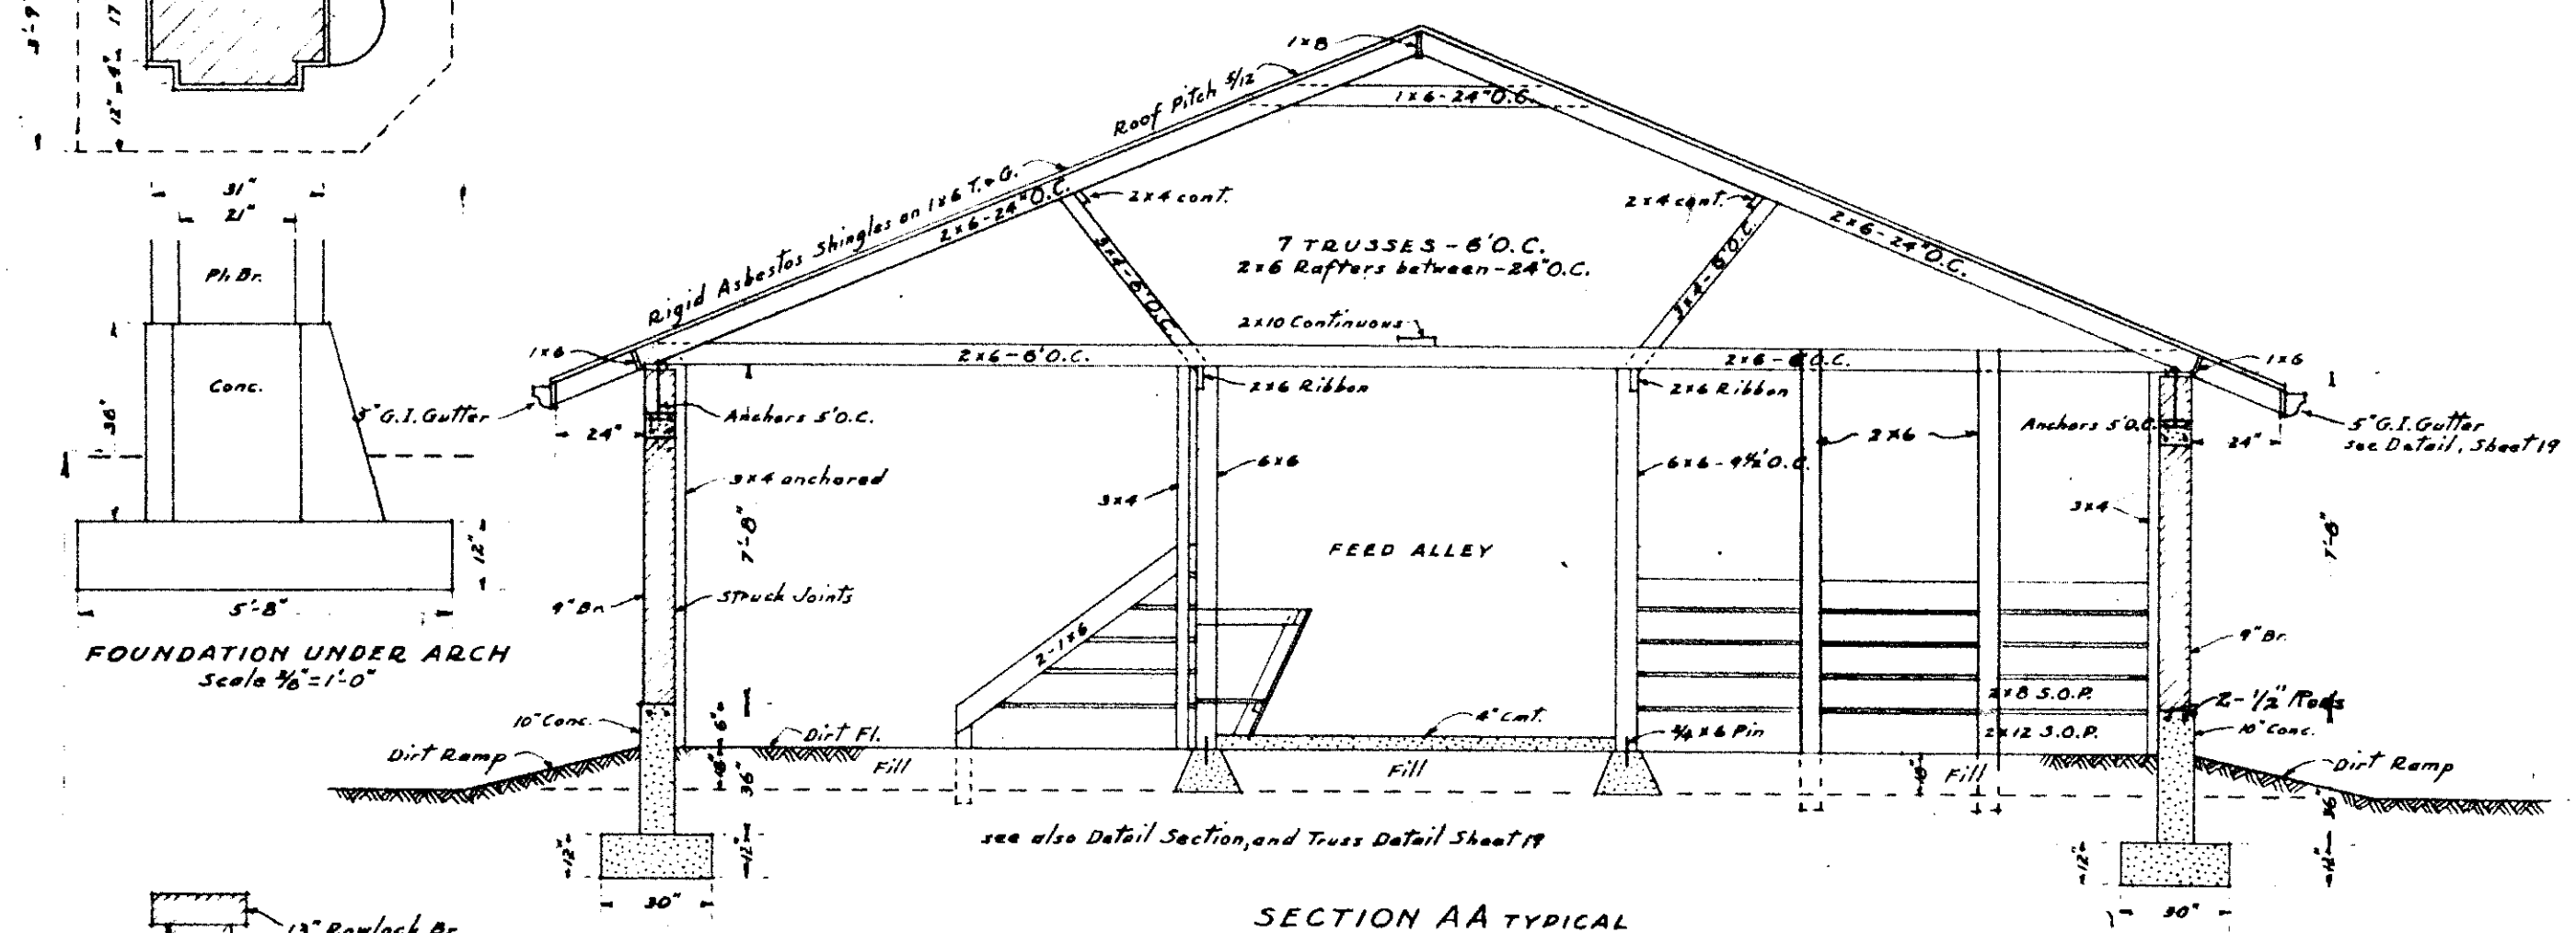
SECTION AA TYPICAL
SCALE 1/4"=1'-0"
