National Register of Historic Places Registration Form

Historic name: University of Arizona Campus Agricultural Center
 Other names/site number: Campus Farm, Campbell Avenue Farm, University Farm; University Campus Farm Complex
 Name of related multiple property listing:
N/A
 (Enter "N/A" if property is not part of a multiple property listing)

Street & number: 4101 N. Campbell Avenue
 City or town: Tucson State: Arizona County: Pima County
 Not For Publication: Vicinity:

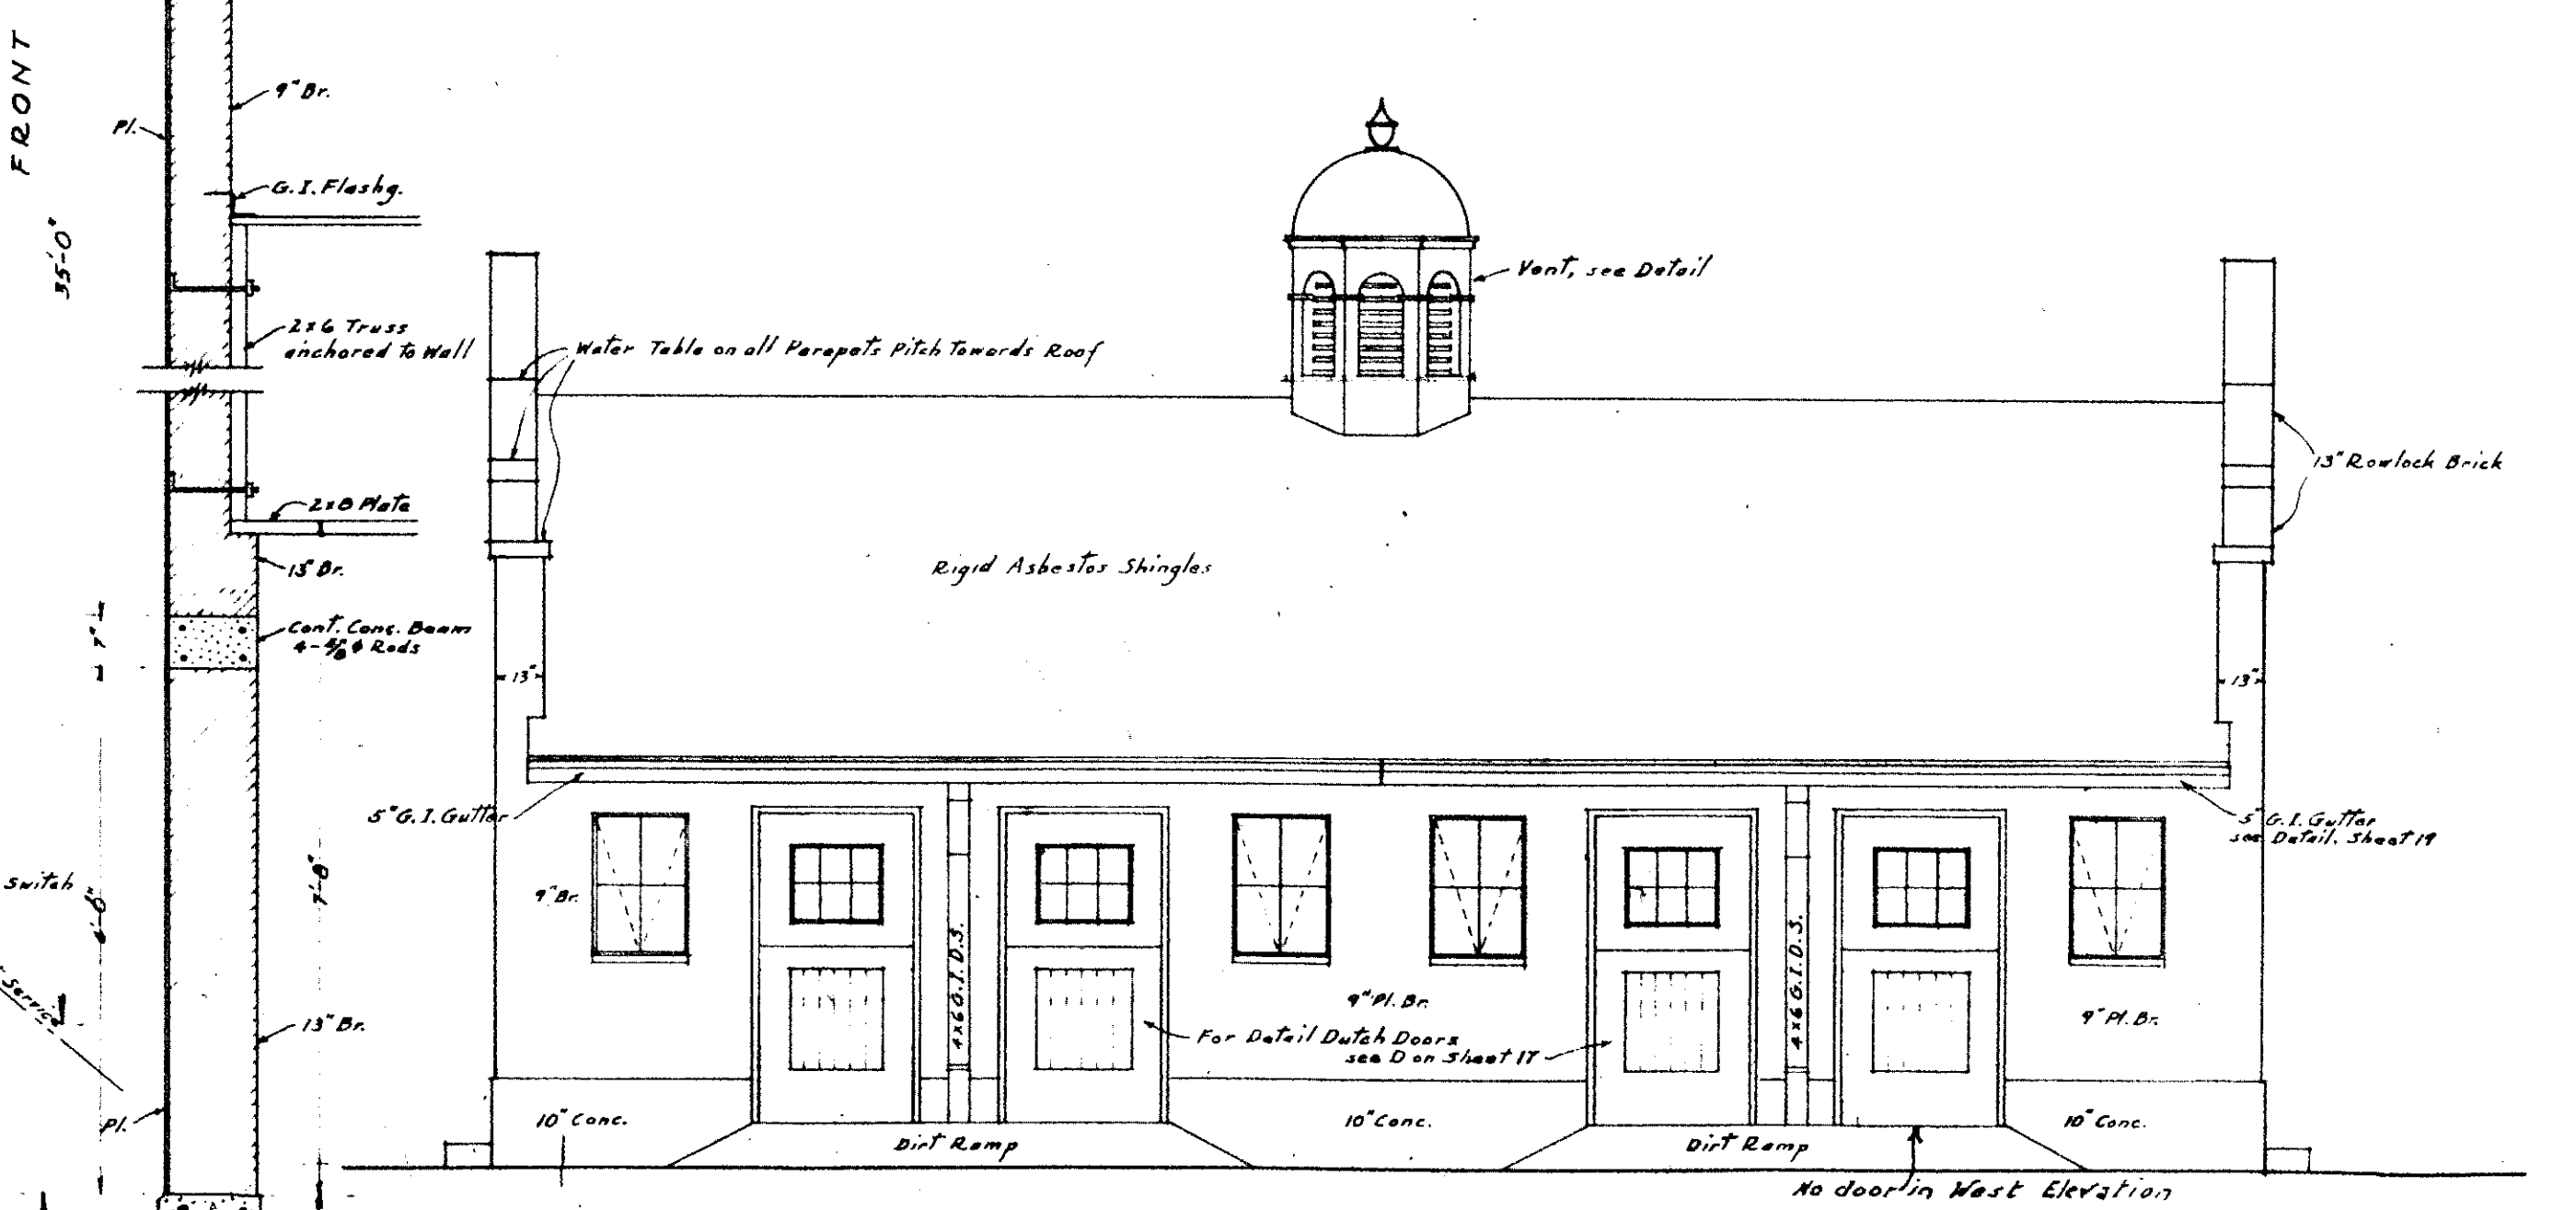
SIDE ELEVATIONS, E. & W.

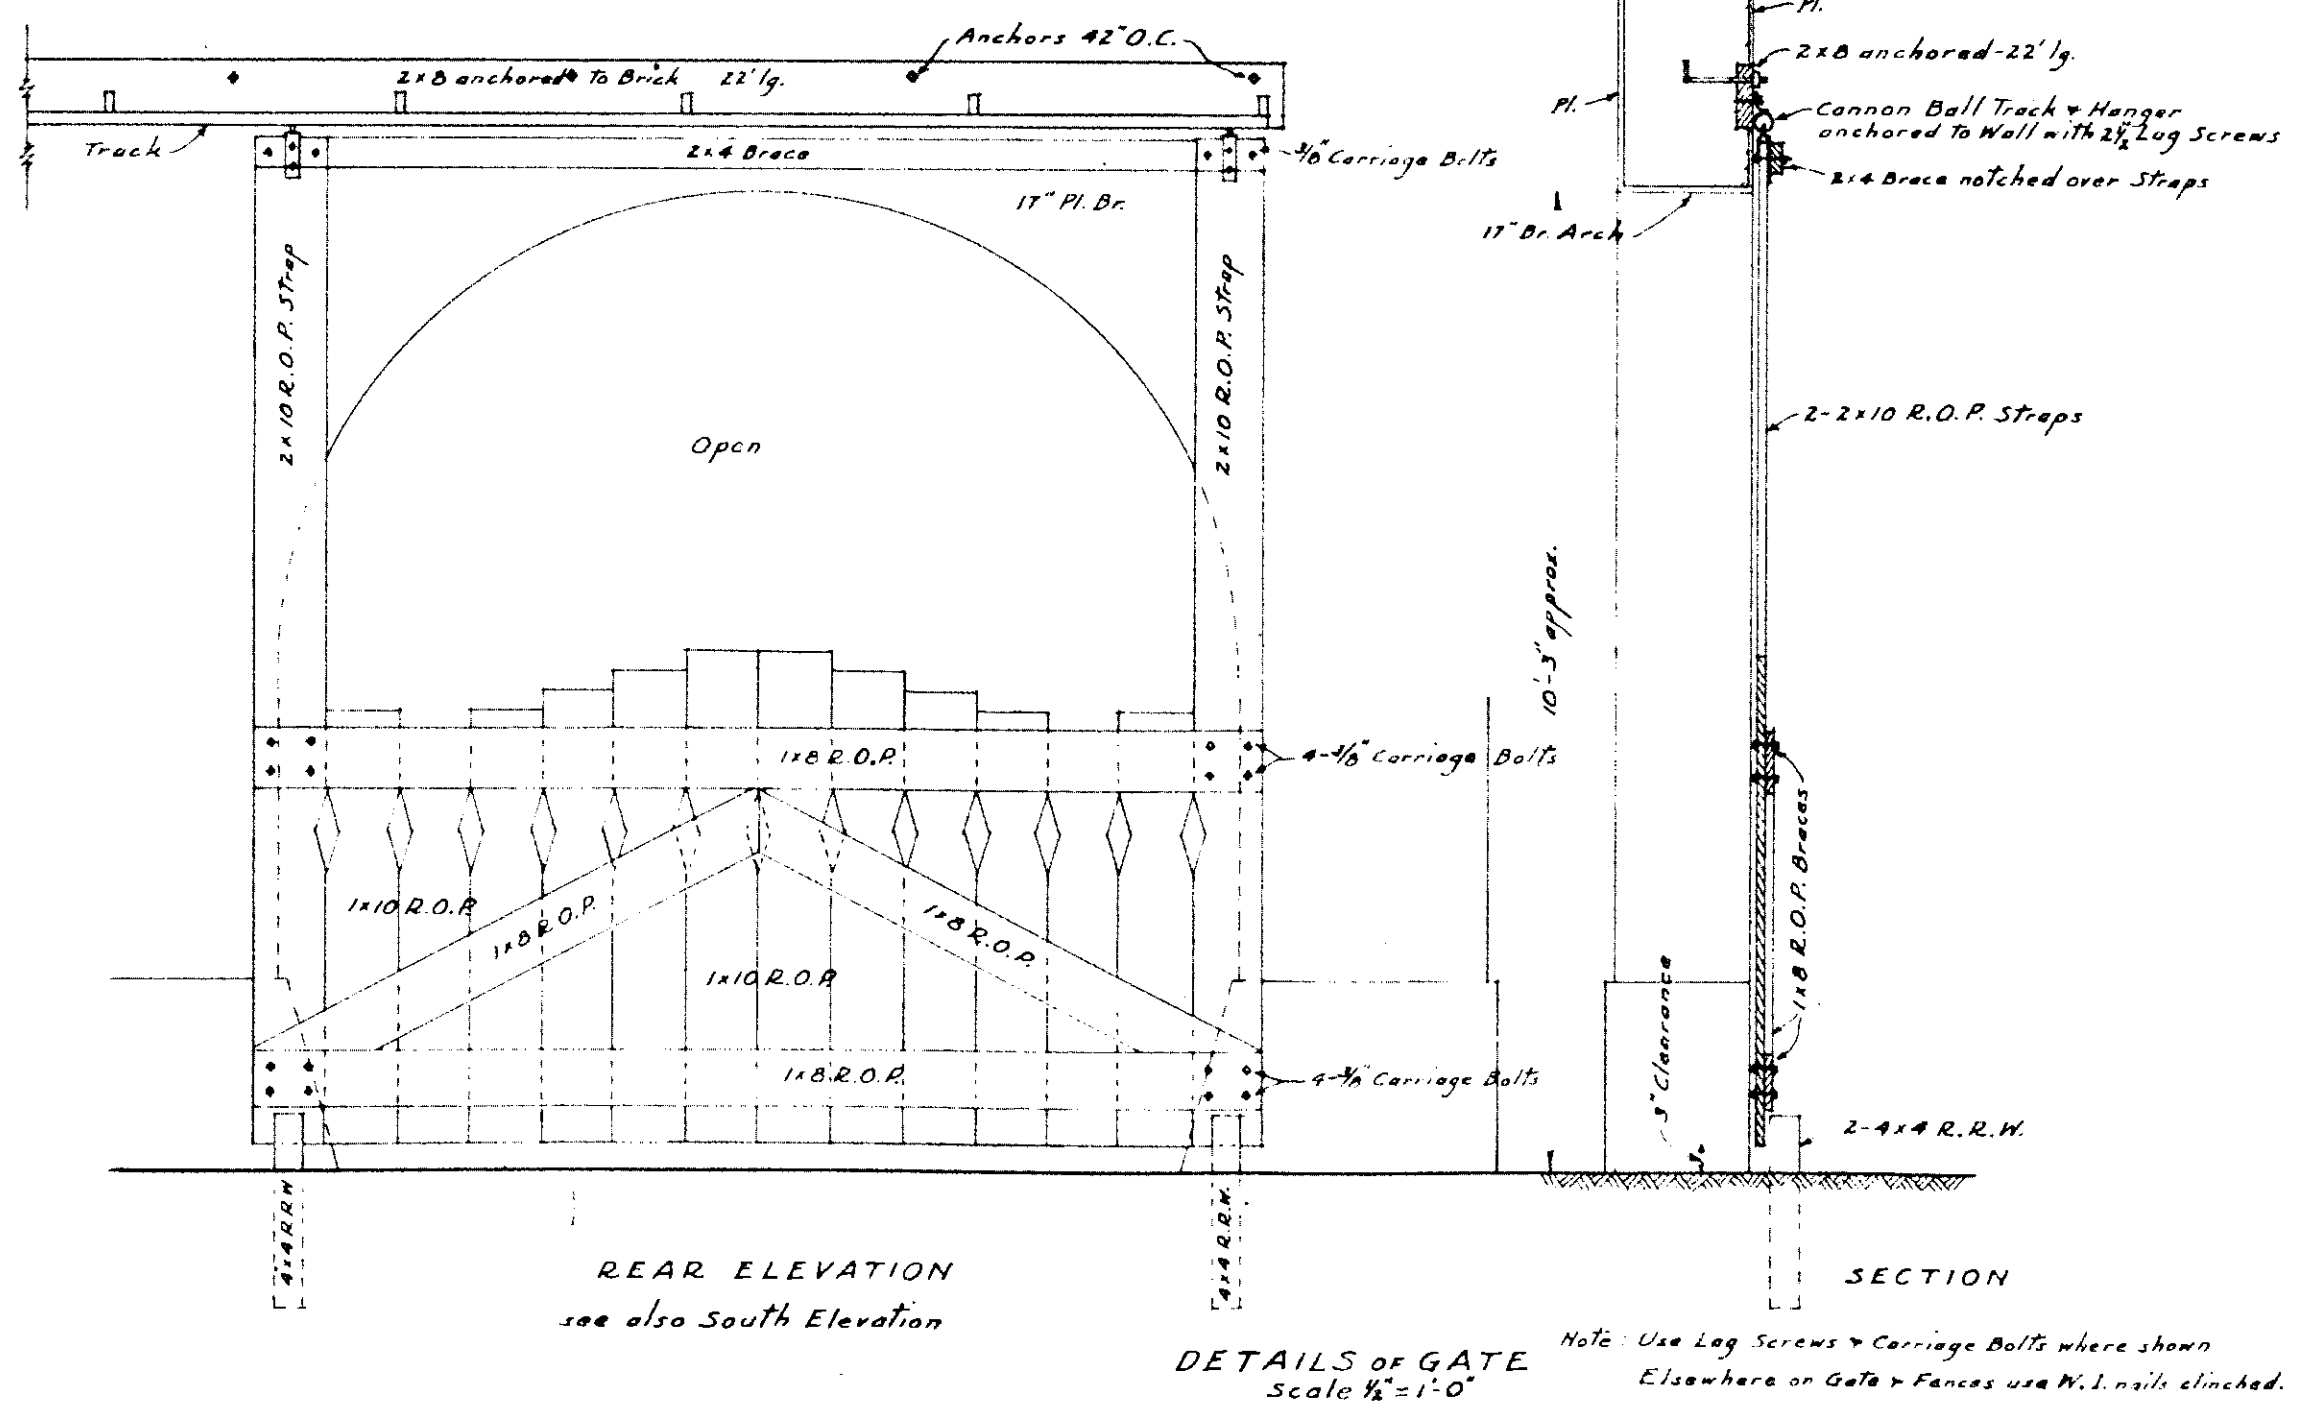
REAR ELEVATION
see also South Elevation

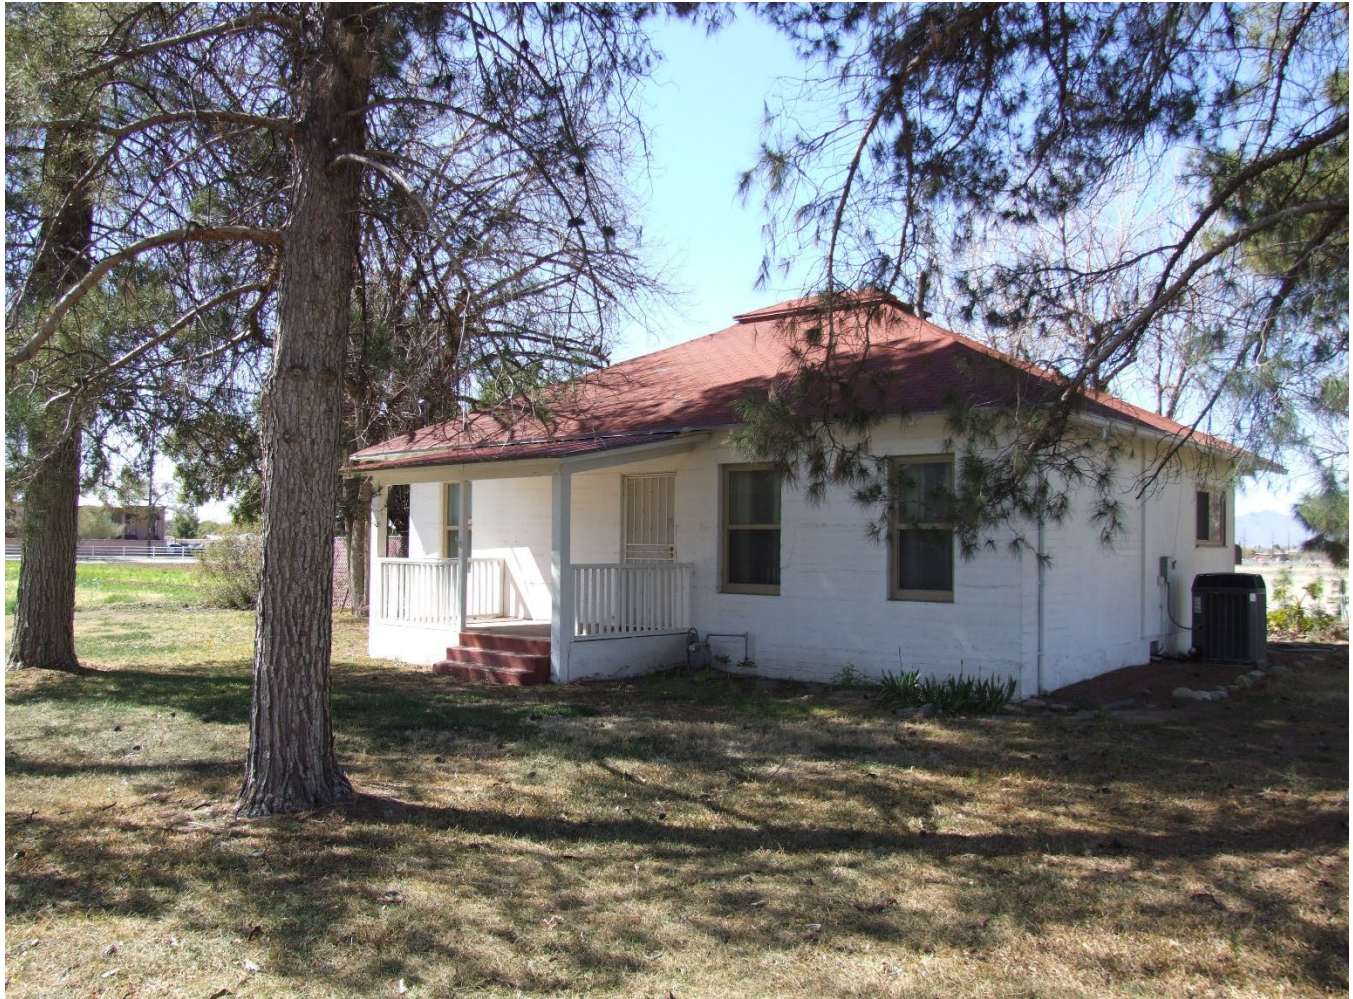
Photograph 1. East and north elevations of the Residence; view facing southwest (UA_Pima County_UA Campus Agricultural Center Historic District_0001).

Photograph 1. East and north elevations of the Residence; view facing southwest (UA_Pima County_UA Campus Agricultural Center Historic District_0001).

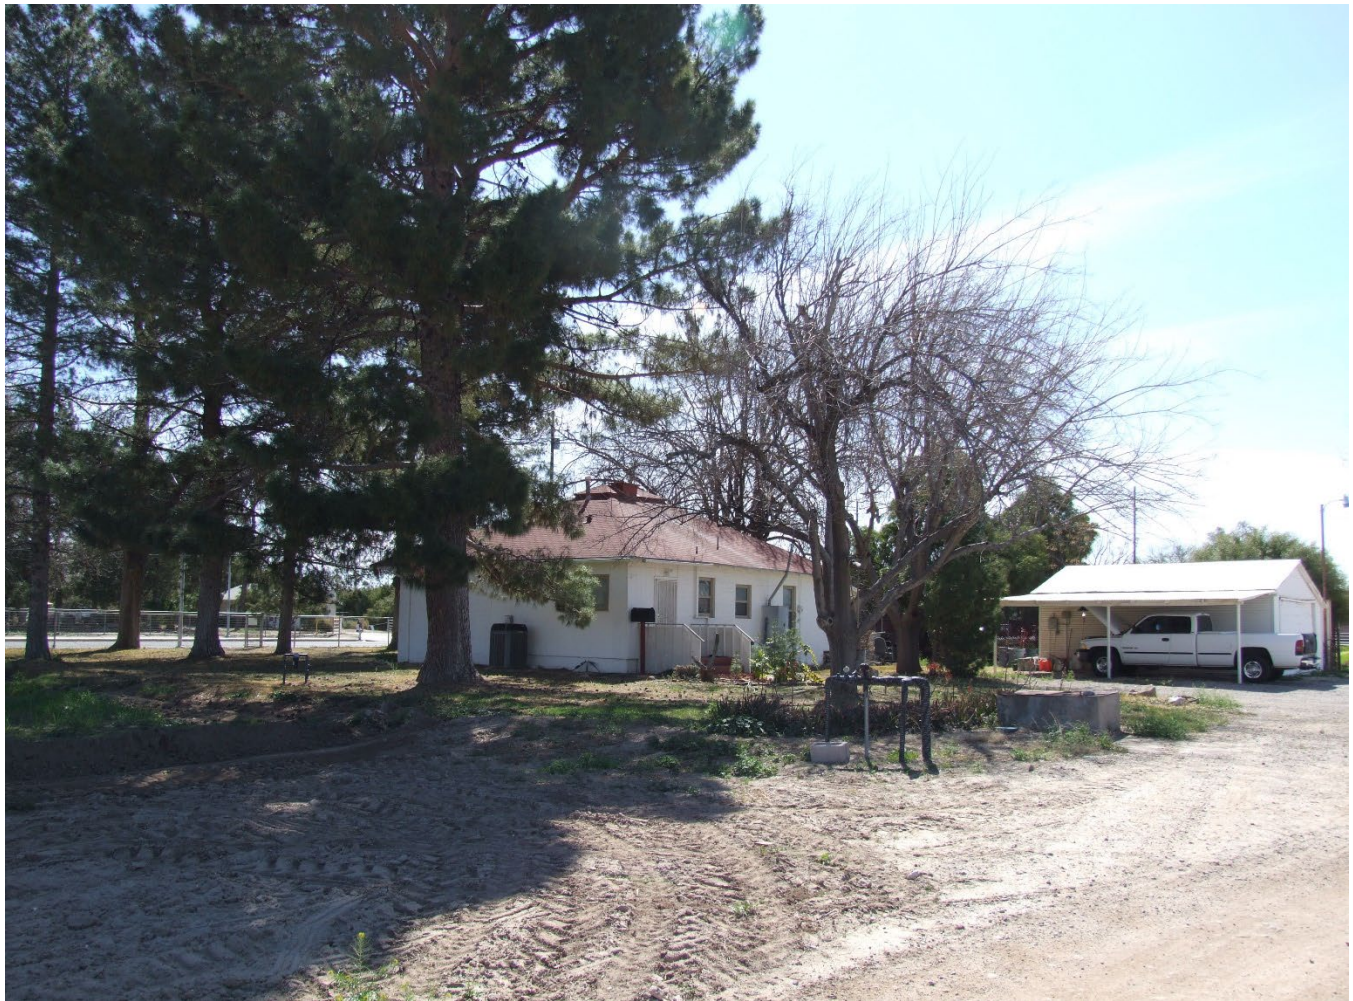
Photograph 2. North and west elevations of the Residence with carport; view facing southeast (UA_Pima County_UA Campus Agricultural Center Historic District_0002).

Photograph 2. North and west elevations of the Residence with carport; view facing southeast (UA_Pima County_UA Campus Agricultural Center Historic District_0002).

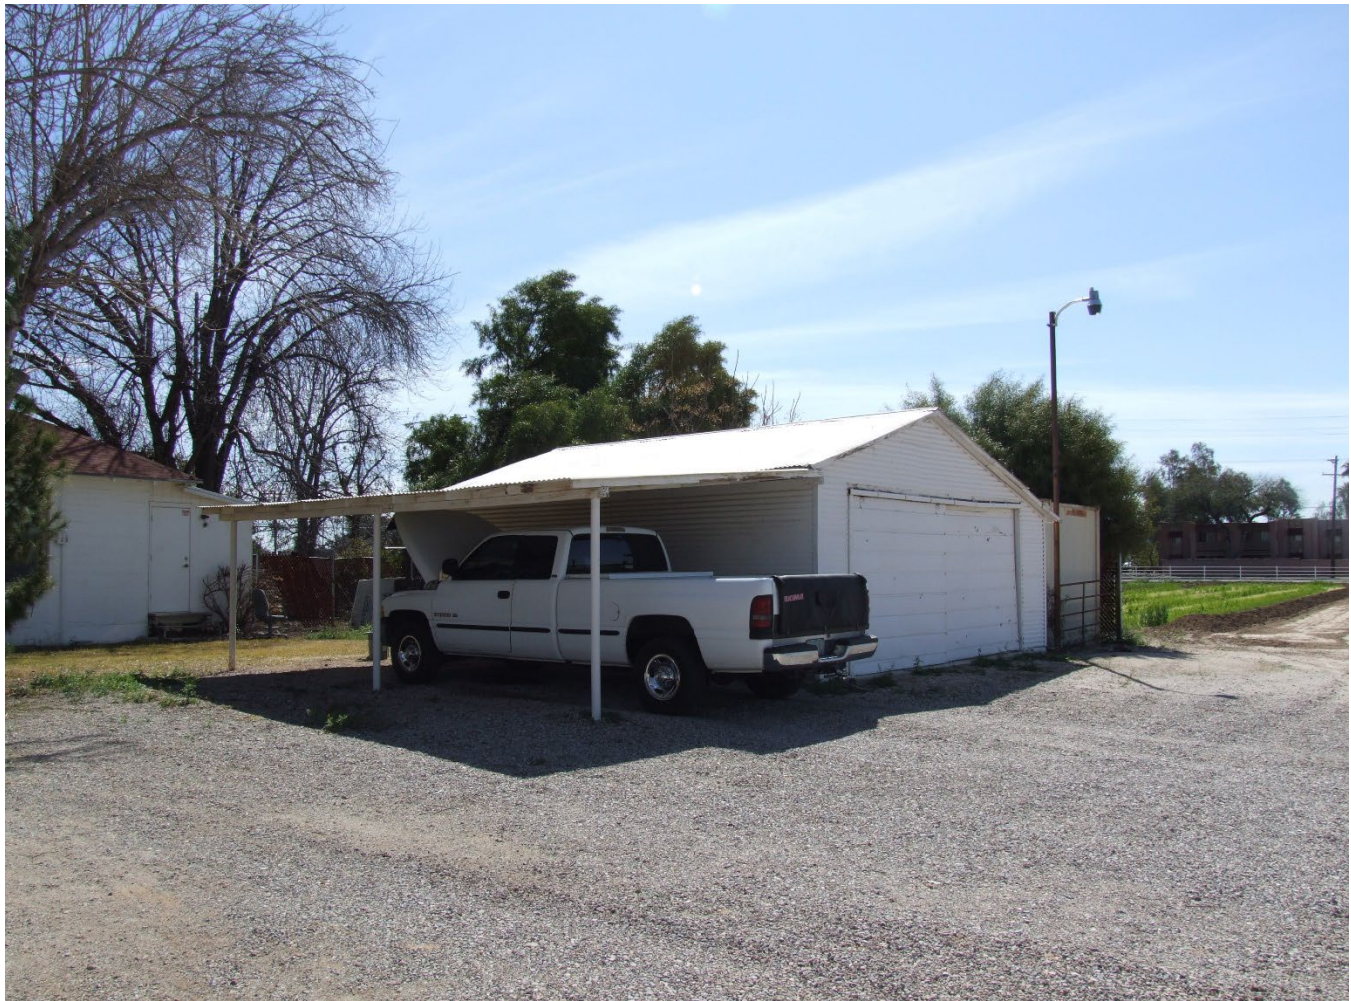
Photograph 3. Overview of the carport at the Residence; view facing southeast (UA_Pima County_UA Campus Agricultural Center Historic District_0003).

Photograph 3. Overview of the carport at the Residence; view facing southeast (UA_Pima County_UA Campus Agricultural Center Historic District_0003).

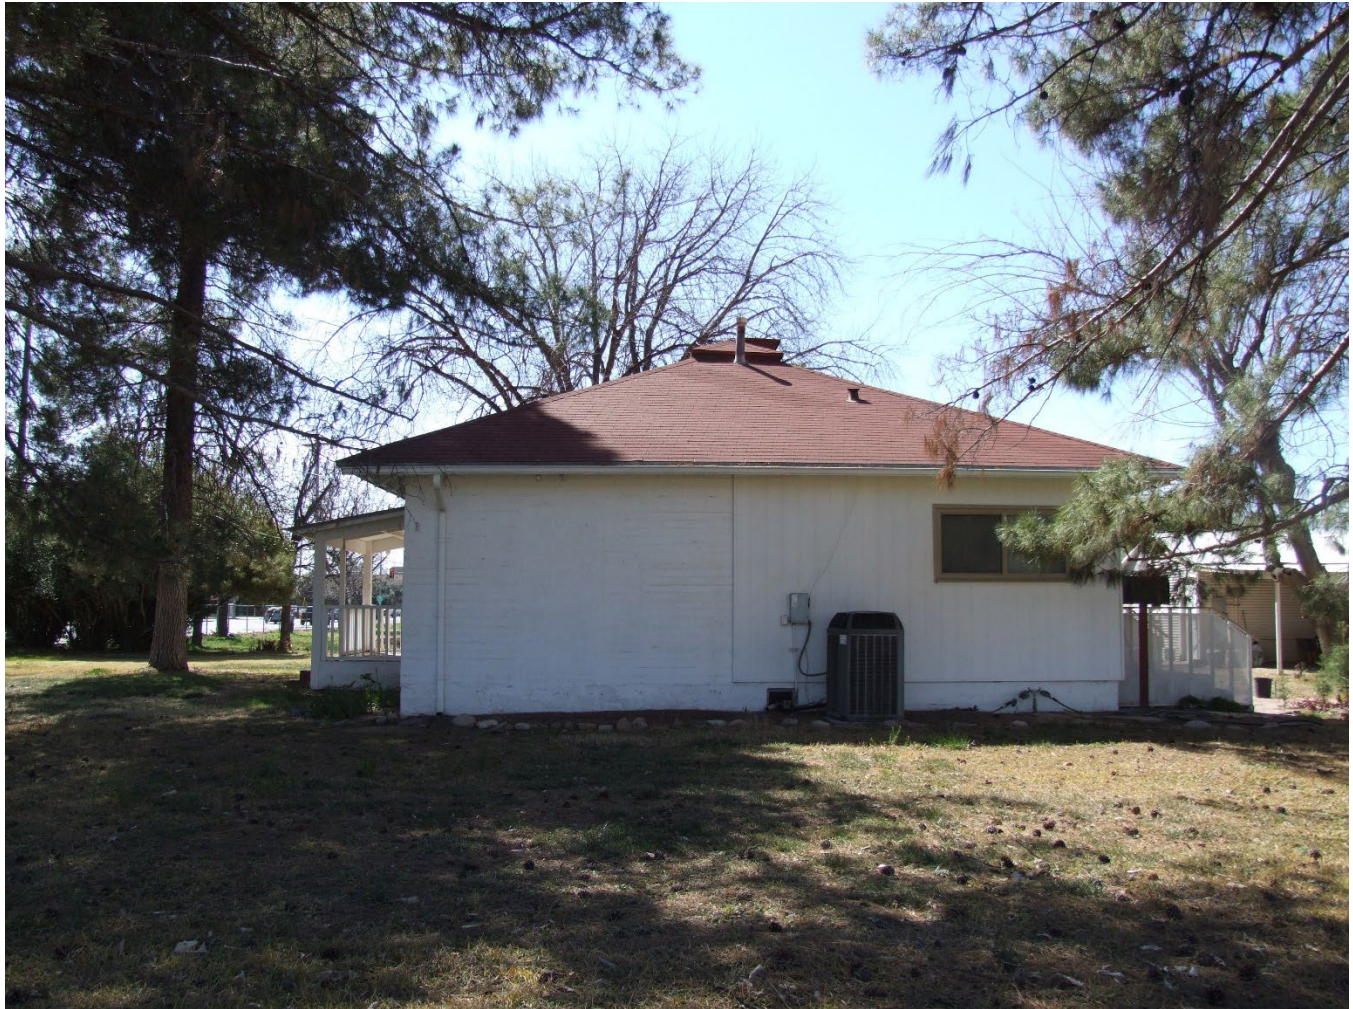
Photograph 4. Overview of north elevation of the Residence; view facing south (UA_Pima County_UA Campus Agricultural Center Historic District_0004).

Photograph 4. Overview of north elevation of the Residence; view facing south (UA_Pima County_UA Campus Agricultural Center Historic District_0004).

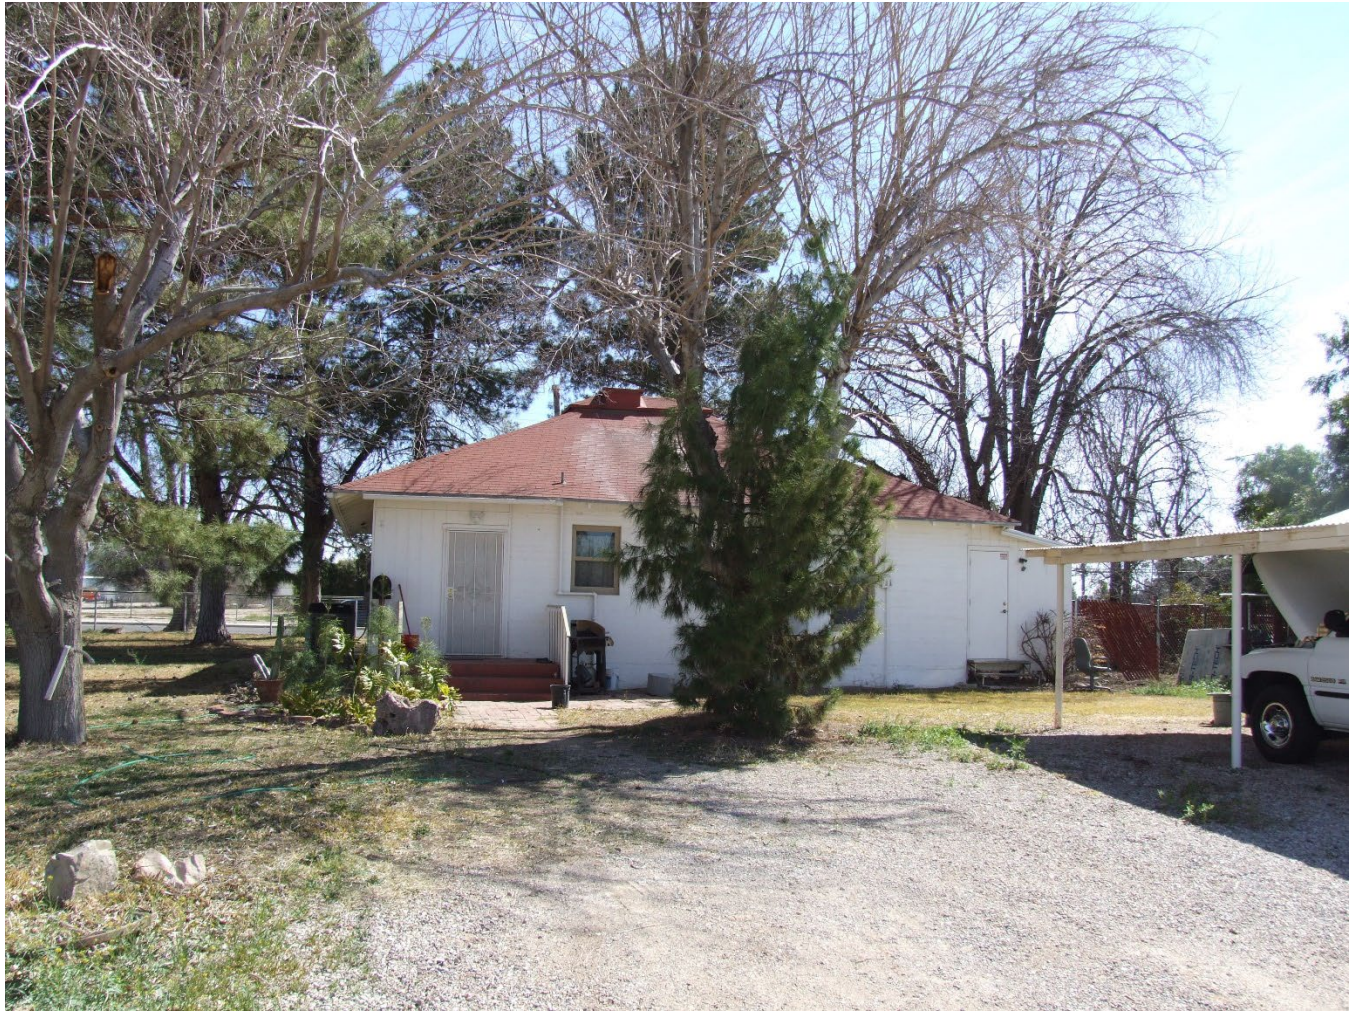
Photograph 5. West elevation of the Residence and back entryway; view facing east (UA_Pima County_UA Campus Agricultural Center Historic District_0005).

Photograph 5. West elevation of the Residence and back entryway; view facing east (UA_Pima County_UA Campus Agricultural Center Historic District_0005).

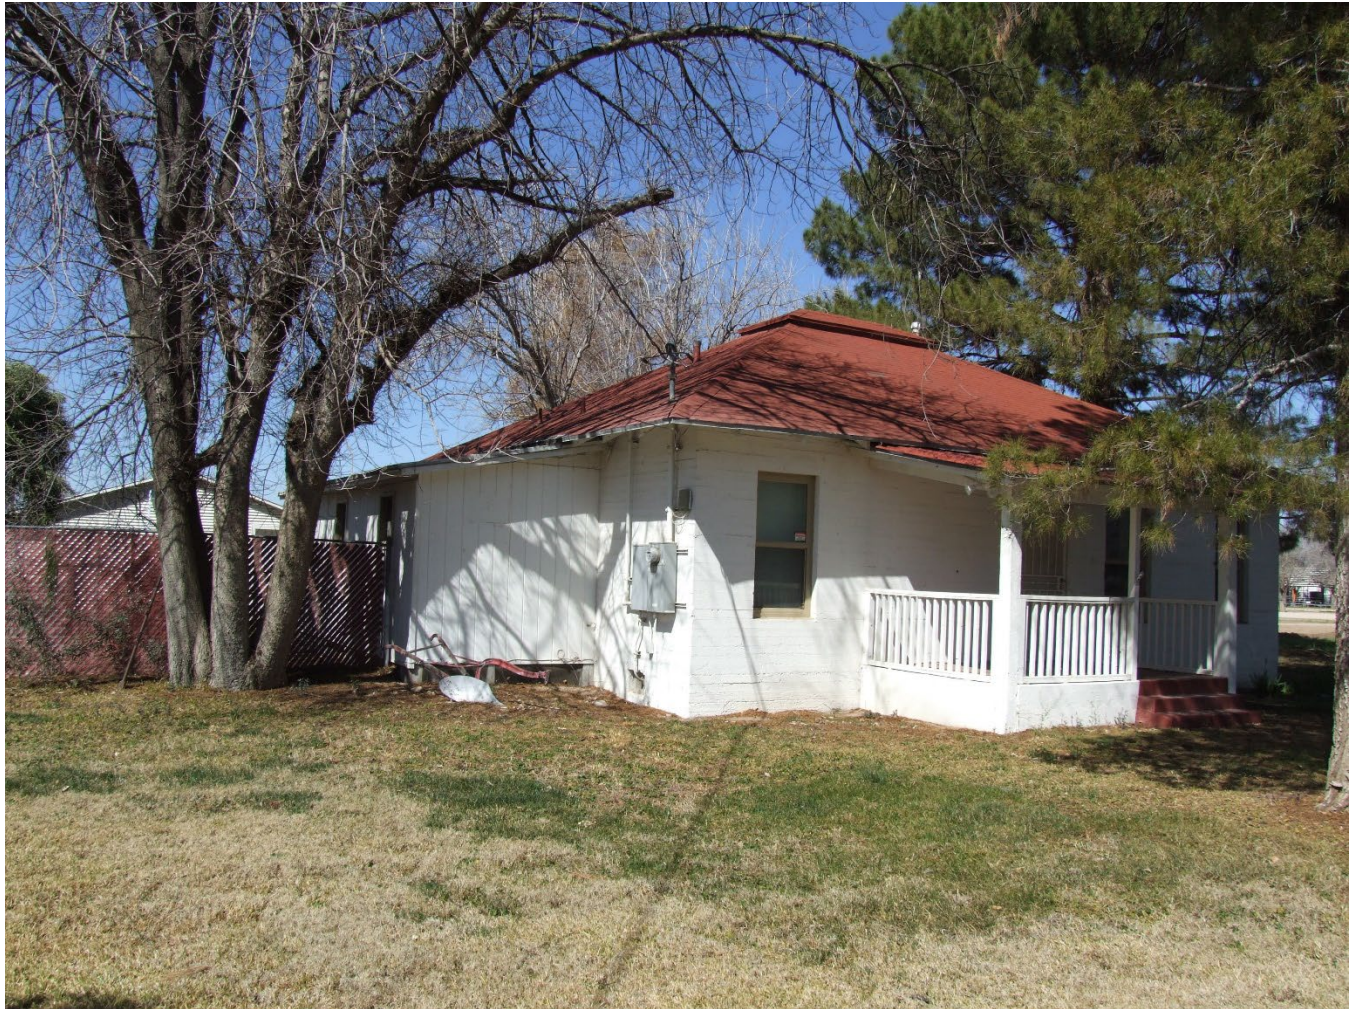
Photograph 6. East and south elevations with south addition of the Residence; view facing northwest (UA_Pima County_UA Campus Agricultural Center Historic District_0006).

Photograph 6. East and south elevations with south addition of the Residence; view facing northwest (UA_Pima County_UA Campus Agricultural Center Historic District_0006).

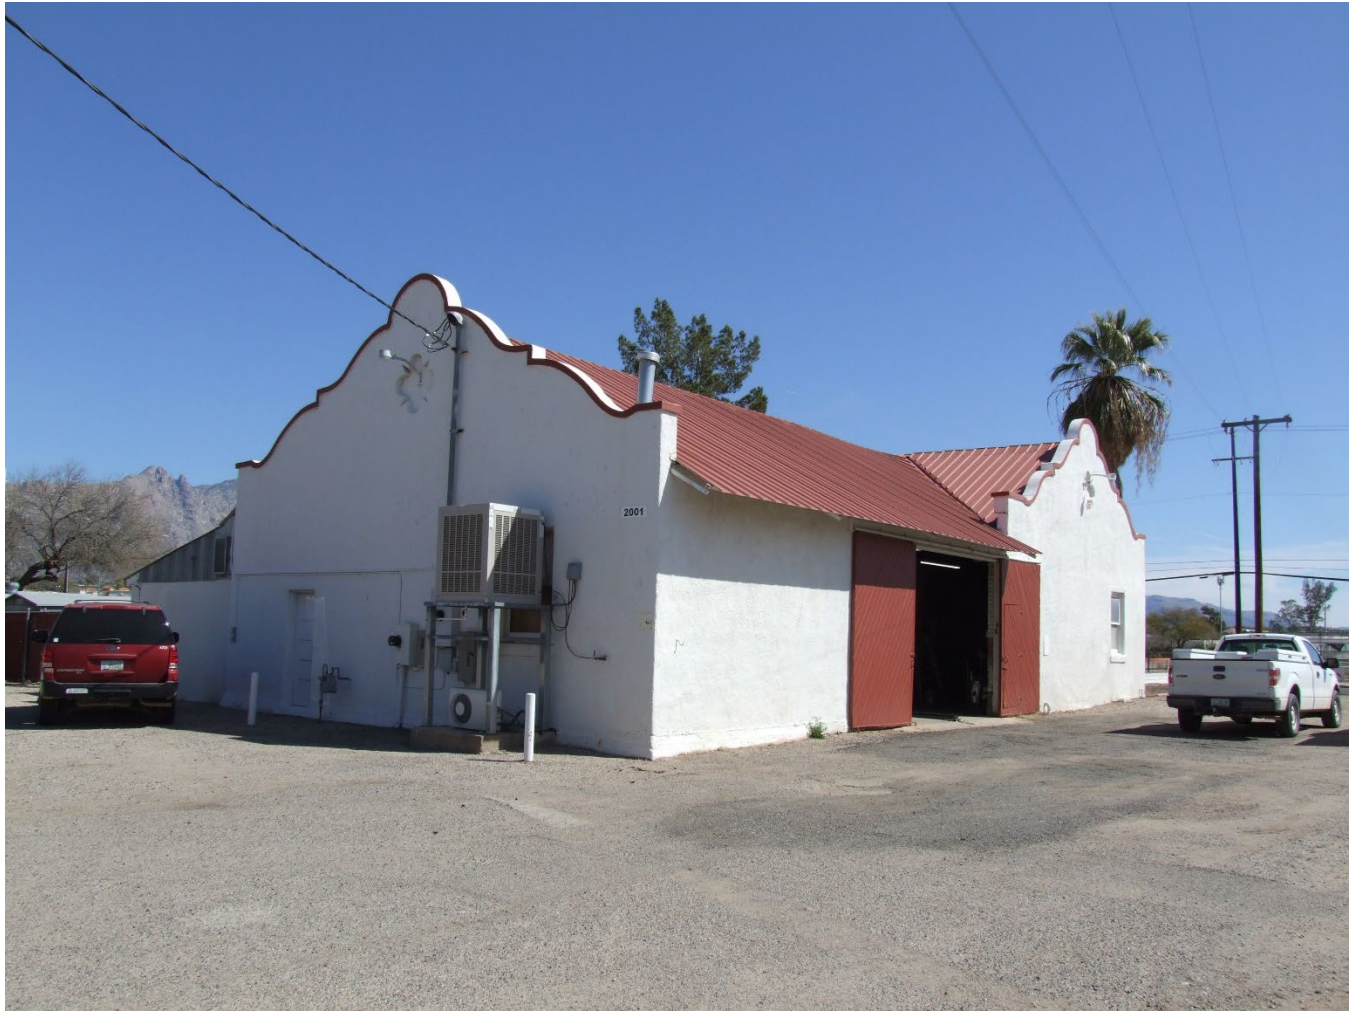
Photograph 9. West and south elevations of the Machine Shop; view facing northeast (AZ_Pima County_UA Campus Agricultural Center Historic District_0009).

The Machine Shop is a one-story Mission Revival style building with a rectangular footprint constructed of masonry brick walls covered in stucco on a concrete foundation. The walls are topped by a medium pitch cross gable roof constructed of galvanized steel with low overhanging eaves. There is a Mission-style arched parapet with brick coping on the west, north, and south elevations, with stucco quatrefoil details around the attic vents. **(Photograph 9)**. The parapet on the Machine Shop differs slightly from the other buildings in that the parapet has been stuccoed over and painted, while others have been left as exposed brick.

The exterior walls are penetrated by the original wood casement and double hung windows and original wood doorways with glass panels. Located on the south elevation is a painted sliding barn door, likely historic. A shed roof addition is located on the north elevation and is constructed of CMU with stucco sheathing and topped with a galvanized steel roof. Additionally, there is a historic concrete water holding tank and water pump located in front of the east elevation **(Photograph 10)**.

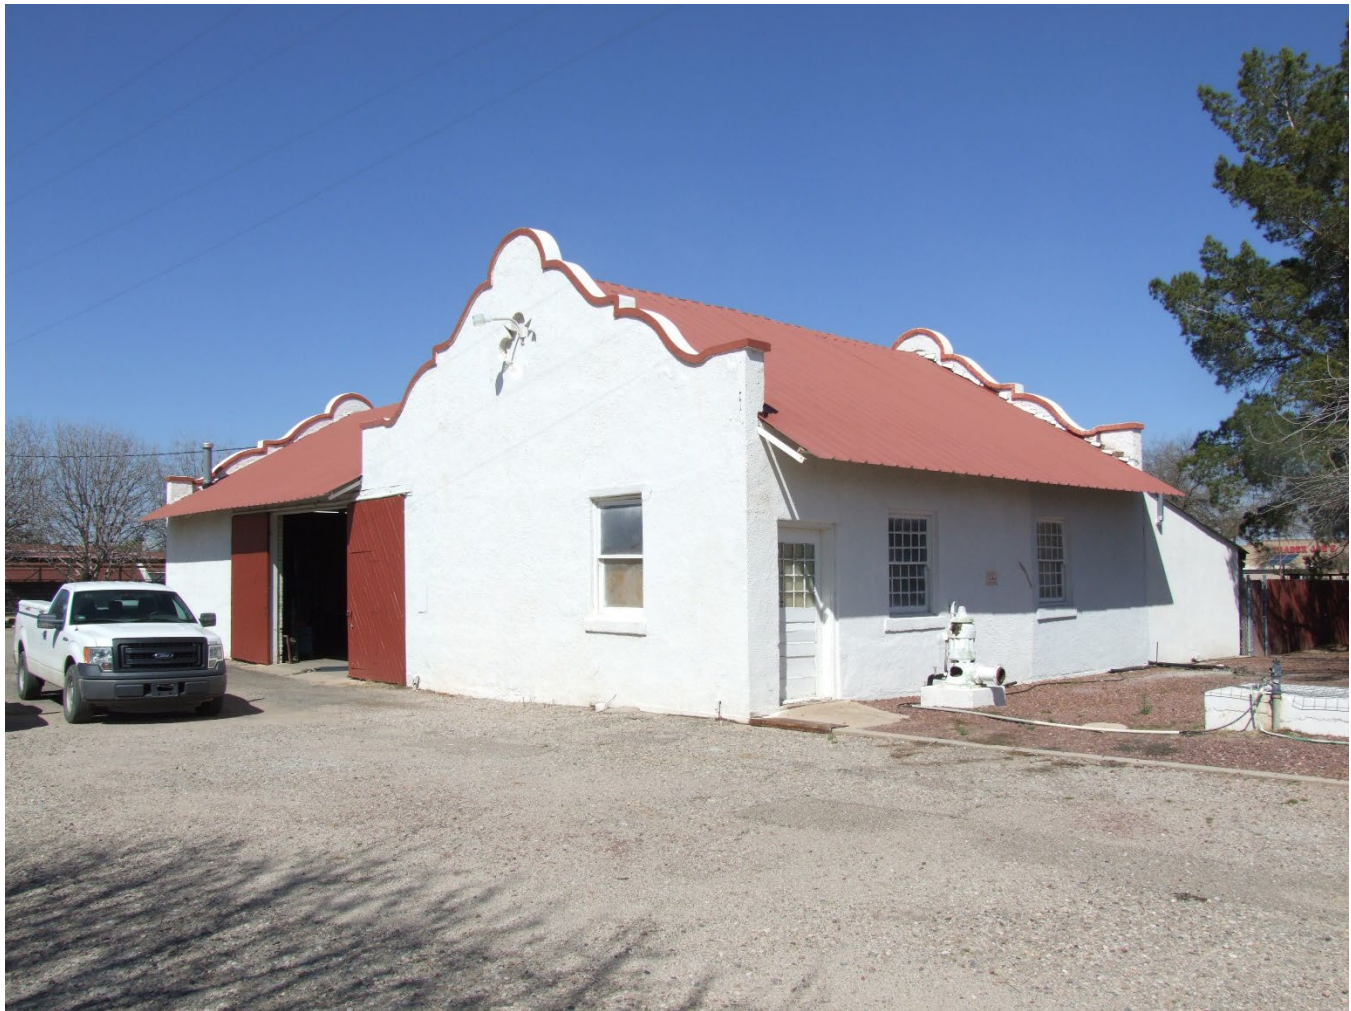
Photograph 10. East and south elevations of the Machine Shop; view facing northwest (AZ_Pima County_UA Campus Agricultural Center Historic District_0010).

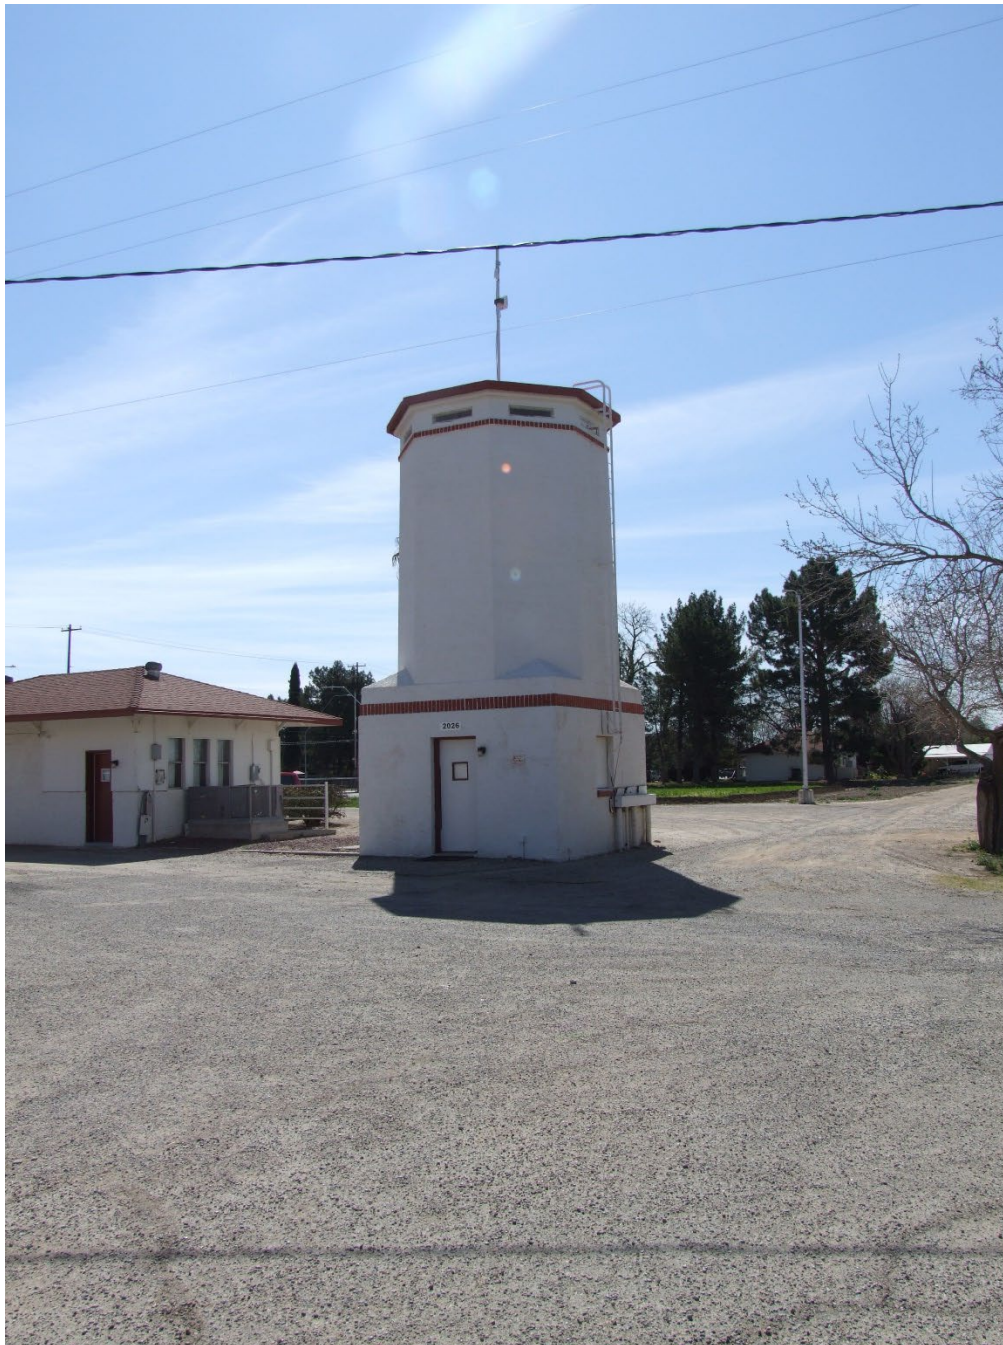
Photograph 11. East and north elevations of the Network Storage Building and Water Tower; view facing southeast (AZ_Pima County_UA Campus Agricultural Center Historic District_0011).

Photograph 11. East and north elevations of the Network Storage Building and Water Tower; view facing southeast (AZ_Pima County_UA Campus Agricultural Center Historic District_0011).

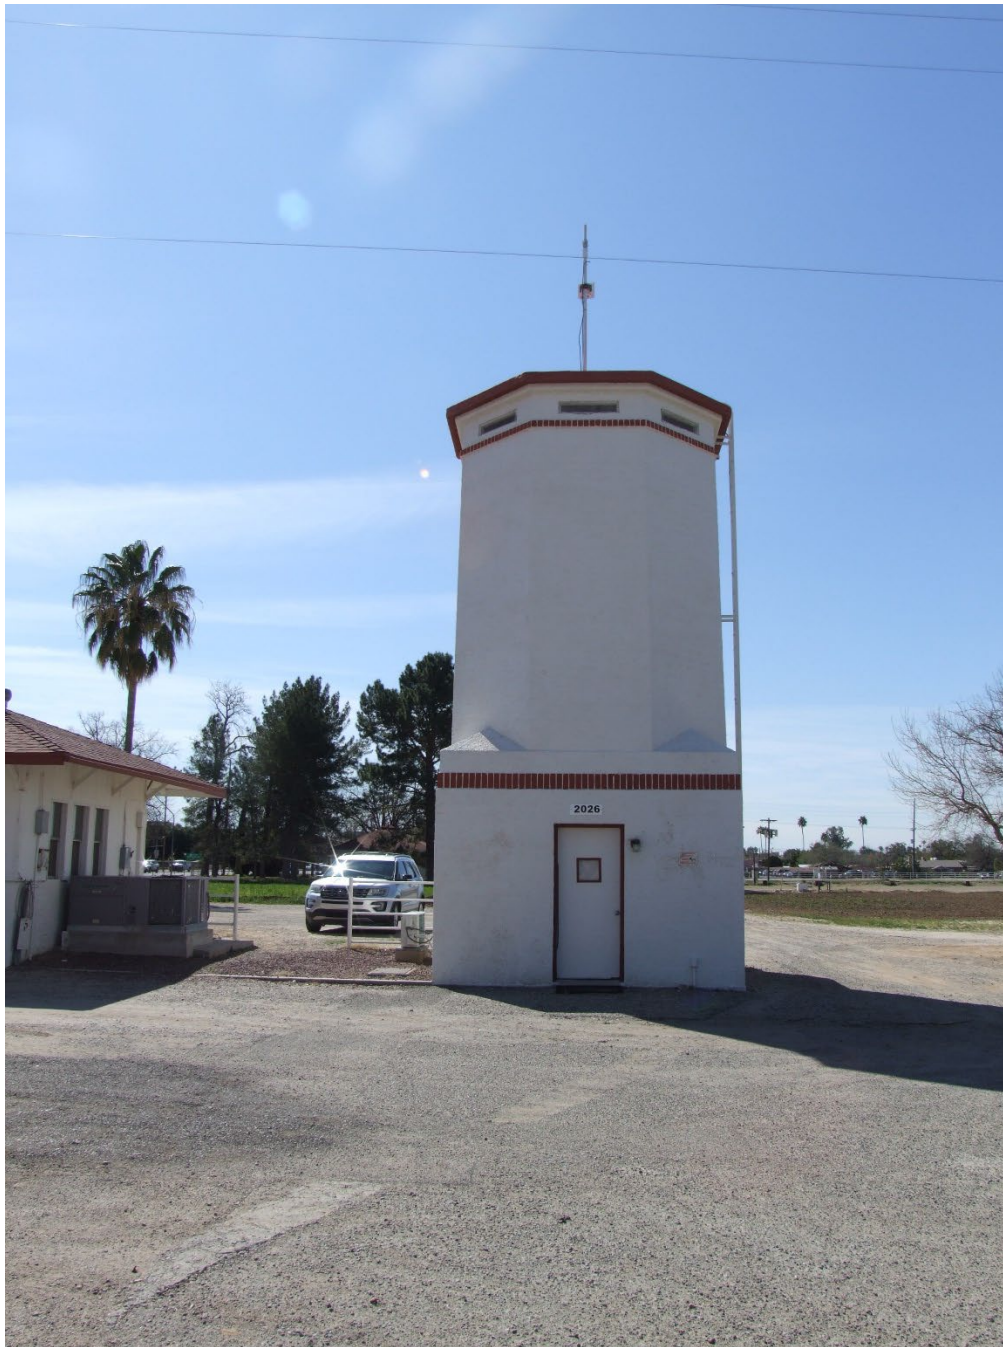
Photograph 12. Overview of north elevation of the Network Storage Building and Water Tower; view facing southeast (AZ_Pima County_UA Campus Agricultural Center Historic District_0012).

Within the CAC Historic District, Lyman was retained to construct the water tower in 1917 and his contribution is noted in Board of Regents meeting minutes from October 3, 1917, as "water tank for Experimental Farm, University of Arizona, Tucson by the firm of J. B. Lyman, Jr. Architect." Per the drawings cited by University of Arizona Architecture Professor Robert

Giebner, they appear to show the same water tower (now network storage building) as the existing octagonal-over-square tower (Giebner 1992). It is presumed that the original tile roof was either never constructed or was replaced historically by concrete; similarly, it is unknown if the stucco was applied in 1917 or later added in 1935–1936 to match the other buildings on campus. Nonetheless, while the building is not strictly Mission Revival in its design, Lyman clearly took a cue from the design of the 1913 Machine Shed directly adjacent to the Water Tower and created a functional building that corresponded with the design of neighboring architecture.

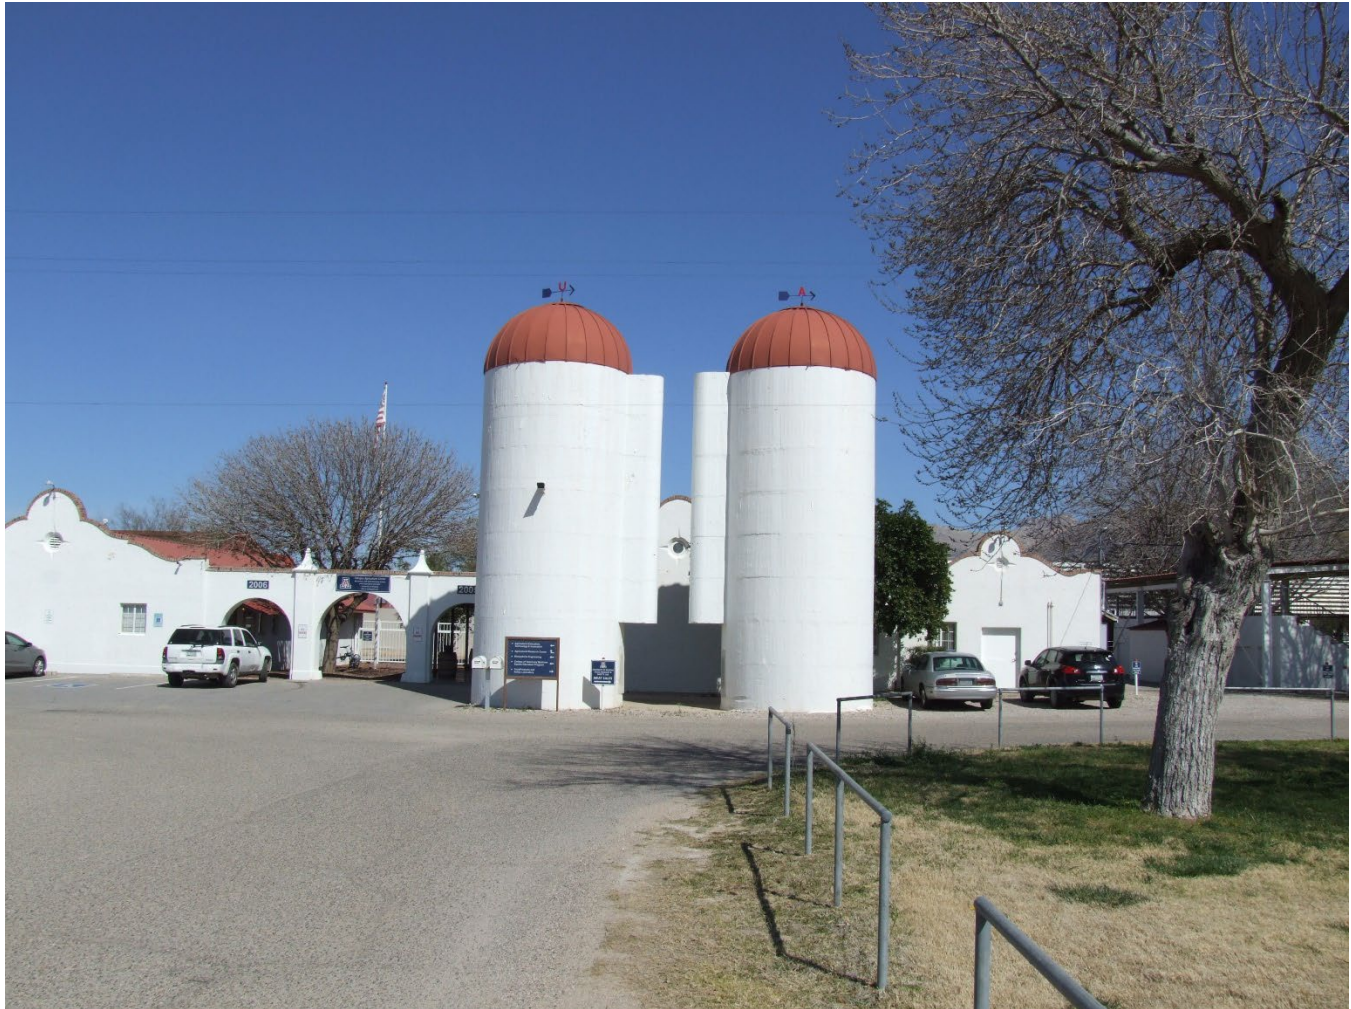
Photograph 15. Overview of south elevations of the two paired silos; view facing north (UA_Pima County_UA Campus Agricultural Center Historic District_0015).

Two paired silos situated immediately south of the Classroom Building and the Office Building are approximately 41 feet tall, with poured concrete walls sheathed in a thin plaster whitewash set on a concrete apron foundation. Both silos are capped with galvanized standing seam domed roofs with a “U of A” weathervane on top. Both have enclosed stairwells facing each other between the silos, on the east and west elevations. An air vent is located near the base of the silos (**Photograph 15**).
