National Register of Historic Places Registration Form

Historic name: University of Arizona Campus Agricultural Center
 Other names/site number: Campus Farm, Campbell Avenue Farm, University Farm; University Campus Farm Complex
 Name of related multiple property listing:
N/A
 (Enter "N/A" if property is not part of a multiple property listing)

Street & number: 4101 N. Campbell Avenue
 City or town: Tucson State: Arizona County: Pima County
 Not For Publication: Vicinity:

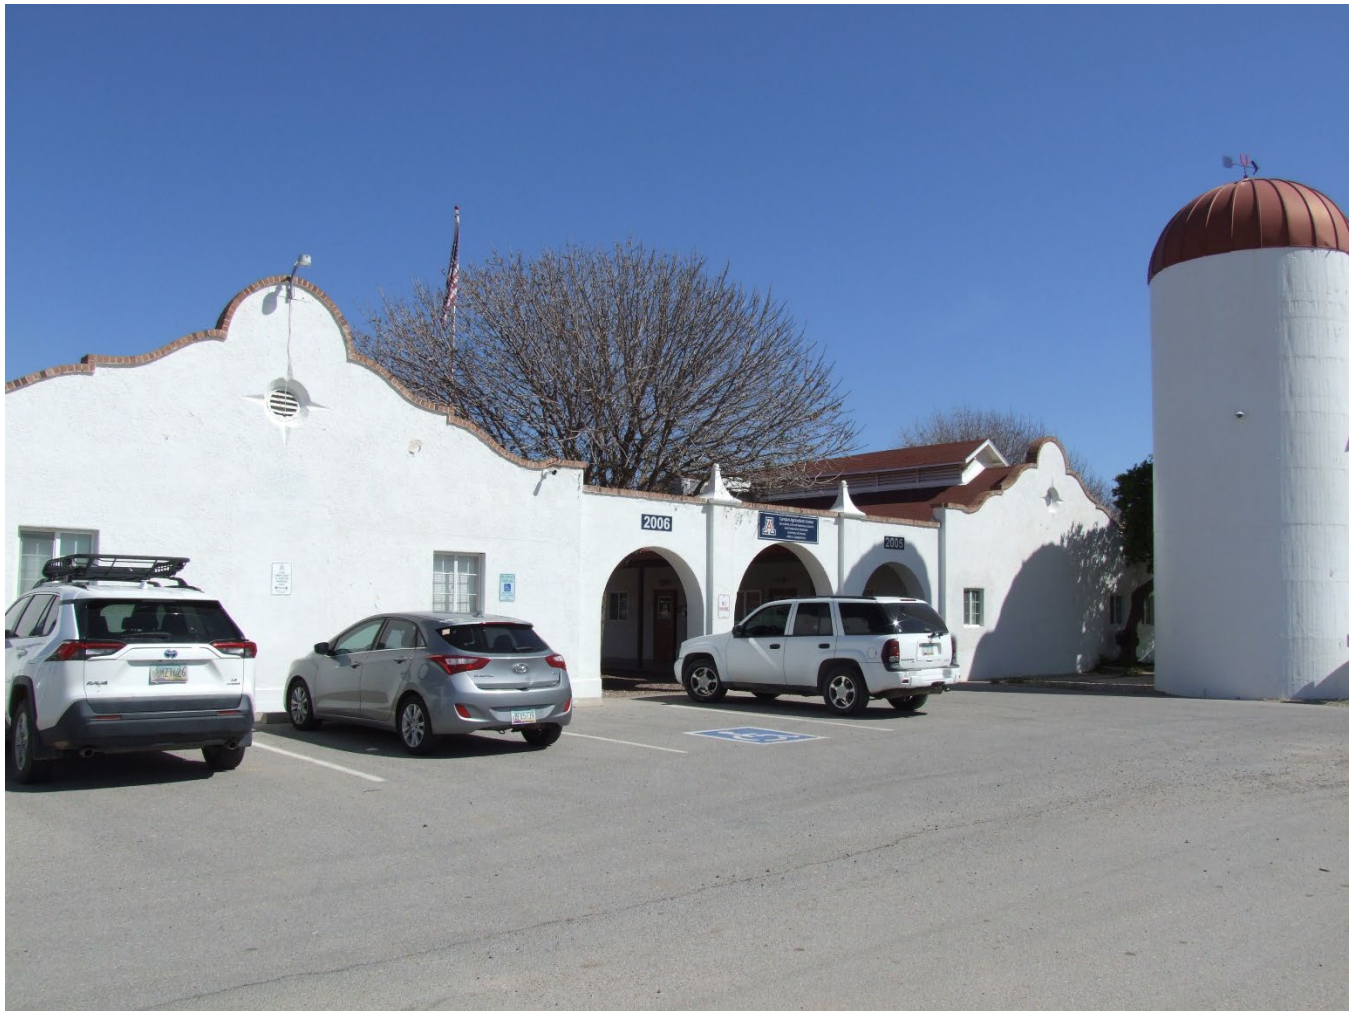
Photograph 16. South elevation of the Office Building and arched arcade openings; view facing northeast (AZ_Pima County_UA Campus Agricultural Center Historic District_0016).

The Office Building, also known as the former Dairy Barn, is a one-story building with a rectangular footprint. Its exterior walls are constructed of brick masonry and are sheathed in stucco resting on a poured concrete foundation. The walls are topped by a medium-pitch asphalt shingle gable roof with a north/south axis, with shallow overhanging eaves. A large monitor runs the length of the roof and once served as ventilation inside the Dairy Barn. There is a Mission-style arched parapet on the north and south elevations with brick coping and quatrefoils around the attic vents. The walls are punctuated with aluminum and vinyl sliding sash windows with ornamental grilles that replaced the original steel casements. The building also has a mix of original solid wood doors and modern doors with glass panels (**Photograph 16**).

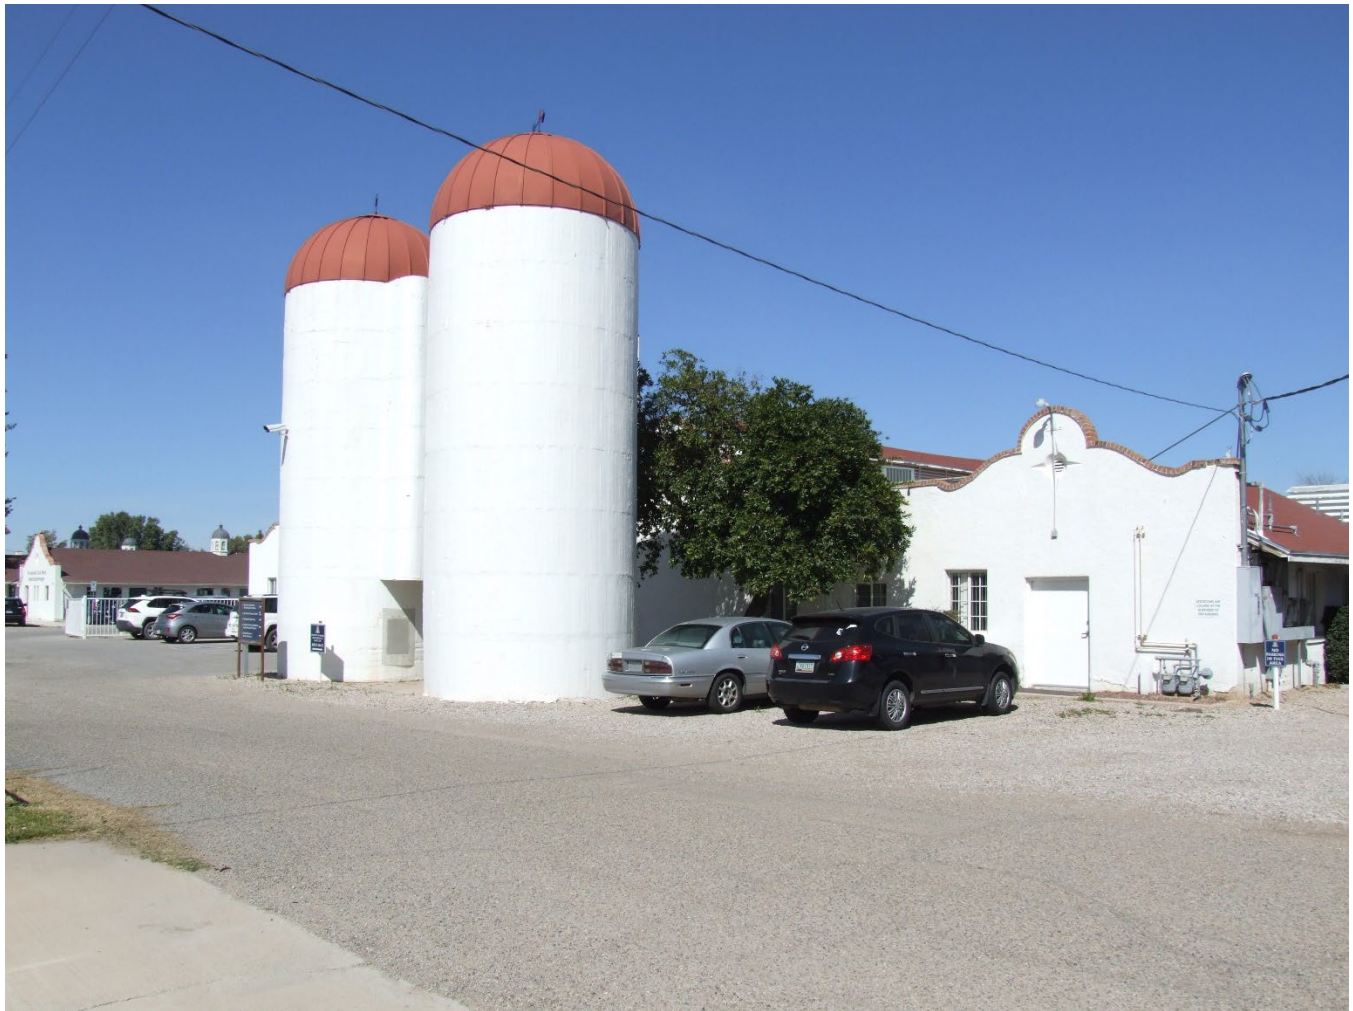
Photograph 17. East and south elevations of the Office Building with silos; view facing northwest (AZ_Pima County_UA Campus Agricultural Center Historic District_0017).

Photograph 17. East and south elevations of the Office Building with silos; view facing northwest (AZ_Pima County_UA Campus Agricultural Center Historic District_0017).

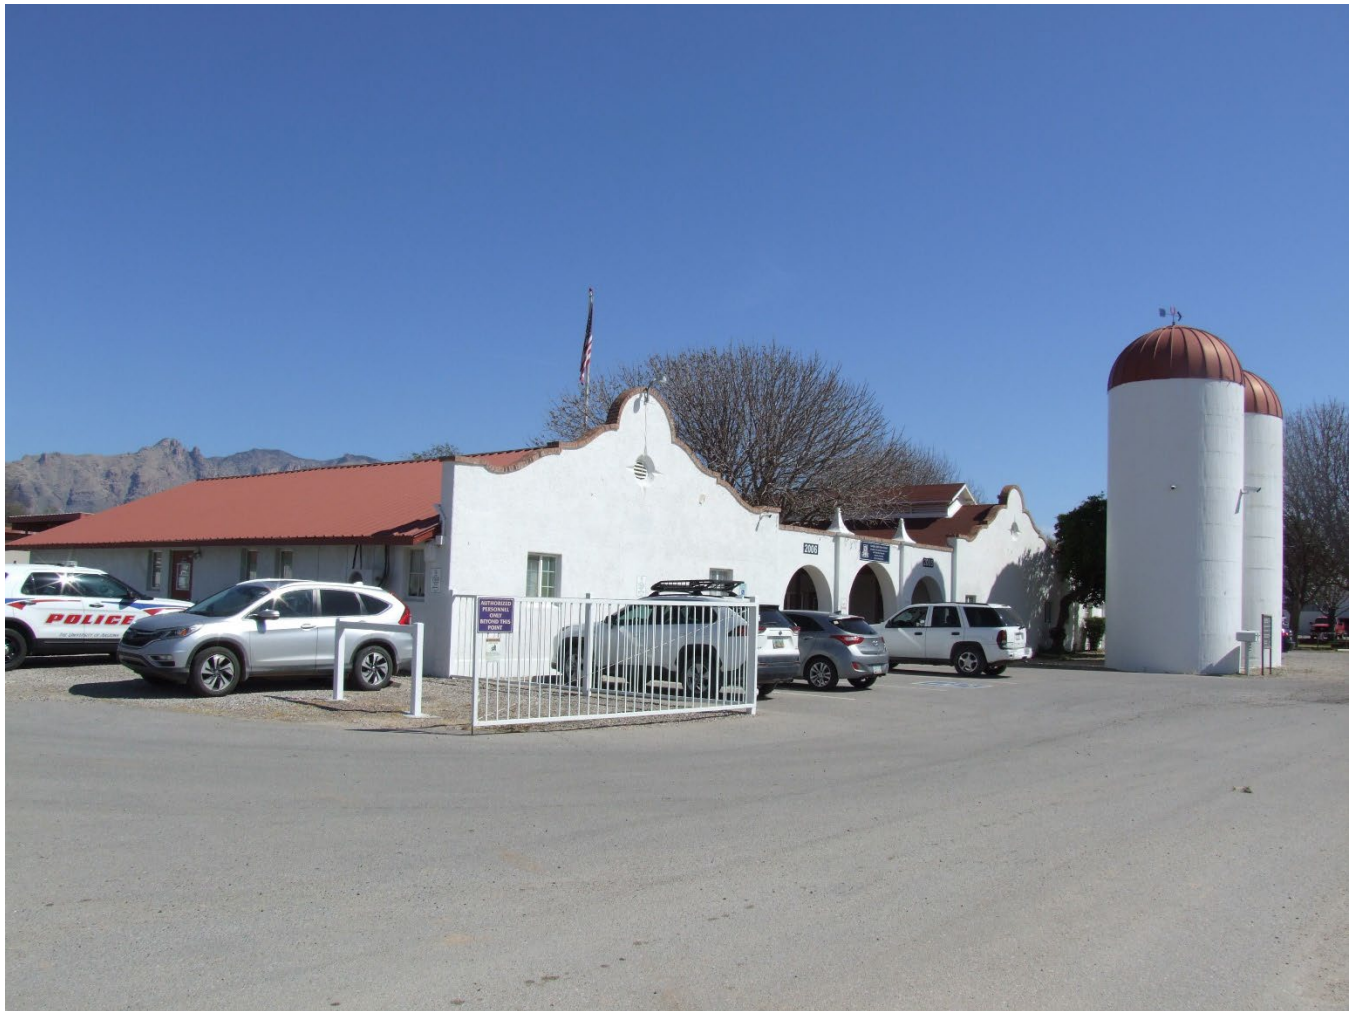
Photograph 18. West and south elevations of the Classroom Building; view facing northeast (AZ_Pima County_UA Campus Agricultural Center Historic District_0018).

The Classroom Building is a one-story building with a rectangular footprint. The exterior walls are constructed of brick masonry covered in stucco on a poured concrete foundation. The walls are topped by a medium-pitch gable roof with a north-south axis with slightly overhanging eaves, with the roof constructed of galvanized steel over wood frame. There is a Mission-style parapet on the north and south elevations. There are attic vents near the gable ends that are surrounded by decorative stucco quatrefoils. The exterior walls are punctuated with fixed vinyl and steel casement windows along the south, west, and east elevations. The building has original solid wood doors and replacement modern doors with glass panels located on the east, west, and north elevations.

As noted in the previous description for the Office Building, there is a central courtyard between the Classroom Building and the Office Building uniting them into a single composition. A modern fence encloses the courtyard along the north elevation, connecting the Classroom Building and the Office Building, and a steel stairway is located along the north (back) elevation for access to the attic. A former doorway on the south elevation has been filled in (**Photograph 18**).

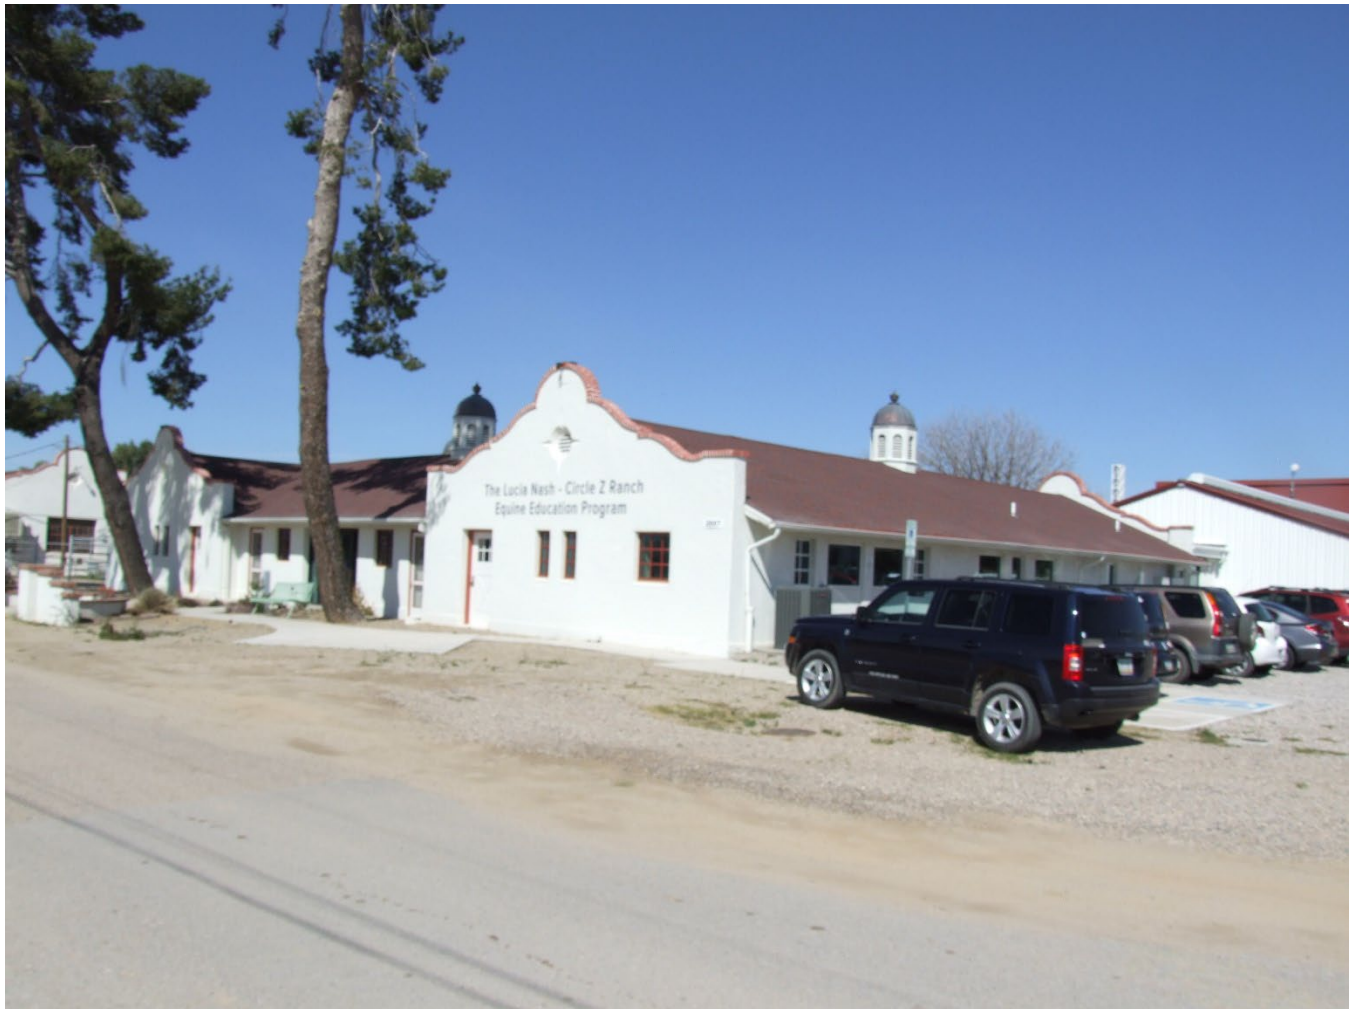
Photograph 19. East and south elevations of the Equine Education Building; view facing northwest (AZ_Pima County_UA Campus Agricultural Center Historic District_0019).

The Equine Education Building, formerly known as the Horse/Equine Barn, is a one-story building with a U-shaped footprint. The exterior walls are constructed of brick masonry and are covered in stucco on a poured concrete foundation. The walls are topped by a medium pitch gable and cross-gable roof with asphalt shingles and shallow overhanging eaves. There is a Mission-style parapet on the north and south elevations with quatrefoils surrounding attic vents on the gable ends. Two decorative copulas with copper domes are located in the center of the east gable and the middle cross gable portions of the roof (**Photograph 19**).

Fenestrations include vinyl windows and modern doors. The east and west wings previously had Dutch door openings for each of the horse stalls, but all of these have been filled in and the windows have been replaced. There is a metal fence connecting the east and west wings, creating an open space/courtyard between each wing (**Photograph 20**). More recently the building was rehabilitated from a stable to a classroom and office space.

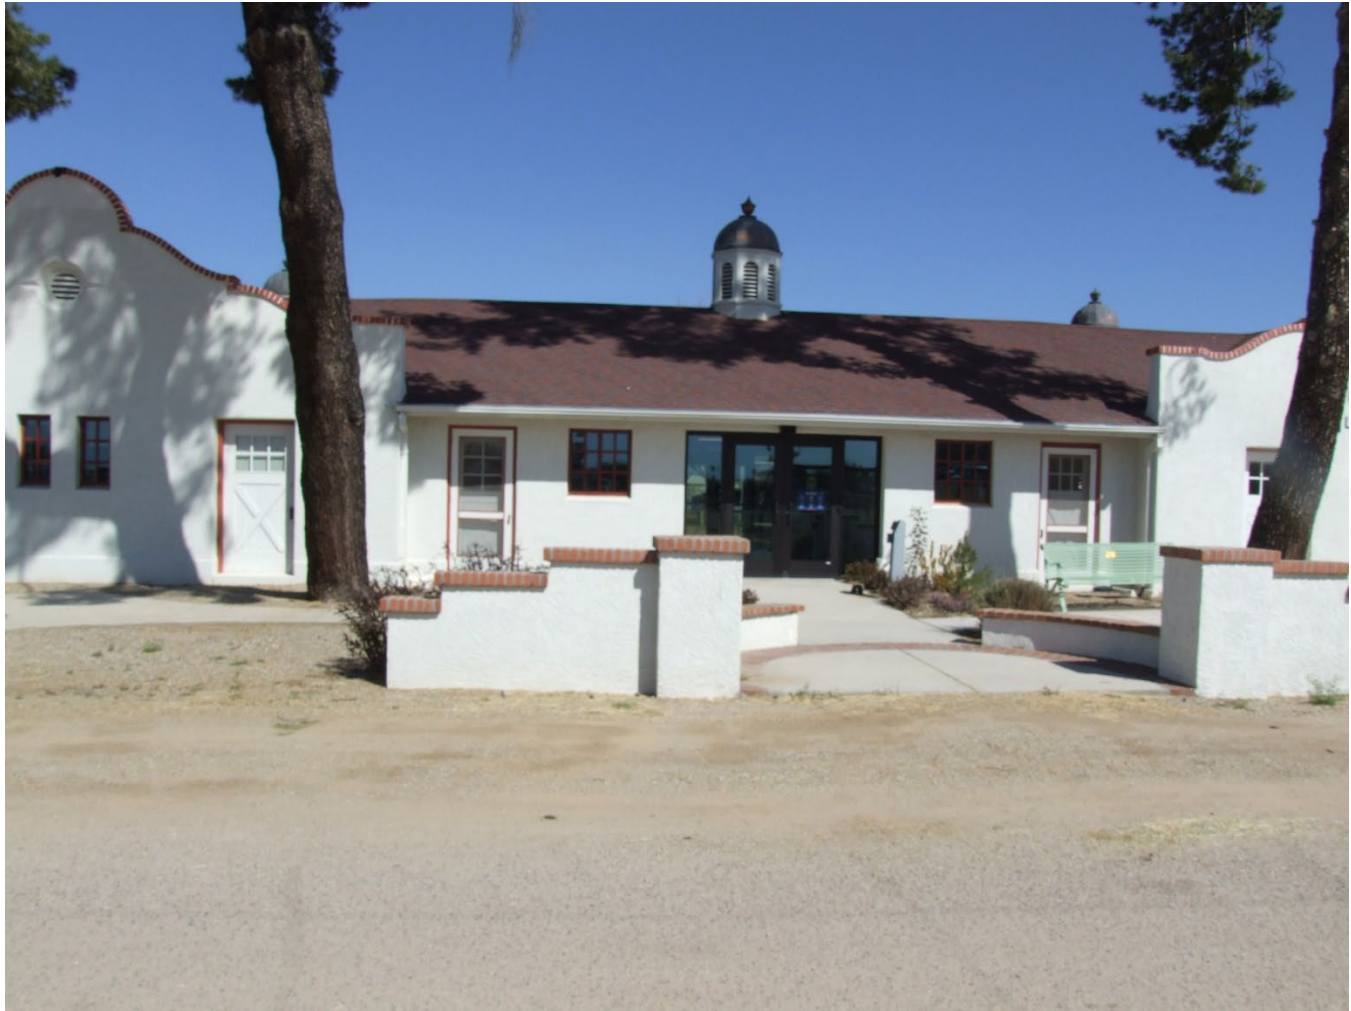
Photograph 20. South elevation overview of the Equine Education Building; view facing north (AZ_Pima County_UA Campus Agricultural Center Historic District_0020).

Photograph 20. South elevation overview of the Equine Education Building; view facing north (AZ_Pima County_UA Campus Agricultural Center Historic District_0020).

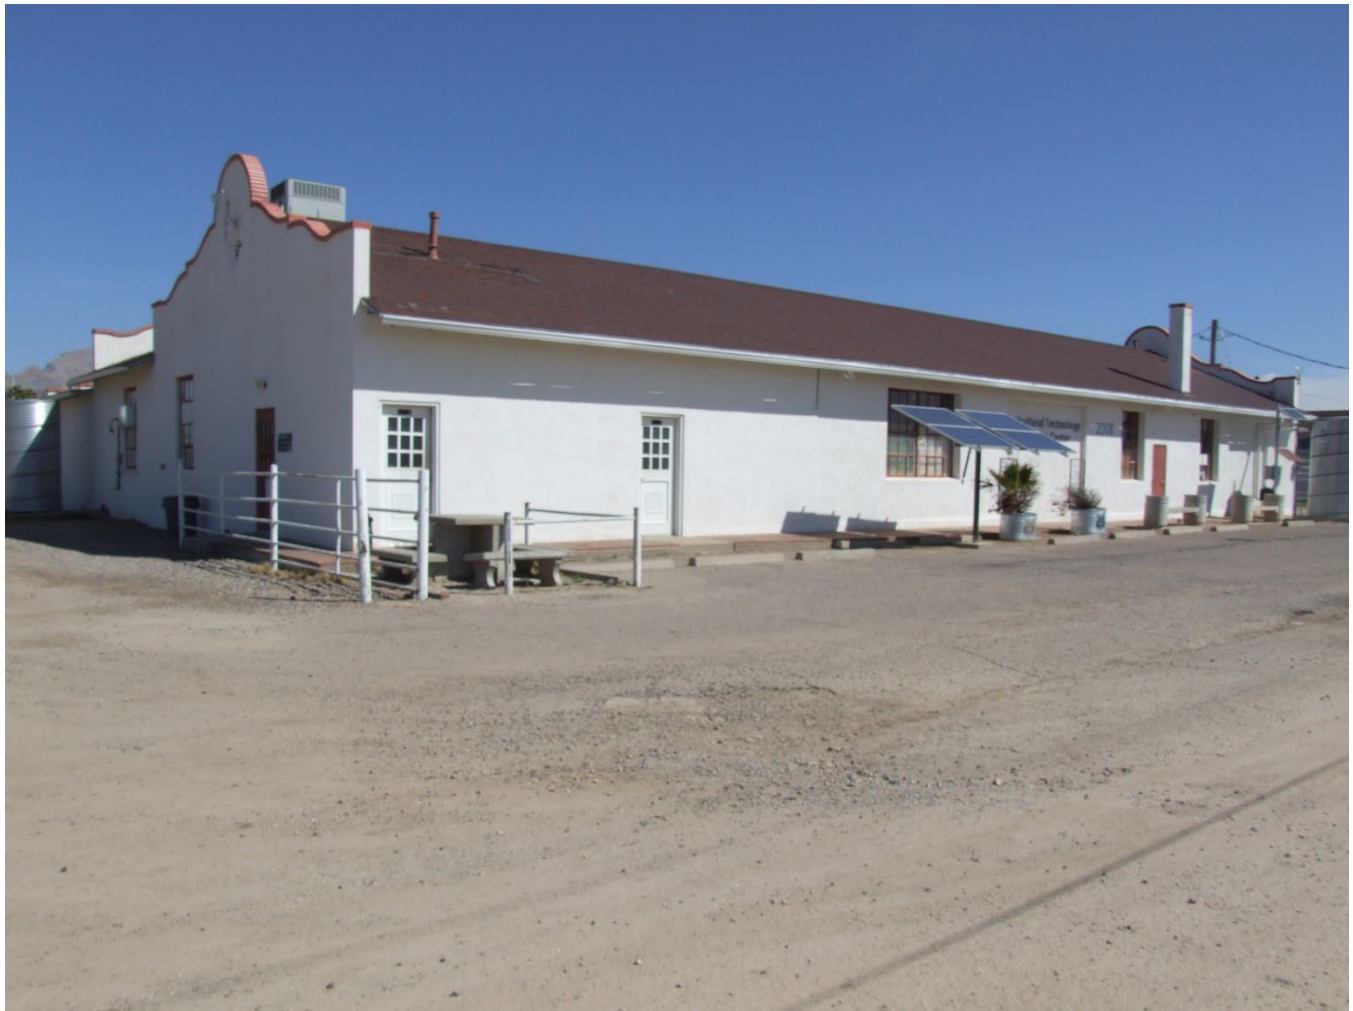
Photograph 21. West and south elevations of Agricultural Education Facility; view facing northeast (AZ_Pima County_UA Campus Agricultural Center Historic District_0021).

The brick and stucco Agricultural Education Facility is a single-story Mission Revival style building with a rectangular plan. The building is constructed of brick masonry walls covered in stucco that are set on a poured concrete foundation. The building's walls are topped by a medium-pitch asphalt shingle gable roof with shallow overhanging eaves. There is a Mission-style parapet on the east and west elevations, in addition to attic vents near the gable ends that are surrounded by quatrefoils. The chimney is flush with the south elevation (**Photograph 21**).

The building's exterior walls are punctuated by original steel casement windows along all elevations. The building's 1930s-era exterior doors have been replaced with modern steel doors along the south and west elevations. Americans with Disabilities Act (ADA)-compliant ramps are located along the main entryway on the west elevation and are constructed of concrete and brick pavers.

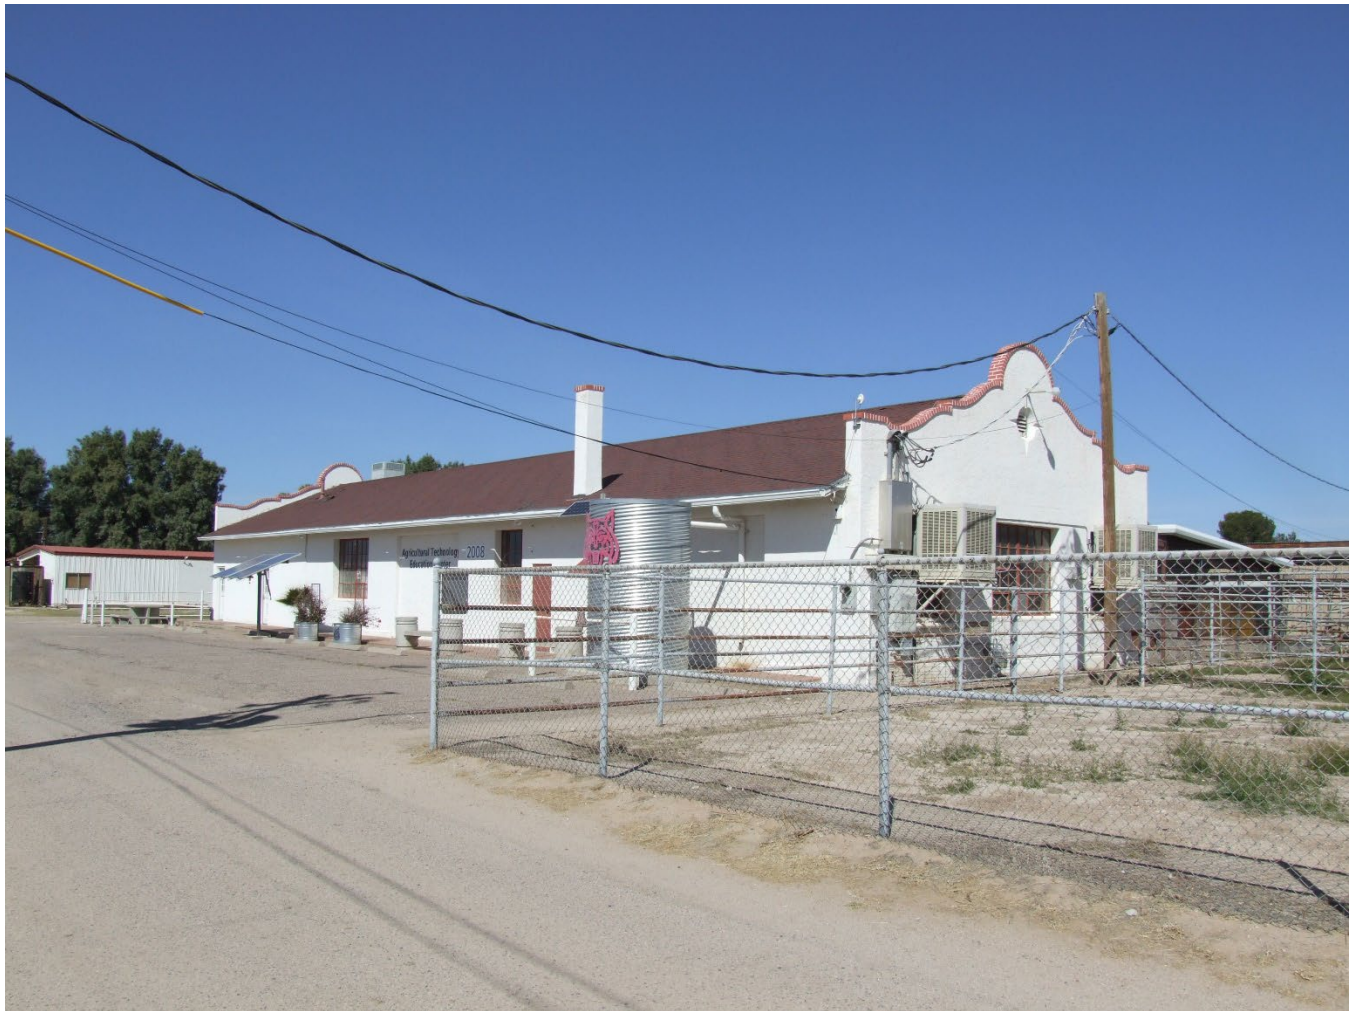
Photograph 22. East and south elevations of Agricultural Education Facility; view facing northwest (AZ_Pima County_UA Campus Agricultural Center Historic District_0022).

Photograph 22. East and south elevations of Agricultural Education Facility; view facing northwest (AZ_Pima County_UA Campus Agricultural Center Historic District_0022).

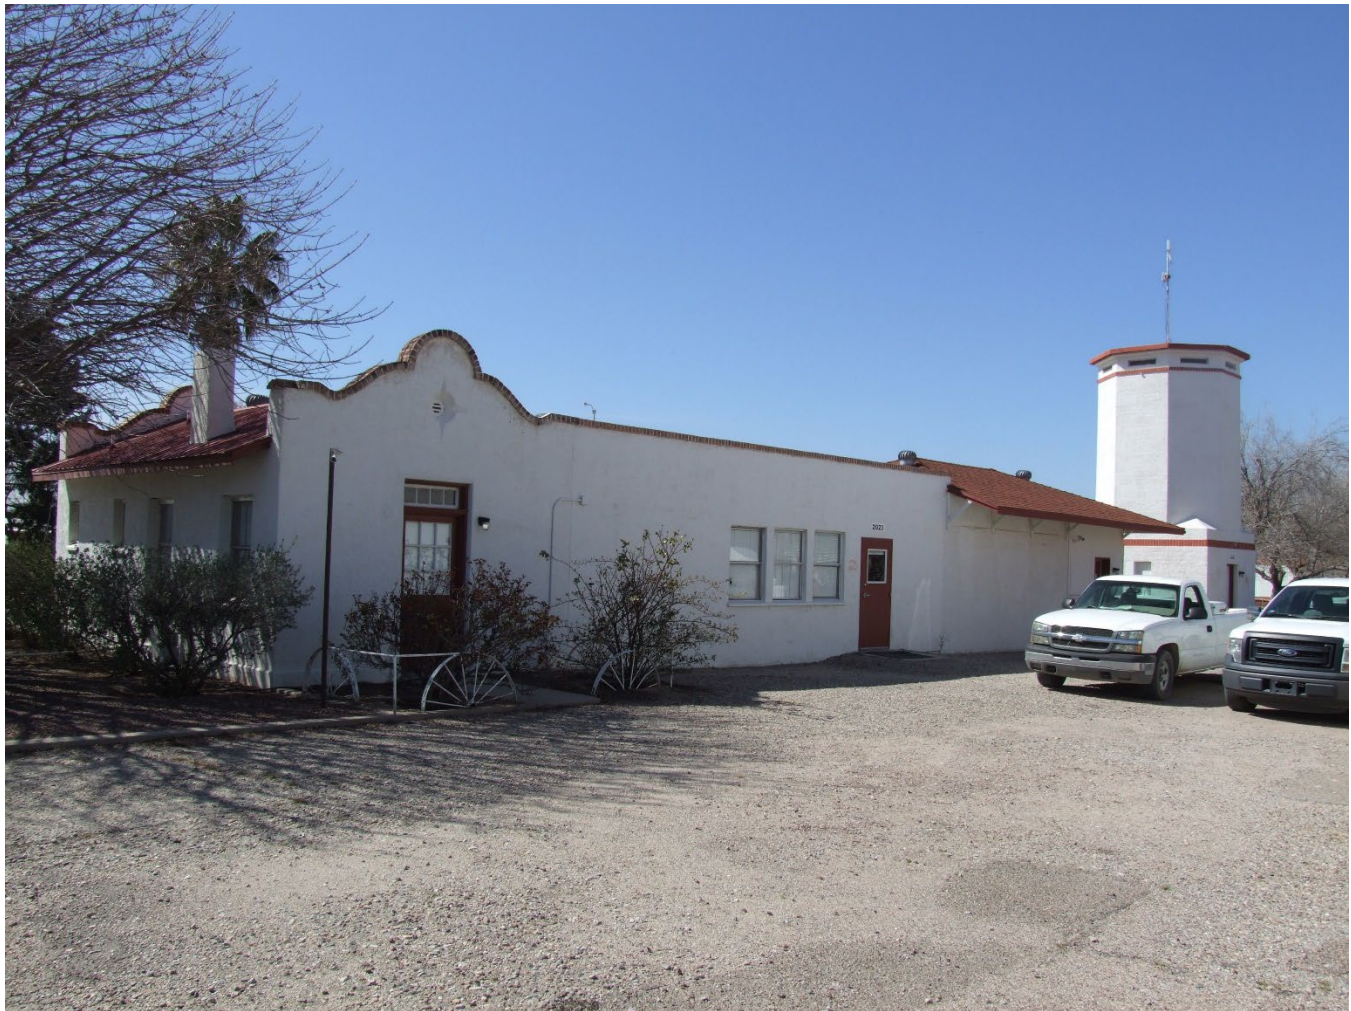
Photograph 23. East and north elevations of the Farm Office; view facing southwest (AZ_Pima County_UA Campus Agricultural Center Historic District_0023).

The exterior walls are pierced by steel casement and double-hung aluminum windows. The doors, except for the main entrance door at the northeast corner of the building, which is topped by a transom window, have been replaced. There is an L-shape addition that extends to the west that is constructed of frame and covered in stucco. Historically the addition in the center of the two ends of the building was built last, with the original farm office on the east, the second building on the west, both free-standing. The center of the building was a later added to connect the two buildings together. The westernmost end/addition is constructed of masonry walls that are covered in stucco with a painted wood veneer on the northwest corner (**Photograph 24**). Historic aerials indicate that the central and western most additions occurred sometime after 1980.

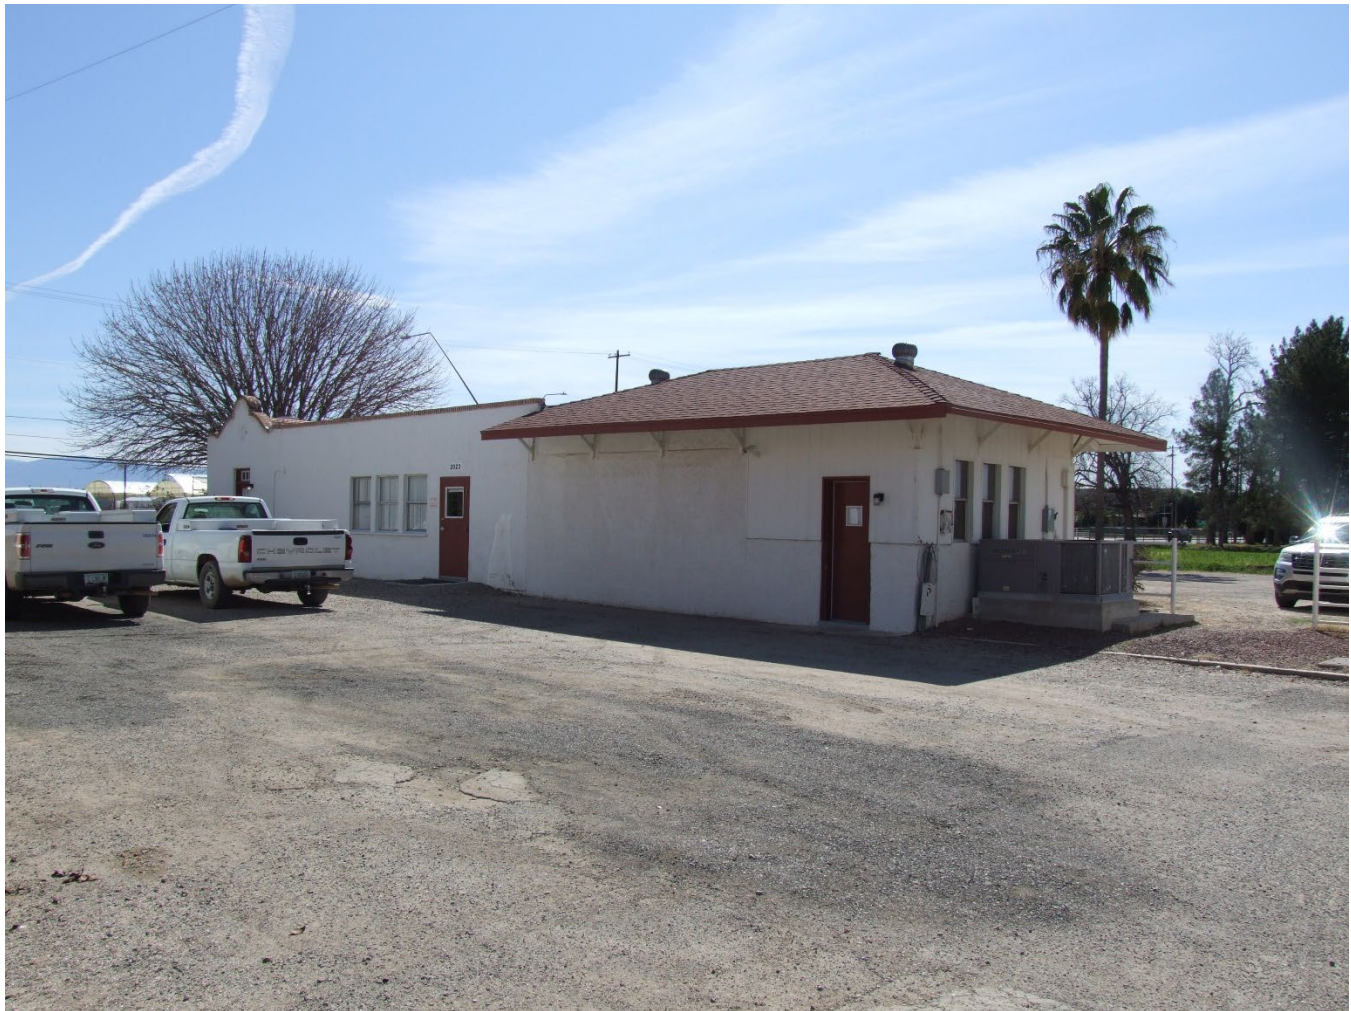
Photograph 24. West and north elevations of the Farm Office; view facing southwest (AZ_Pima County_UA Campus Agricultural Center Historic District_0024).

Photograph 24. West and north elevations of the Farm Office; view facing southwest (AZ_Pima County_UA Campus Agricultural Center Historic District_0024).

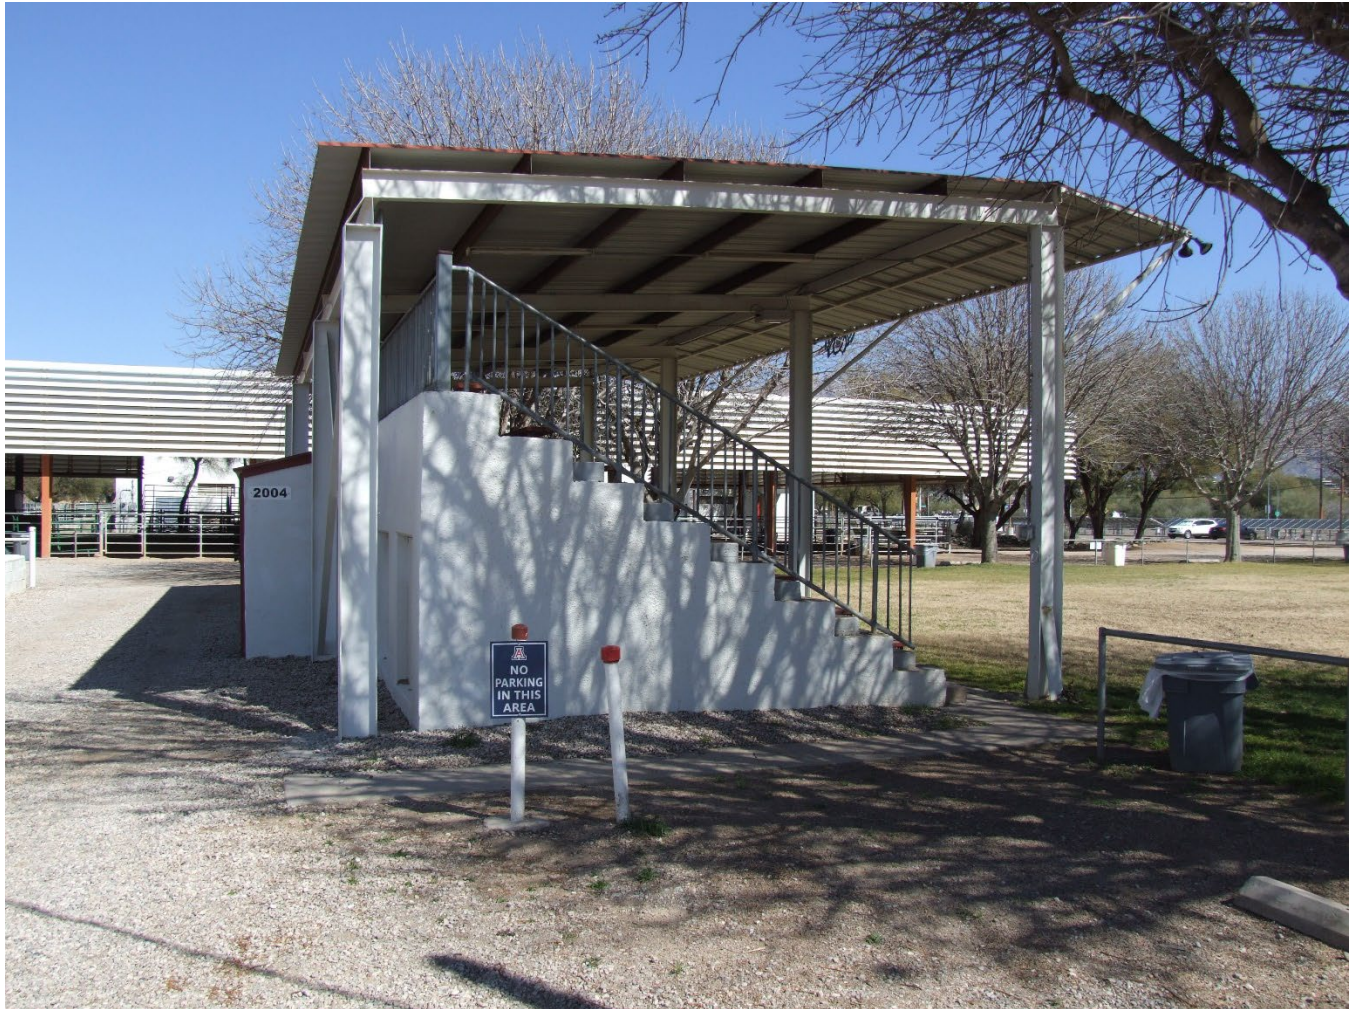
Photograph 27. South elevation of Grandstand; view facing north-northeast (AZ_Pima County_UA Campus Agricultural Center Historic District_0027).

Photograph 27. South elevation of Grandstand; view facing north-northeast (AZ_Pima County_UA Campus Agricultural Center Historic District_0027).

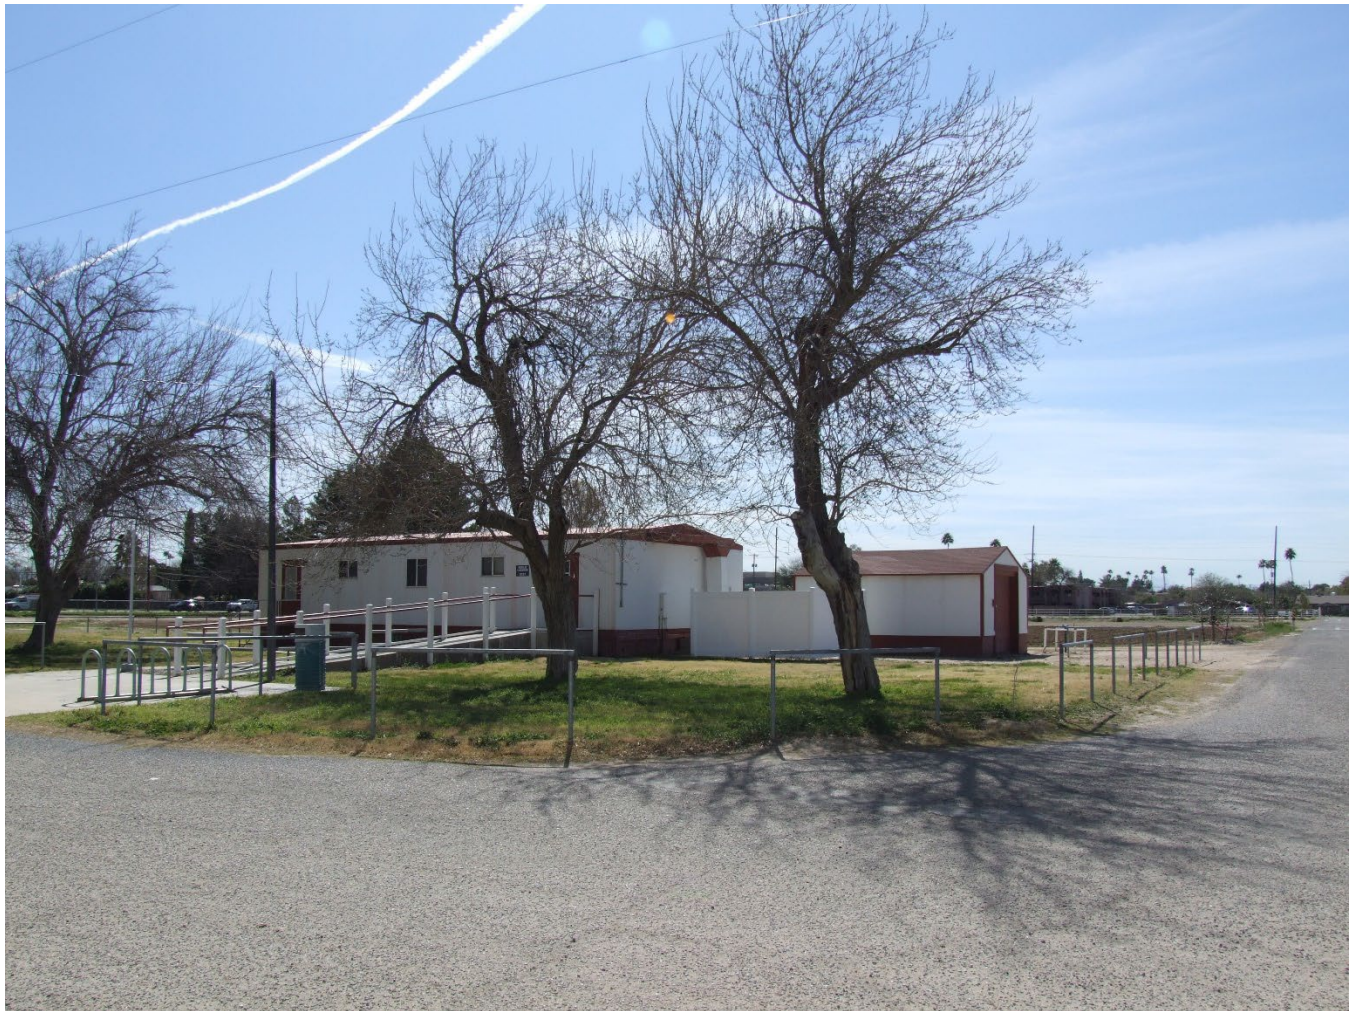
Photograph 28. West and north elevations of the modular Storage building and storage shed; view facing southeast (UA_Pima County_UA Campus Agricultural Center Historic District_028).

Photograph 28. West and north elevations of the modular Storage building, and storage shed; view facing southeast (UA_Pima County_UA Campus Agricultural Center Historic District_028).

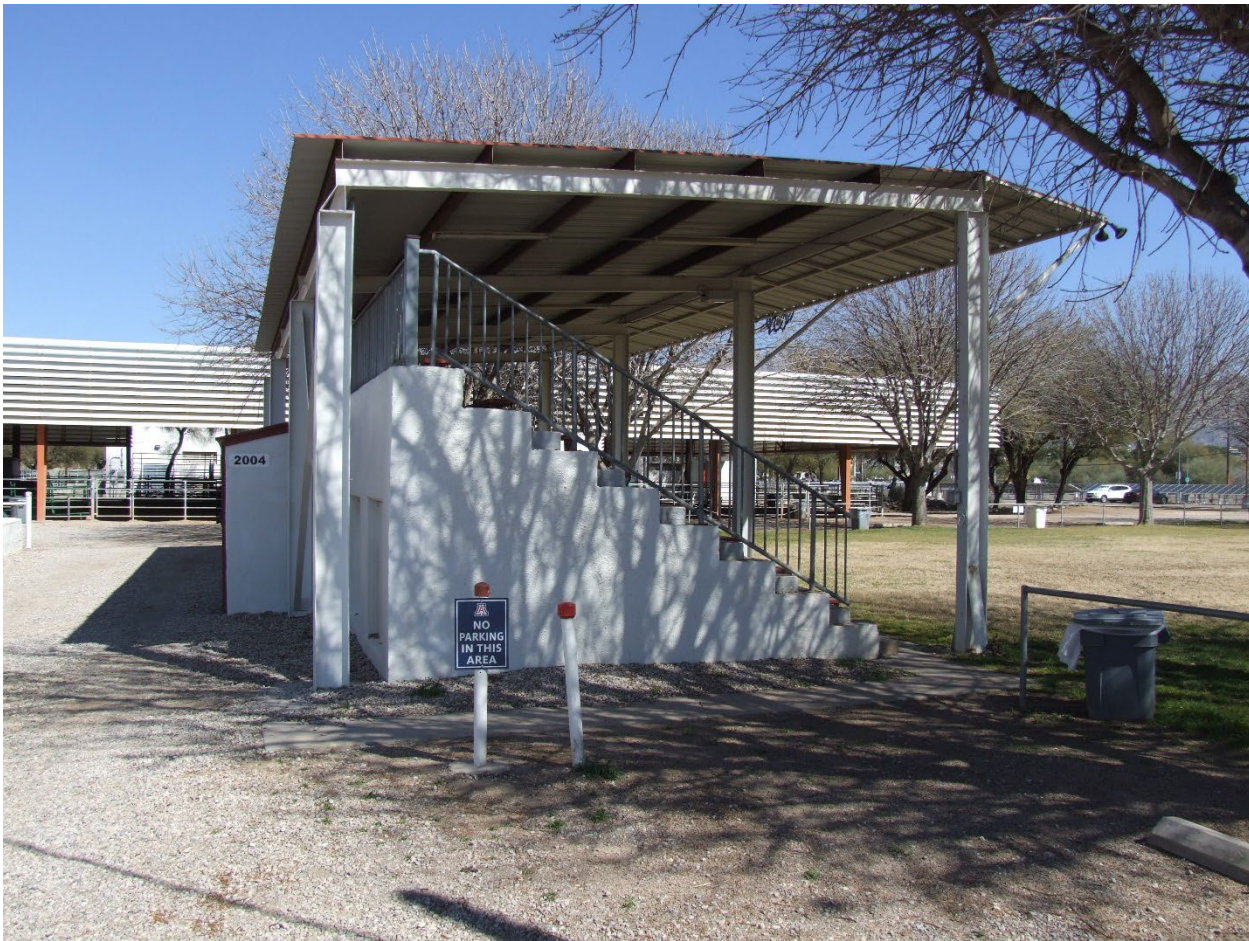
The University of Arizona Campus Agricultural Center, south side of grandstand profile, view facing north-northeast. WestLand Resources, Inc., March 8, 2023.

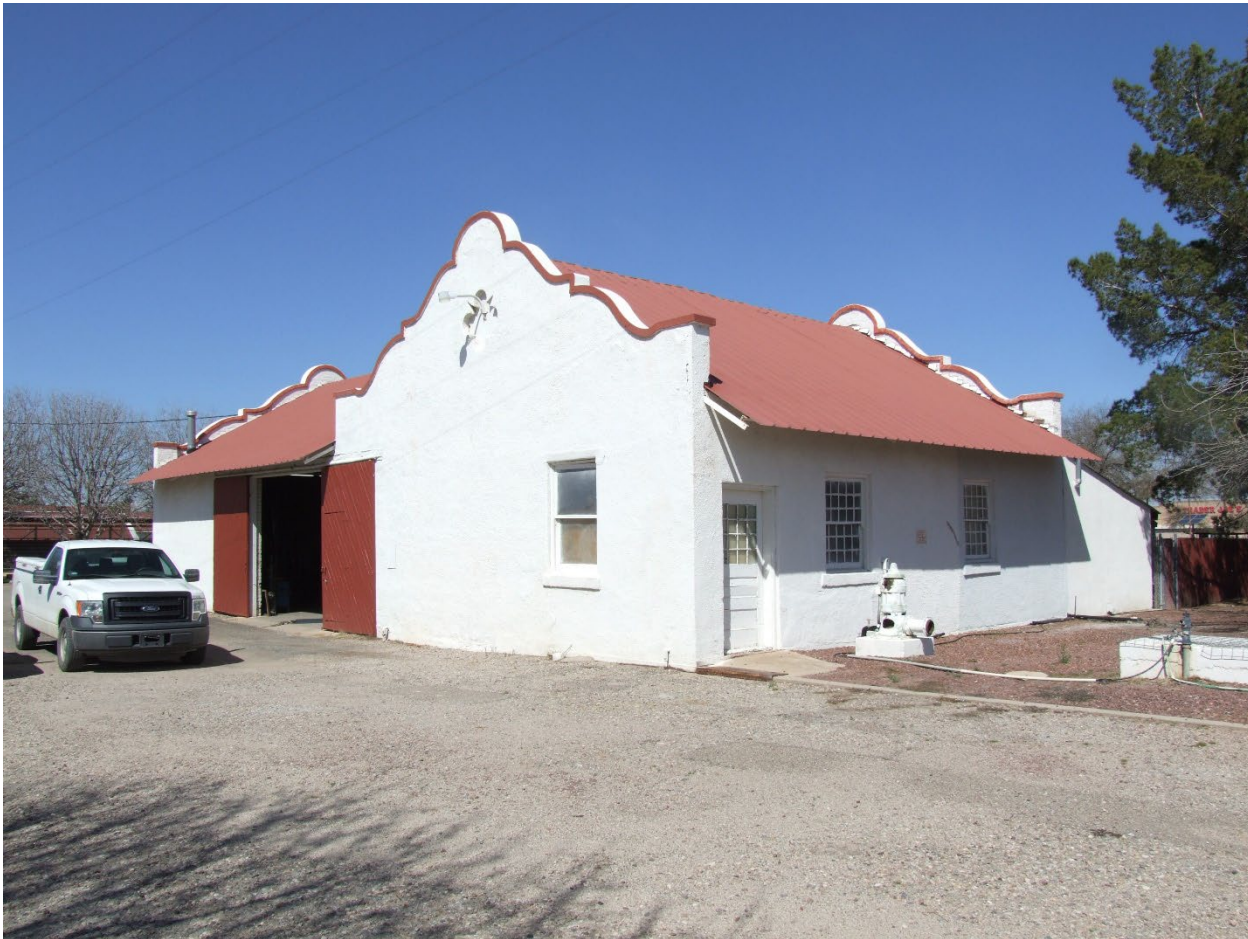
The University of Arizona Agricultural Center, Machine Shop, view facing northwest. WestLand Resources, Inc., March 8, 2023.

- 1. LOCATION** Original Site Moved (date _____) Original Site: _____
- 2. DESIGN** (Describe alterations from the original design, including dates—known or estimated—when alterations were made) The Machine Shop is a one-story Mission Revival style building with a rectangular footprint constructed of masonry brick walls covered in stucco on a concrete foundation. The walls are topped by a medium pitch cross gable roof, constructed of galvanized steel, with low overhanging eaves. There is a Mission-style arched parapet with brick coping on the west, north, and south elevations, with stucco ornamental quatrefoil details around the attic vents. The exterior walls are pierced by the original wood casement and double hung windows and original wood doorways with glass panels. Located on the south elevation is a painted sliding barn door, likely historic. There is a shed roof addition located on the north elevation constructed of CMU with stucco walls and topped with a galvanized steel roof. Additionally, there is a historic concrete water holding tank and water pump located in front of the east elevation.

- 4. MATERIALS** (Describe the materials used in the following elements of the property)
Walls (structure): Brick/CMU Foundation: Concrete Roof: Galvanized steel
Windows: Wood casement
If the windows have been altered, what were they originally? N/A
Wall Sheathing: Stucco
If the sheathing has been altered, what was it originally? N/A

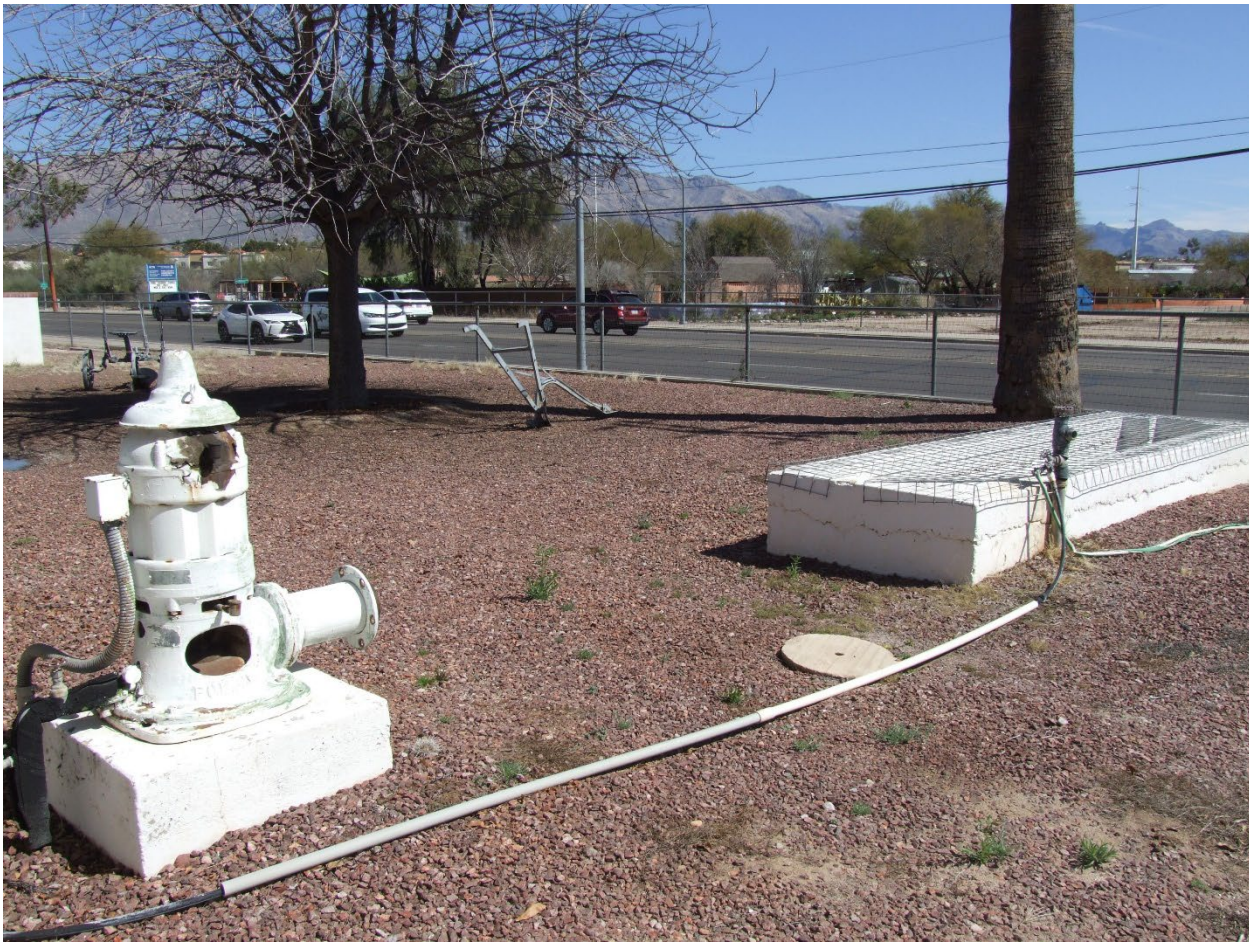
The University of Arizona Agricultural Center, Details of water pump and water holding tank, view facing northeast. WestLand Resources, Inc., March 8, 2023.

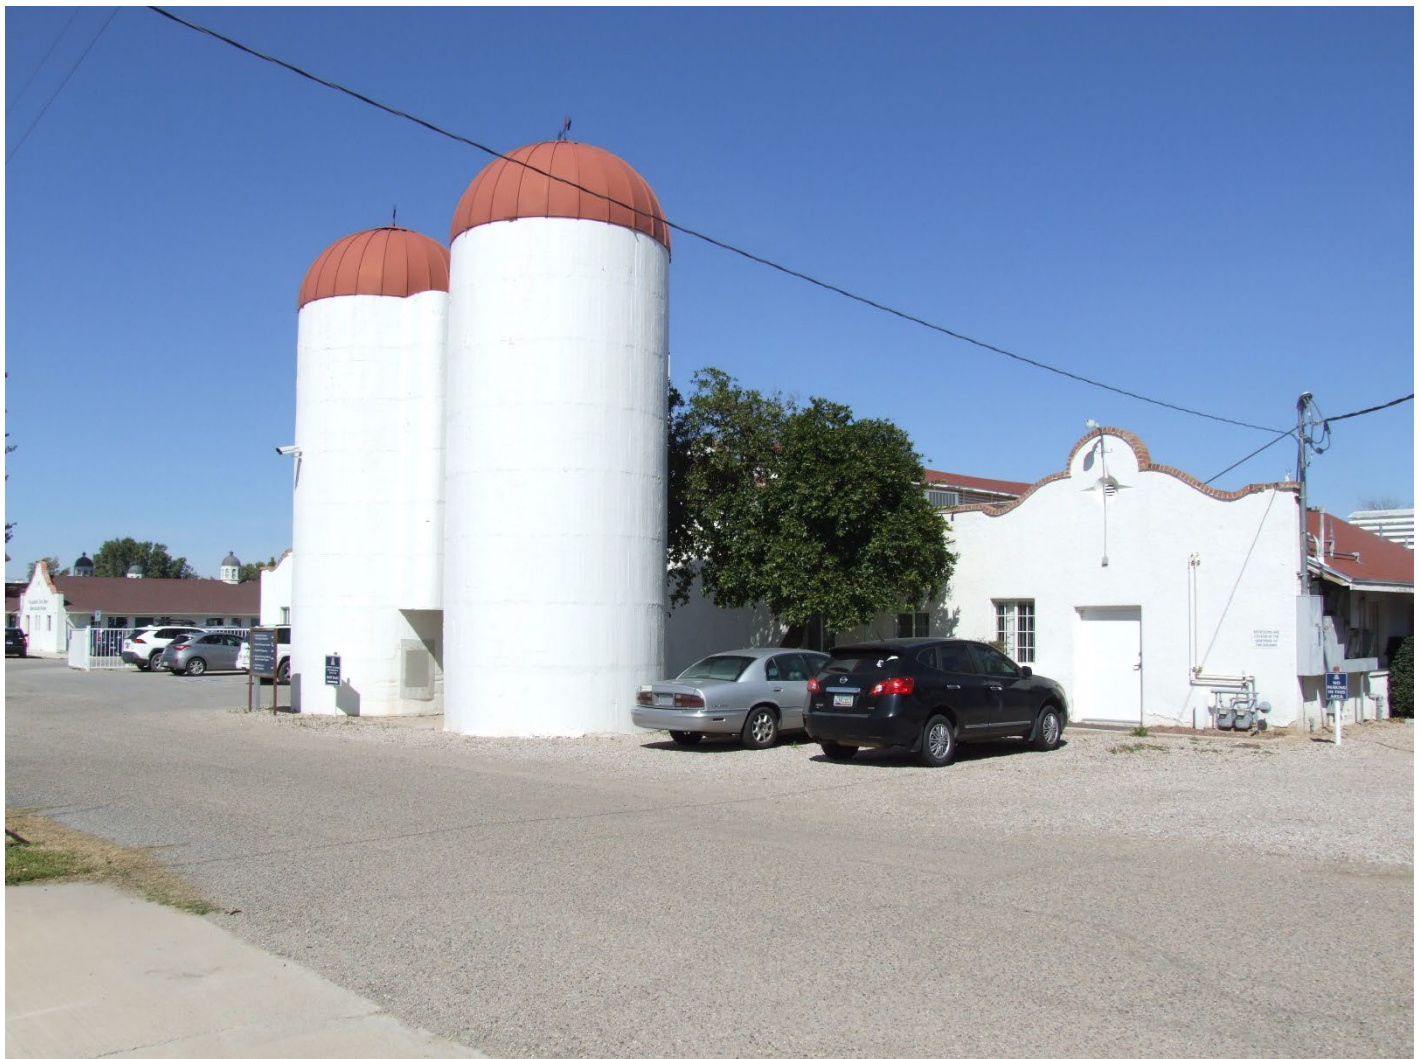
"The probable designer is Annie G. Rockfellow. A portion of this was originally a dairy barn and milk house constructed before 1925. They were renovated in the Mission Revival style in 1935-1936 in order to match the style of other farm buildings. It matches the unified campus/farm design, agricultural experimentation" (AZ State Historic Property Inventory form [Giebner 1992]).

The University of Arizona Campus Agricultural Center, Office Building, view facing northwest, WestLand Resources, Inc., March 8, 2023.
