National Register of Historic Places Registration Form

Historic name: University of Arizona Campus Agricultural Center
 Other names/site number: Campus Farm, Campbell Avenue Farm, University Farm; University Campus Farm Complex
 Name of related multiple property listing:
N/A
 (Enter "N/A" if property is not part of a multiple property listing)

Street & number: 4101 N. Campbell Avenue
 City or town: Tucson State: Arizona County: Pima County
 Not For Publication: Vicinity:

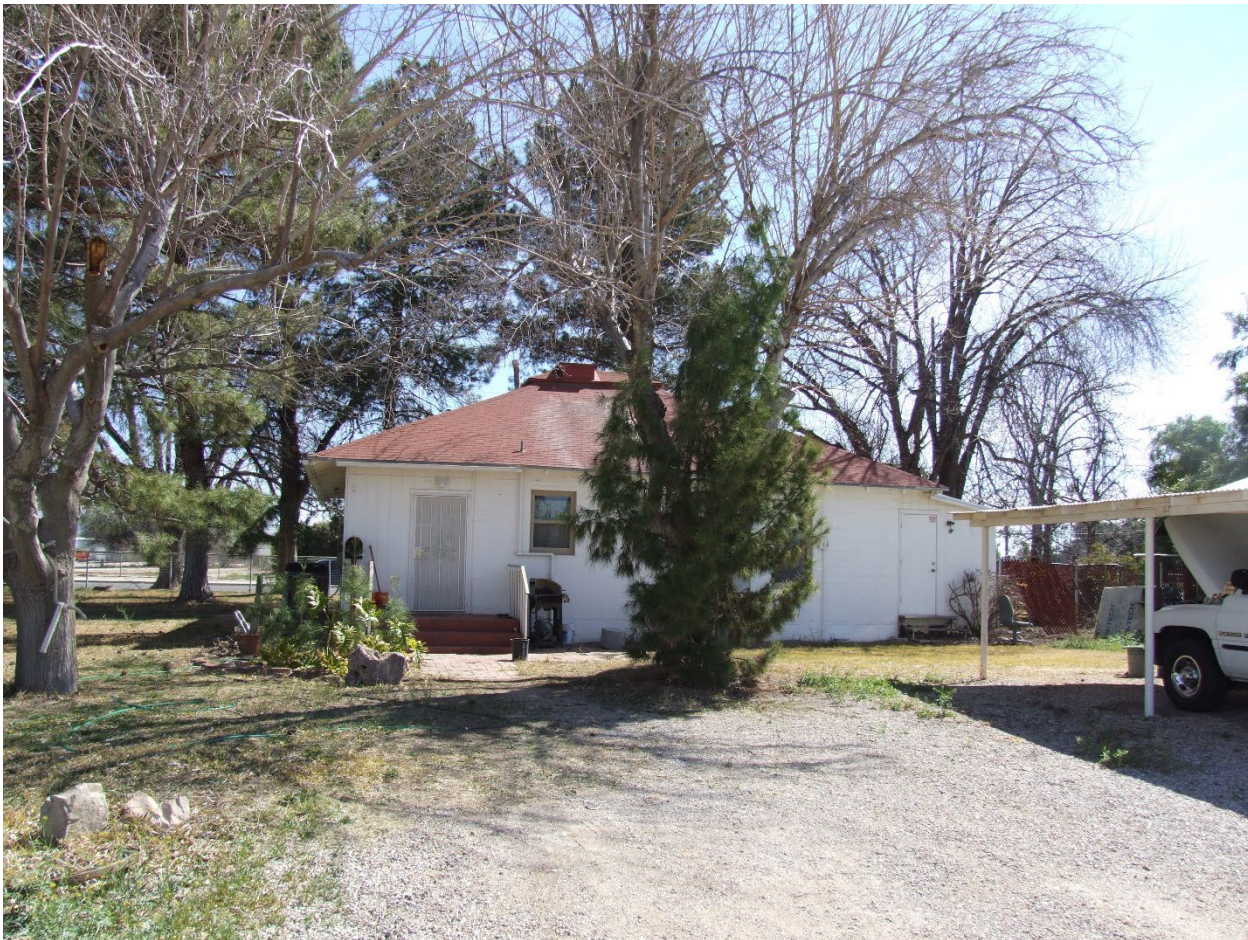
"Perhaps the city's only early poured concrete residence existing. Part of the farm complex" (AZ State Historic Property Inventory form [Giebner 1992]).

The University of Arizona Campus Agricultural Center, Main Residence, west elevation, view facing east. WestLand Resources, Inc., March 8, 2023.

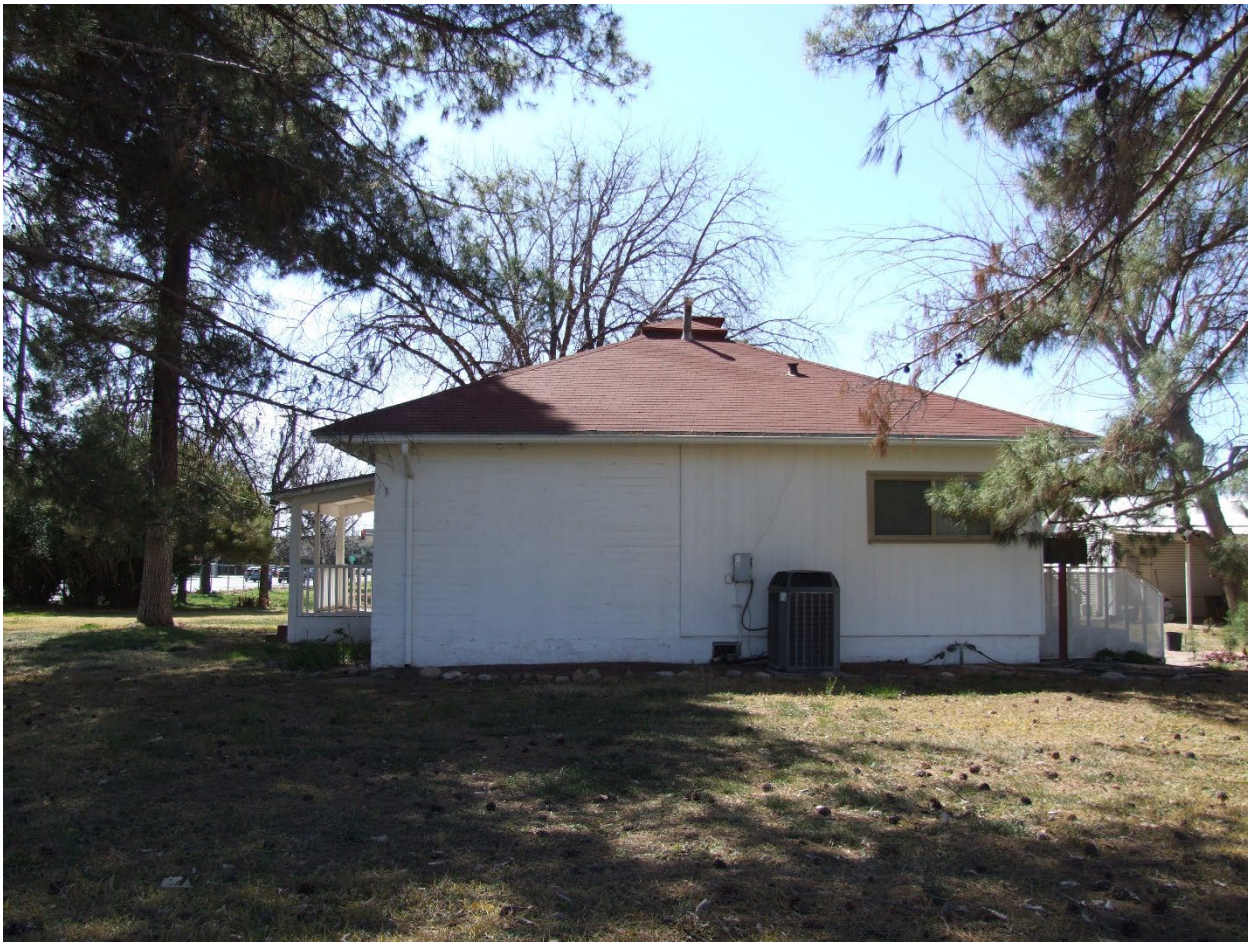
The University of Arizona Campus Agricultural Center, Main Residence, north elevation, view facing south. WestLand Resources, Inc., March 8, 2023.

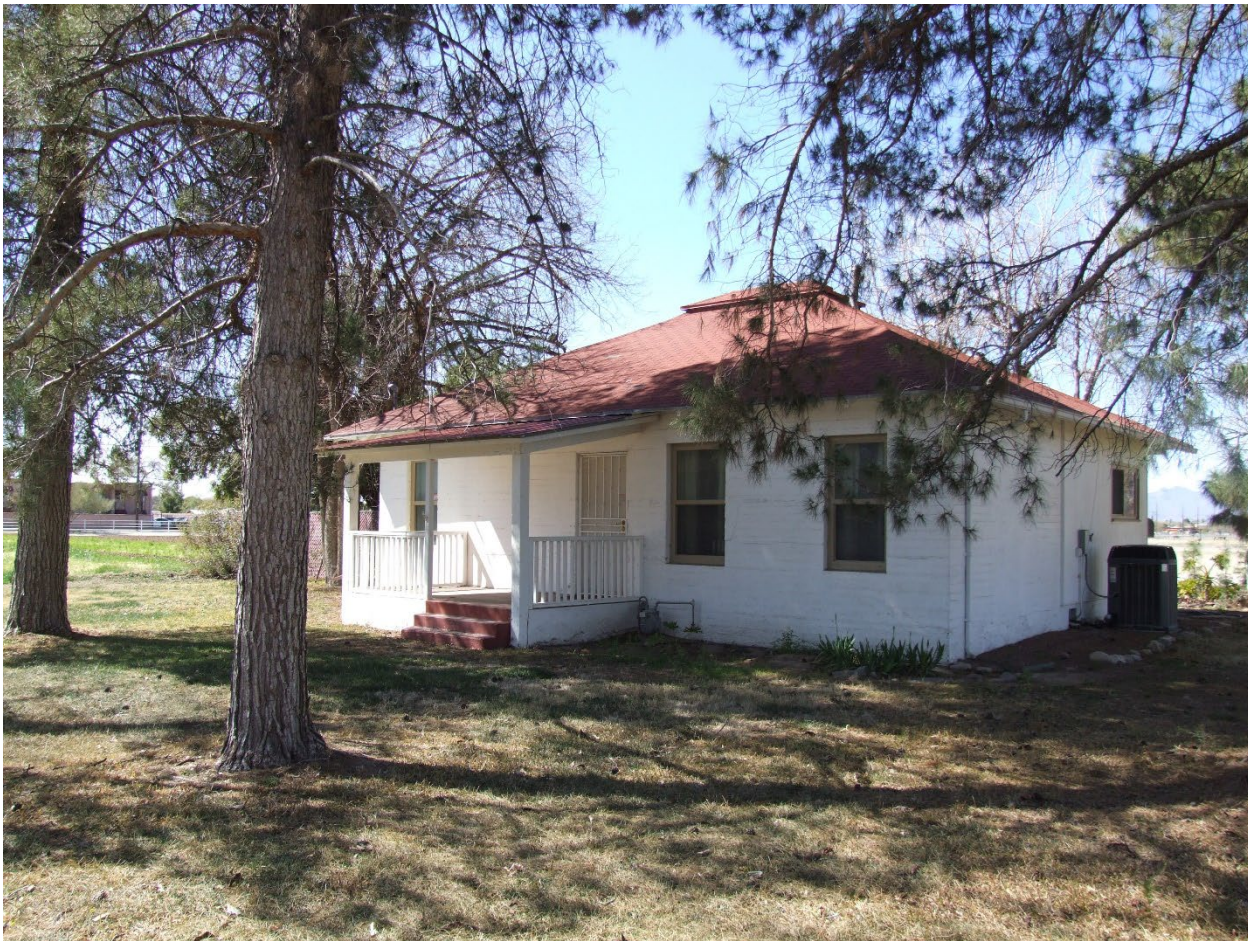
The University of Arizona Campus Agricultural Center, Main Residence, east and north elevations, view facing southwest. WestLand Resources, Inc., March 8, 2023.

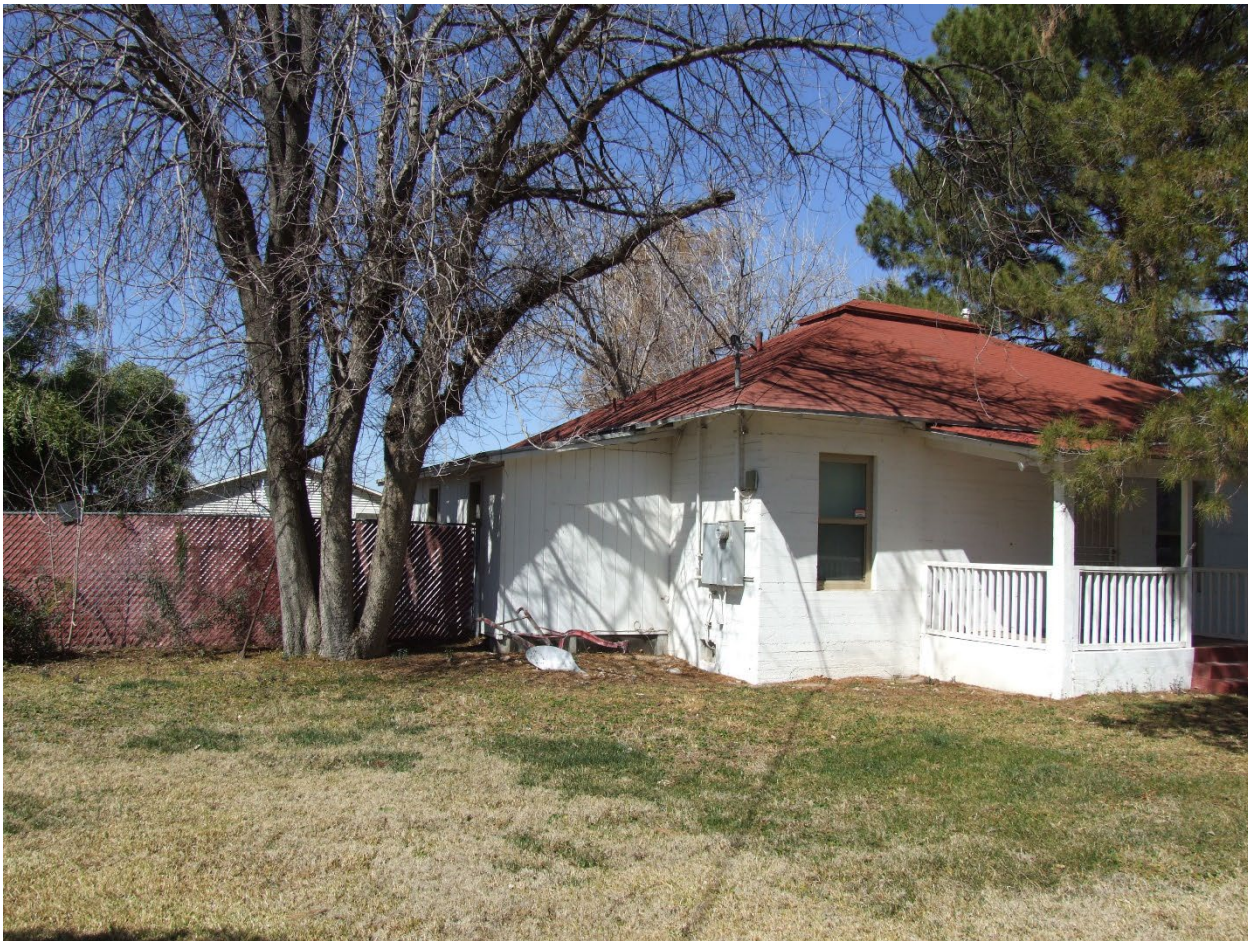
The University of Arizona Campus Agricultural Center, Main Residence, east and south elevations, view facing northwest. WestLand Resources, Inc., March 8, 2023.
