### TONAL REGISTER OF HISTORIC PLACES **INVENTORY -- NOMINATION FORM**

CITE STREET, S				
SEE	INSTRUCTIONS IN HOW TYPE ALL ENTRIES	TO COMPLETE NATION COMPLETE APPLICAE	VAL REGISTER FORM	S
1 NAME			SEE GEGITORS	
HISTORIC				
HISTORIC	University of Arizon	a Old Library Duil	1.0	
AND/OR COMMON				
	Arizona State Museum	, Building #26, Un	iversity of Arizona	a
2 LOCATION	Ň		0	
STREET & NUMBER	University of Arizo	na		
CITY, TOWN			NOT FOR PUBLICATION

University of Arizona Old Library Building

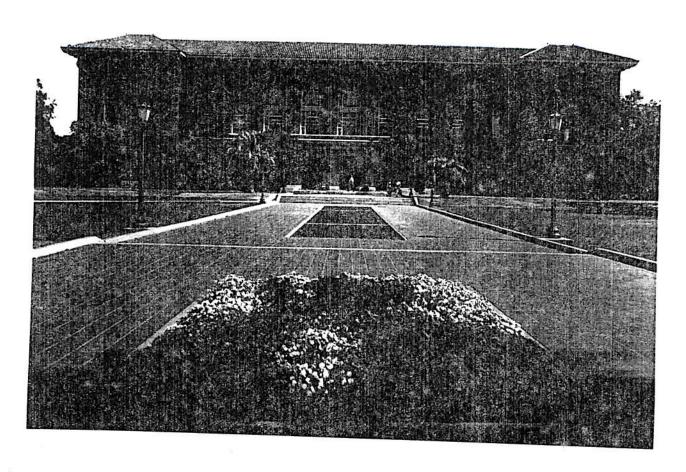
Photographer: Helga Teiwes Negative: Arizona State Museum South Facade and Tiled Entry Walk Photo 1 of 24

The main entry into the building faces south towards University Street. A proal, tiled and terraced walkway, 40 feet wide, leads from University Street to the main entry of the building. Flower beds are located in the center of this walkway which is flanked by cast iron lamp posts, three on each side.

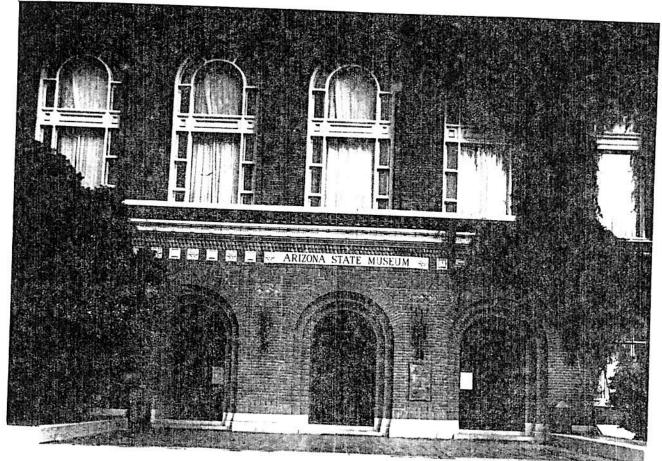
University of Arizona Old Library Building Tucson, Pima County Arizona Photo Date: 1978 Photographer: Helga Teiwes Negative: Arizona State Museum South Facade, main entry.

Public access to the building is through the main entry, south facade, which consists of three doorways set in arches with receding vousoirs.

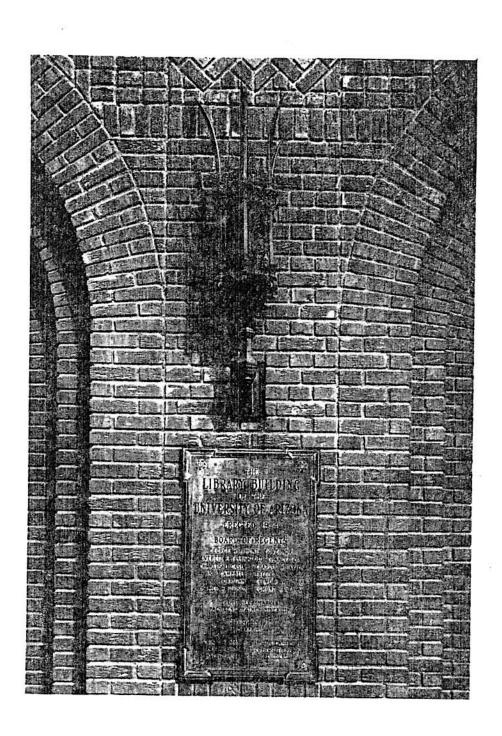
University of Arizona Old Library Building Tucson, Pima County Arizona
Photo Date: 1978
Photographer: Helga Teiwes
Negative: Arizona State Museum
South Facade, example of brick patterning and light fixtures flanking doorways.
Photo 3 of 24

The original three story building is modified renaissance in design and is steel framed with English bonded red, rug-faced brick walls with terra cotta trim. The brick work reflects the high quality of masonry craftsmanship in the 1920s. The patterning of the bricks, especially on the south facade, is particularly notable. Consequently, this brick work served as a model for subsequent buildings on the Jniversity campus. In addition, the terra cotta embellishments are notable for their variety and correctness of detail.

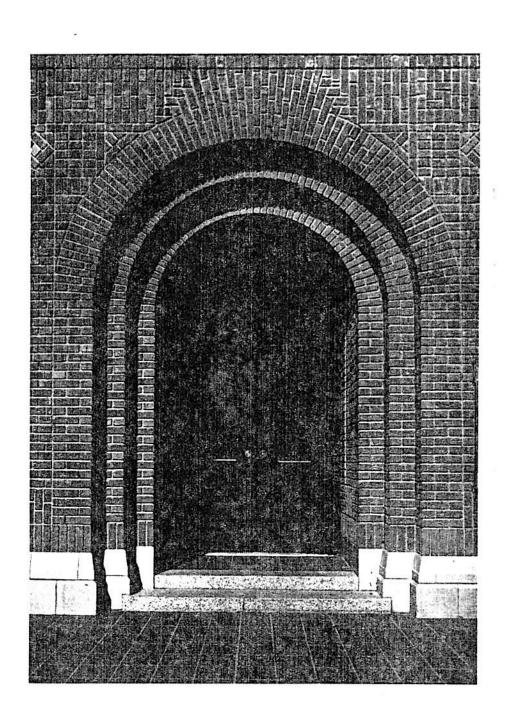
University of Arizona Old Library Building
Tucson, Pima County Arizona
Photo Date: 1978
Photographer: Helga Teiwes
Negative: Arizona State Museum
South facade, example of doorway main entry.
Photo 4 of 24

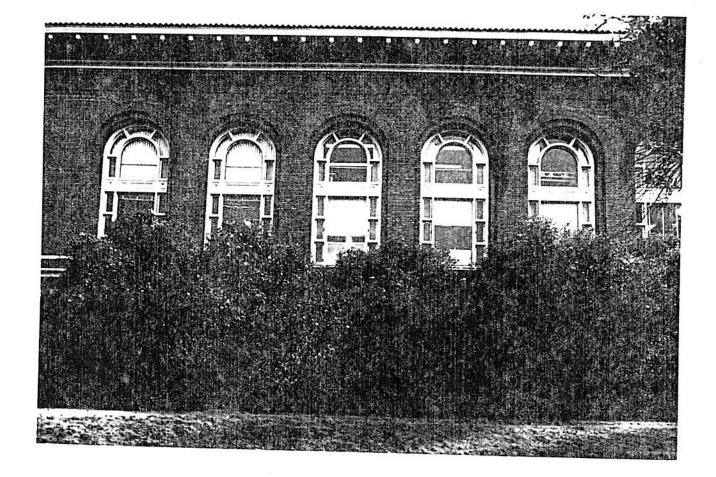
University of Arizona Old Library Building Tucson, Pima County Arizona
Photo Date: 1978
Photographer: Helga Teiwes
Negative: Arizona State Museum
West facade, view looking north.
Photo 5 of 24

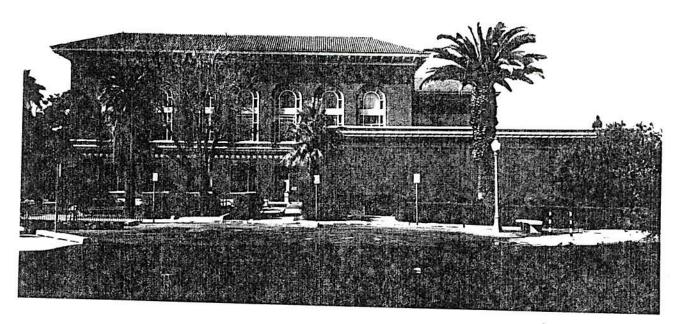
University of Arizona Old Library Building Tucson, Pima County Arizona
Photo Date: 1978
Photographer: Helga Teiwes
Negative: Arizona State Museum
West facade.
Photo 6 of 24

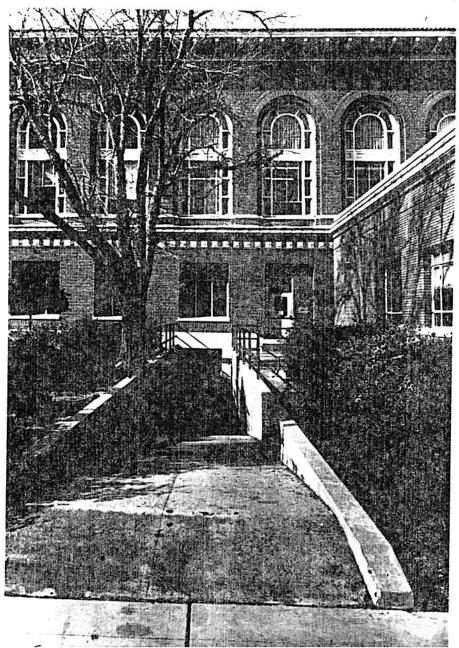
University of Arizona Old Library Building Tucson, Pima County Arizona
Photo Date: 1978
Photographer: Helga Teiwes
Negative: Arizona State Museum
East facade, original building and
1962 additions with flat roof.
Photo 7 of 24

Finally, in 1962, the building was brought to its present state with the addition of the one story portions to the east and west, and the three story portion between the other two arms of the "E" in plan. Thus, the present area of the building is some 114,600 square feet. The sketch below indicates the present form of the building in plan.

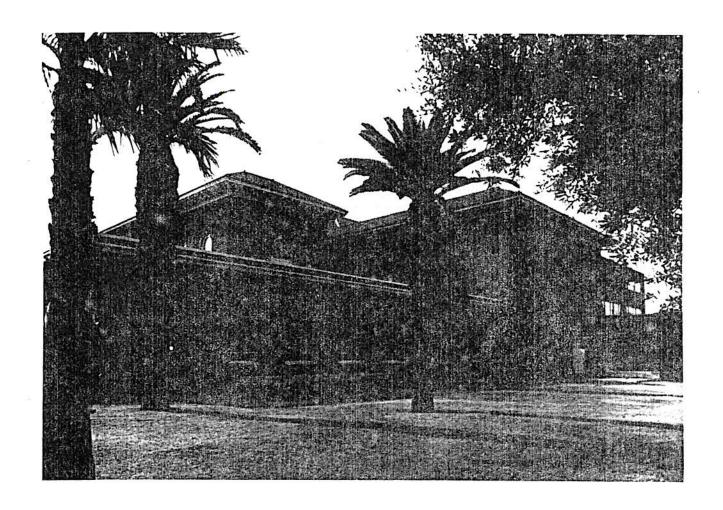
University of Arizona Old Library Building Tucson, Pima County Arizona
Photo Date: 1978
Photographer: Helga Teiwes
Negative: Arizona State Museum
East facade, entry ramp to basement.
Photo 8 of 24

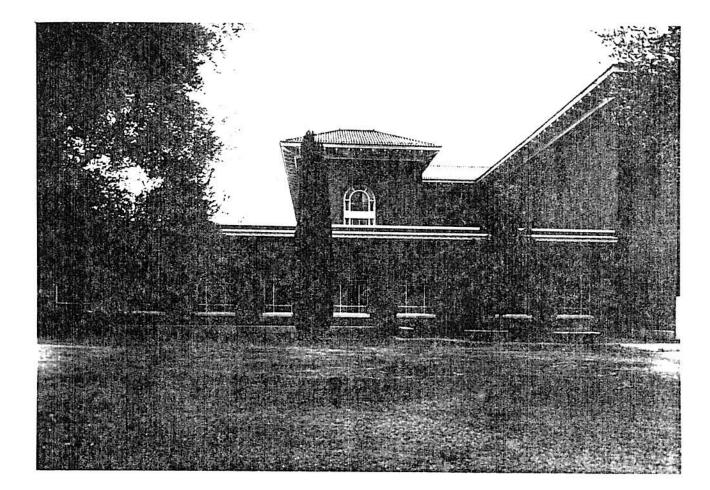
University of Arizona Old Library Building Tucson, Pima County Arizona
Photo Date: 1978
Photographer: Helga Teiwes
Negative: Arizona State Museum
North facade, 1962 additions
Photo 9 of 24

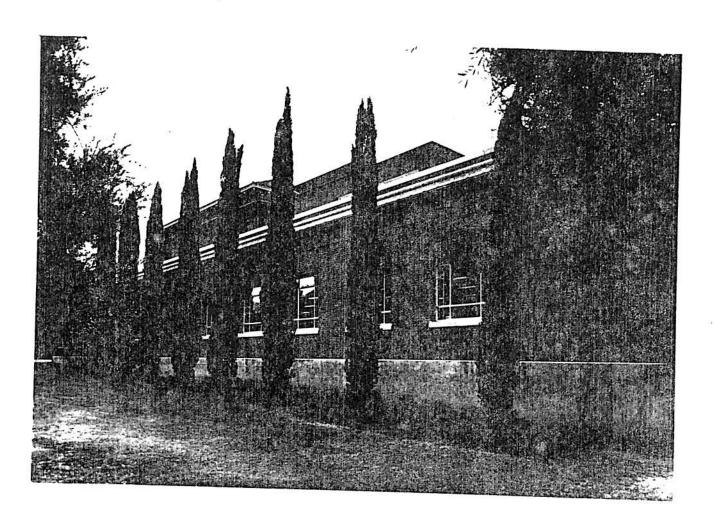
University of Arizona Old Library Building Tucson, Pima County Arizona Photo Date: 1978 Photographer: Helga Teiwes Negative: Arizona State Museum North facade, east end, 1962 additions. Photo 10 of 24

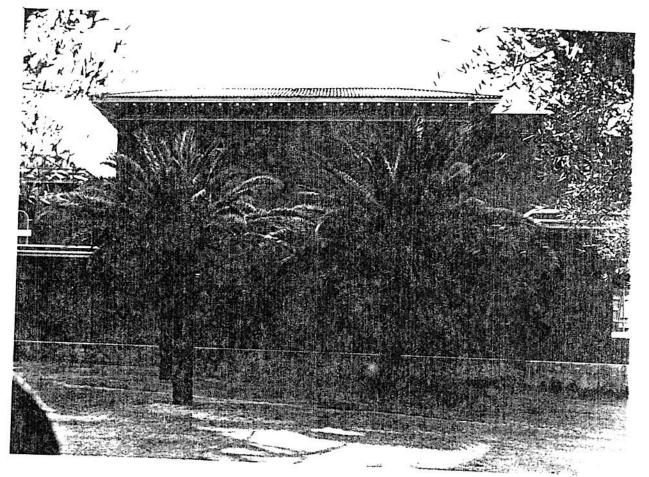
University of Arizona Old Library Building Tucson, Pima County Arizona
Photo Date: 1978
Photographer: Helga Teiwes
Negative: Arizona State Museum
North facade, west end, 1962 additions
Photo 11 of 24

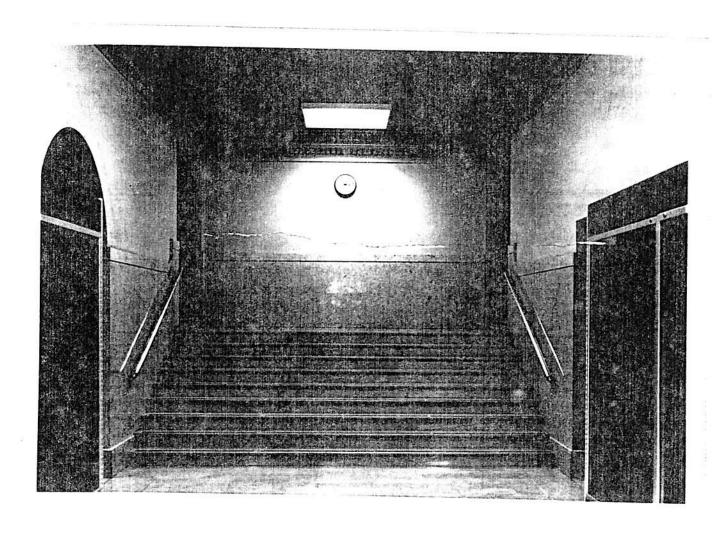
Photo 13 of 24

University of Arizona Old Library Building Tucson, Pima County Arizona Photo Date: 1978 Photographer: Helga Teiwes Negative: Arizona State Museum First floor lobby, stairway to second floor

Of the numerous rooms in the original structure, two are worthy of special note. The most interesting room on the first floor is the lobby. The side walls of the lobby are finished in Italian Tavernille claire marble with rose base. The floor and stairway are of pink tennessee marble. The stairway splits to the left and right as it leads to the second floor. The ceiling has a classical cornice-frieze decoration in molded plaster.

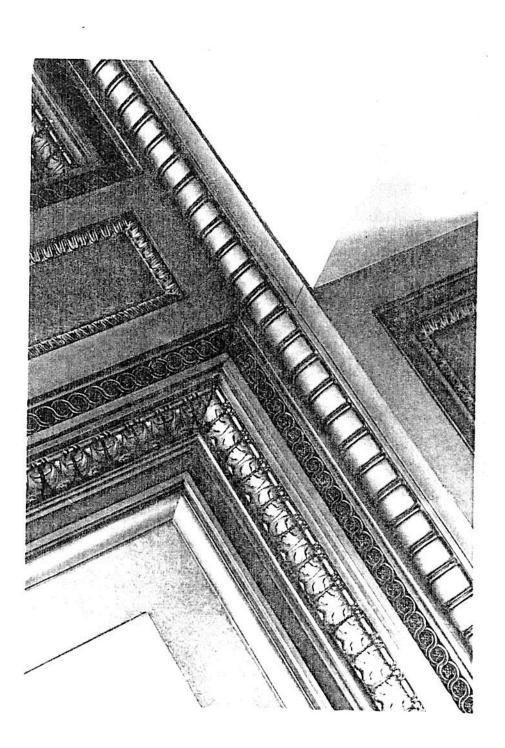
University of Arizona Old Library Building Tucson, Pima County Arizona
Photo Date: 1978
Photographer: Helga Teiwes
Negative: Arizona State Museum
First floor lobby, ceiling detail,
cast plaster ornament.
Photo 14 of 24

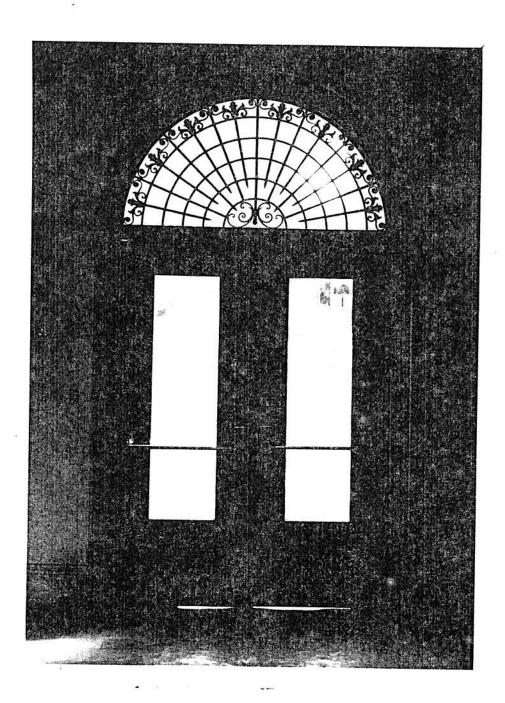
University of Arizona Old Library Building Tucson, Pima County Arizona
Photo Date: 1978
Photographer: Helga Teiwes
Negative: Arizona State Museum
First floor lobby, center doorway.
Photo 15 of 24

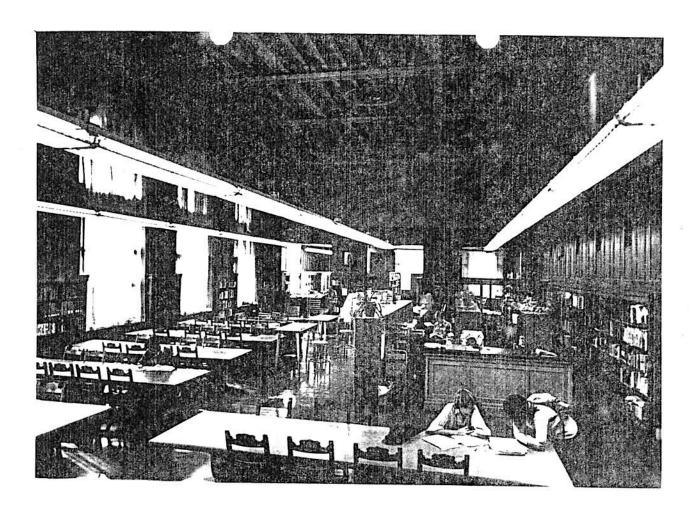
University of Arizona Old Library Building
Tucson, Pima County Arizona
Photo Date: 1978
Photographer: Helga Teiwes
Negative: Arizona State Museum
Second floor, reading room, view looking
west
Photo 16 of 24

The second floor reading room which remains intact was considered the finest room in the library. It is  $40 \times 125$  feet in size. The walls are paneled to the spring line of the window arches in dark Mexican amapa wood. A beamed ceiling effect is created by the framed in structural members. These beams are decorated in a classical motif with stencil painted dull, rich colors after the manner of an Italian courtroom of the sixteenth century.

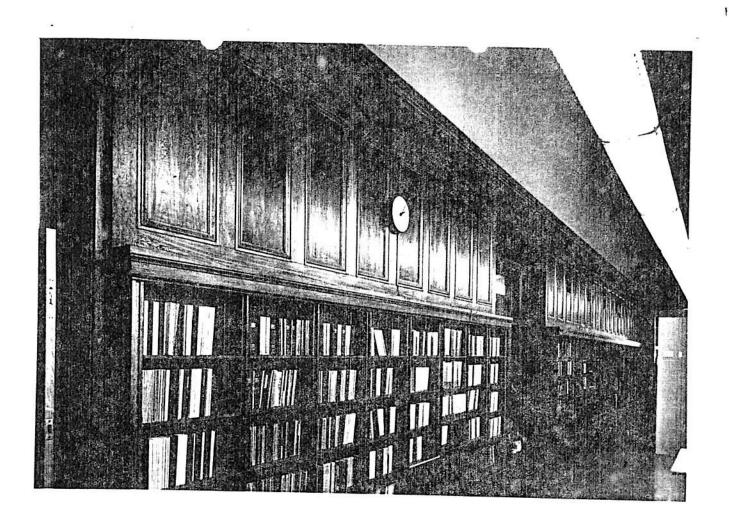
University of Arizona Old Library Building Tucson, Pima County Arizona
Photo date: 1978
Photographer: Helga Teiwes
Negative: Arizona State Museum
Second floor, reading room, woodwork detail,
north wall
Photo 18 of 24

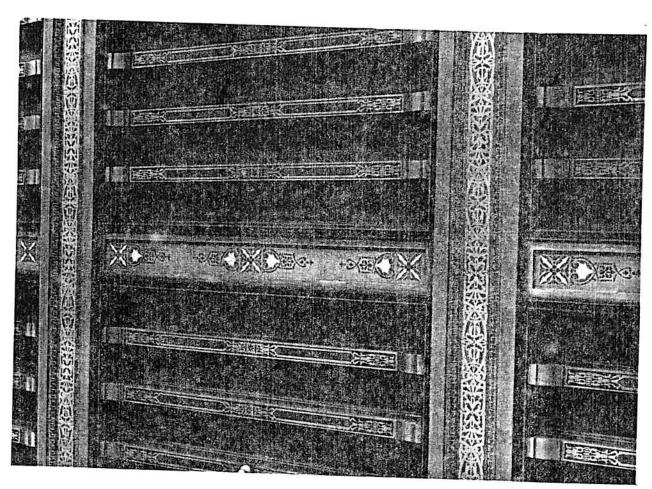
University of Arizona Old Library Building
Tucson, Pima County Arizona
Photo Date: 1978
Photographer: Helga Teiwes
Negative: Arizona State Museum
Second floor, reading room, ceiling detail,
stenciled ornament.
Photo 19 of 24

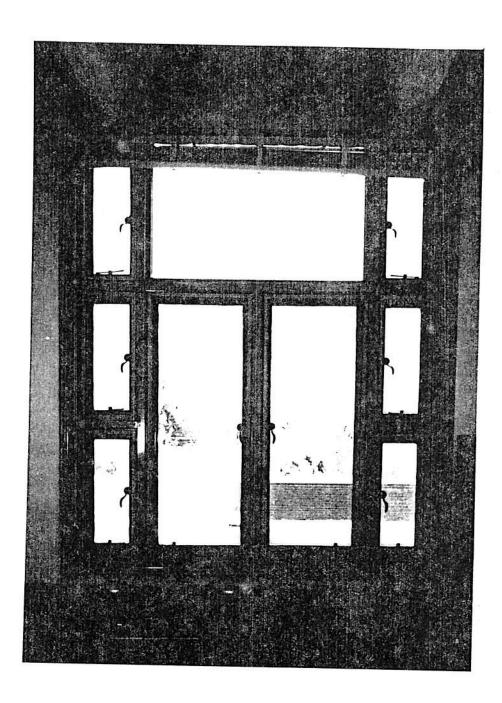
University of Arizona Old Library Building Tucson, Pima County Arizona
Photo Date: 1978
Photographer: Helga Teiwes
Negative: Arizona State Museum
Second floor, window, north wall
Photo 21 of 24

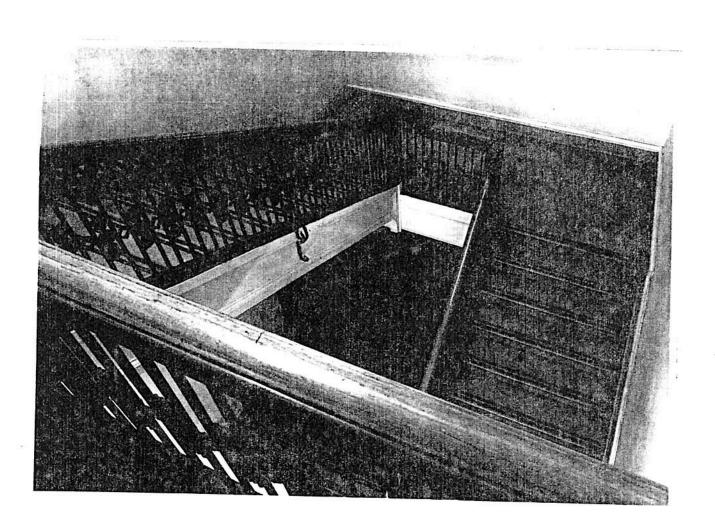
University of Arizona Old Library Building Tucson, Pima County Arizona
Photo Date: 1978
Photographer: Helga Teiwes
Negative: Arizona State Museum
Third floor

Third floor, stairway from third floor. Photo <u>22</u> of 24

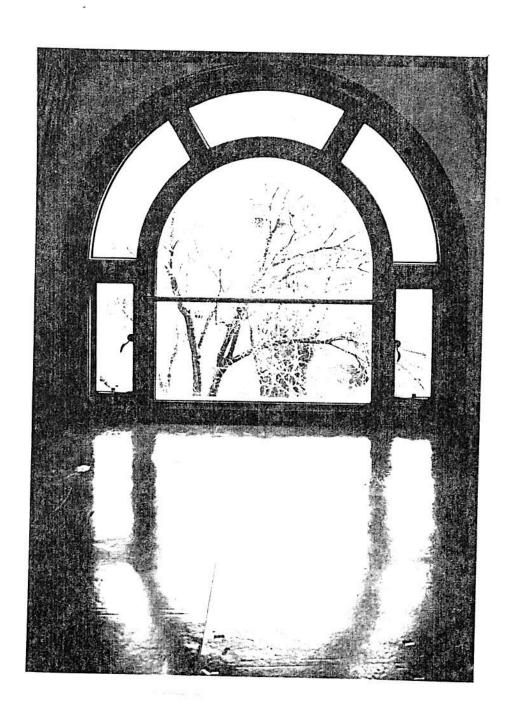
University of Arizona Old Library Building Tucson, Pima County Arizona
Photo Date: 1978
Photographer: Helga Teiwes
Negative: Arizona State Museum
Third floor arched window east wall
Photo 24 of 24
