HISTORIC PRESERVATION REVIEW APPLICATION

Property Development Name: 626 NORTH 6TH AVENUE

626 NORTH 6TH AVENUE
HPZ PACKAGE
T21DV00835

Brief Description of Proposed Work: REPLACE WINDOWS, ENCLOSE GARAGE DOOR OPENING

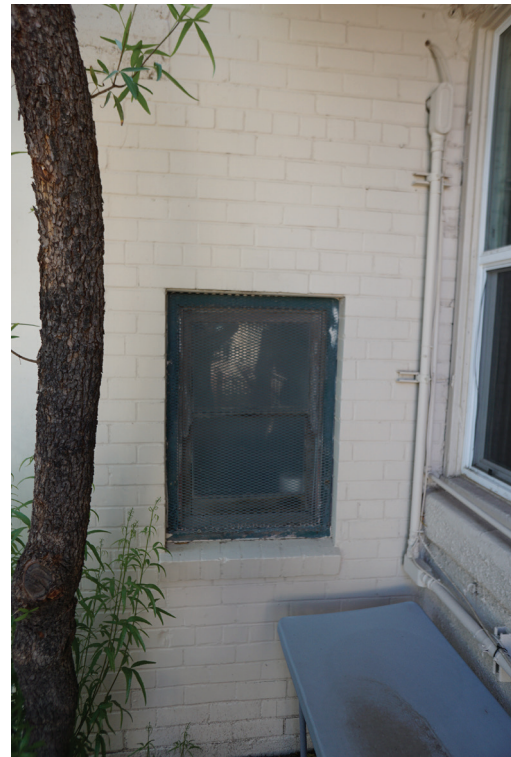
REPLACED
 ORIGINAL: WOOD FIXED, PICTURE
 NEW: VINYL FIXED, PICTURE
 DOOR REPLACED
 ORIGINAL: HOLLOW CORE WOOD
 NEW: SOLID CORE WOOD

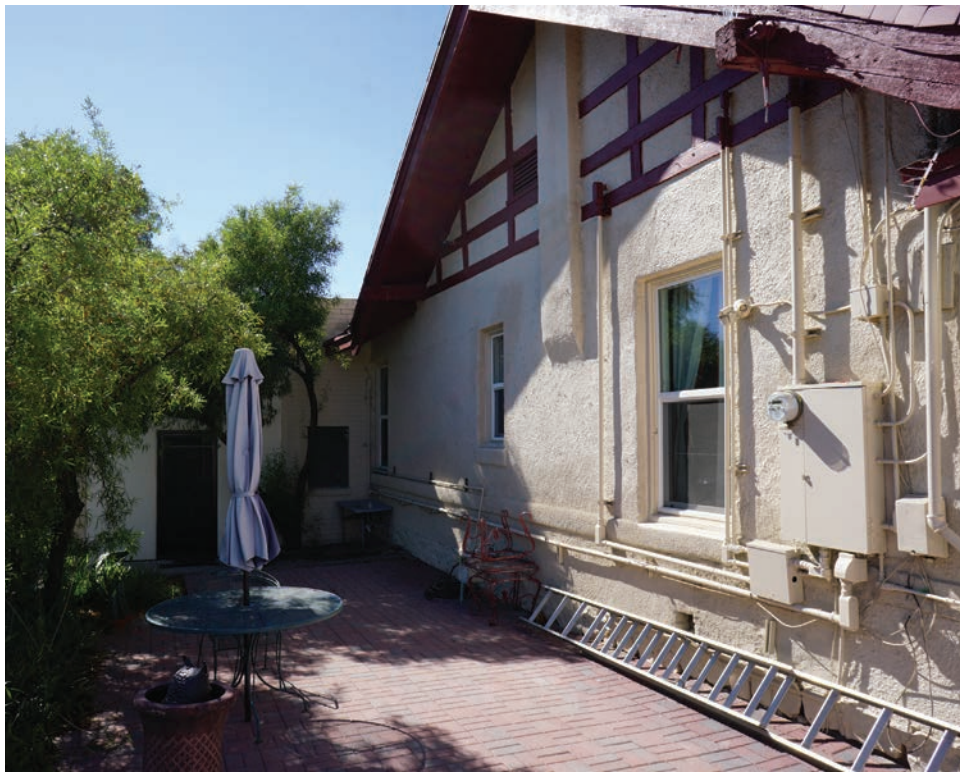
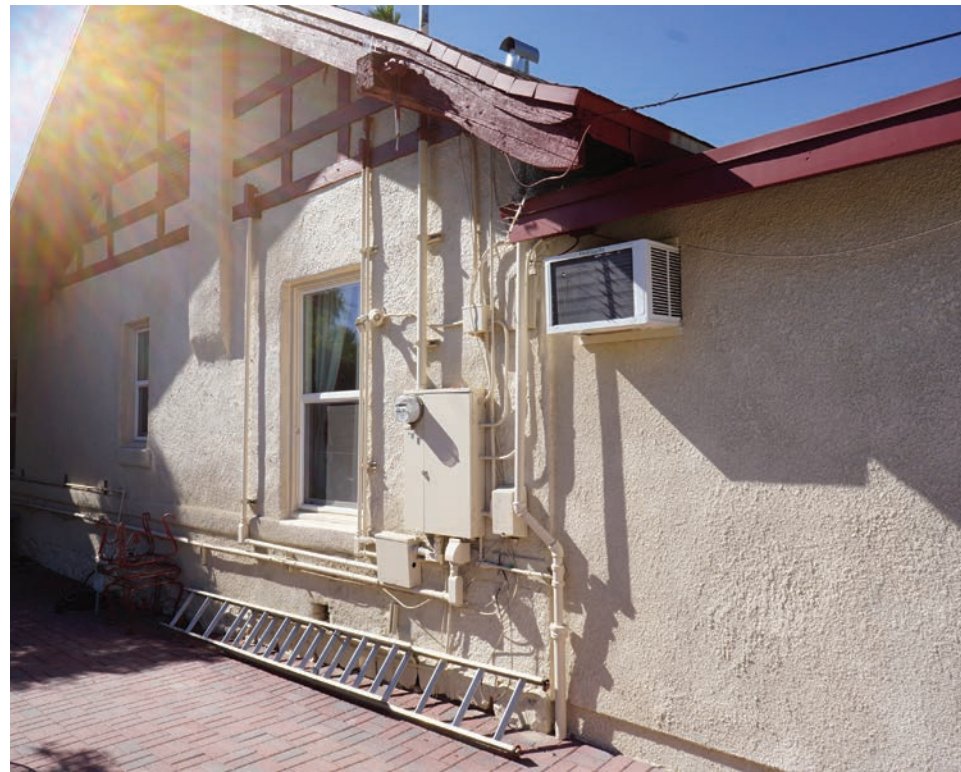
SOUTH ELEVATION

REPLACED
 ORIGINAL: WOOD SINGLE HUNG, 1/1
 NEW: VINYL SINGLE HUNG, 1/1

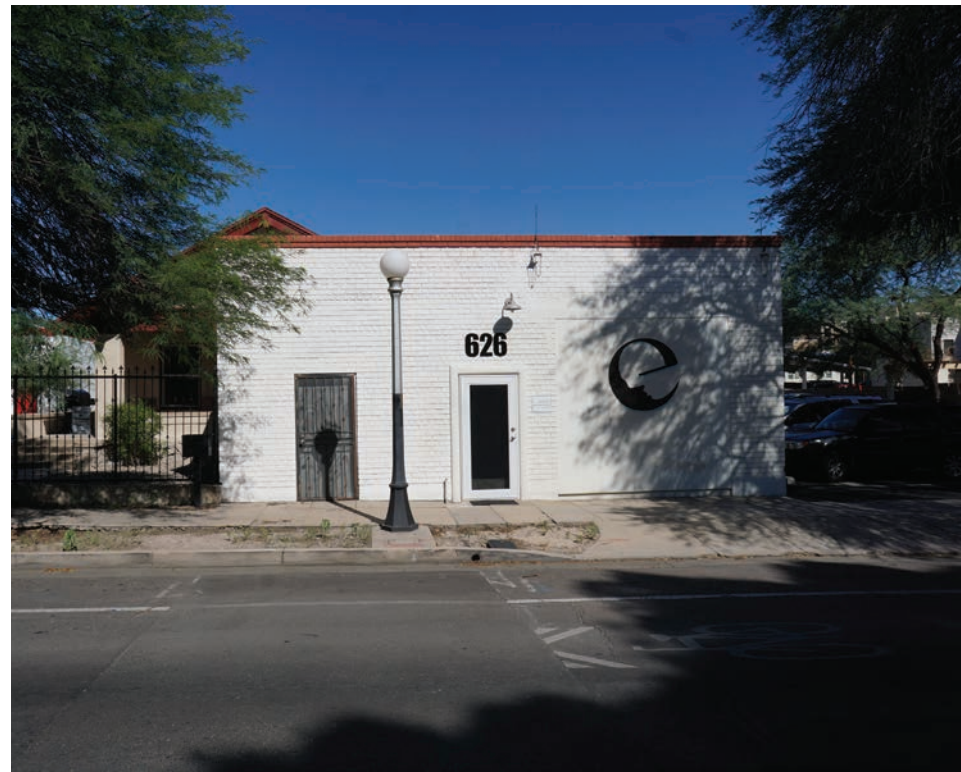
WEST ELEVATION

REPLACED
ORIGINAL: OVERHEAD GARAGE DOOR
NEW: STUCCO FINISH WOOD FRAME
WALL

The garage door opening, which is situated in a structure that was identified as "ruining" the architectural integrity of the property, is replaced with a solid stucco surface. The opening dimensions are apparent because the material is differentiated from the surface of the brick building.
