National Register of Historic Places Registration Form

1. Name of Property	141 C4
Historic name: <u>University of Arizona Campus Agric</u> Other names/site number: Campus Farm, Campbell A	
University Campus Farm Complex	evenue Farm, Oniversity Farm,
Name of related multiple property listing:	
N/A	
(Enter "N/A" if property is not part of a multiple proper	ty listing

The University of Arizona Campus Agricultural Center Historic District (CAC) is a 13-acre Lshaped area within a larger 176.1-acre research, teaching, and extension facility located in northcentral Tucson immediately south of the Rillito River within Township 13 South, Range 14 East, Sections 19, 20, and 29 as depicted on the U.S. Geological Survey (USGS) Tucson North 7.5' topographic quadrangle (Figure 1 [the proposed district is within Section 19 only])*. The main portion of the facility is bounded by East Limberlost Road to the north, East Roger Road to the south, North Campbell Avenue to the east, and North Mountain Avenue to the west. Within the same acreage, a J-shaped extension of the agricultural facility is located directly across from the main portion of the facility, east of North Campbell Avenue, and is bord

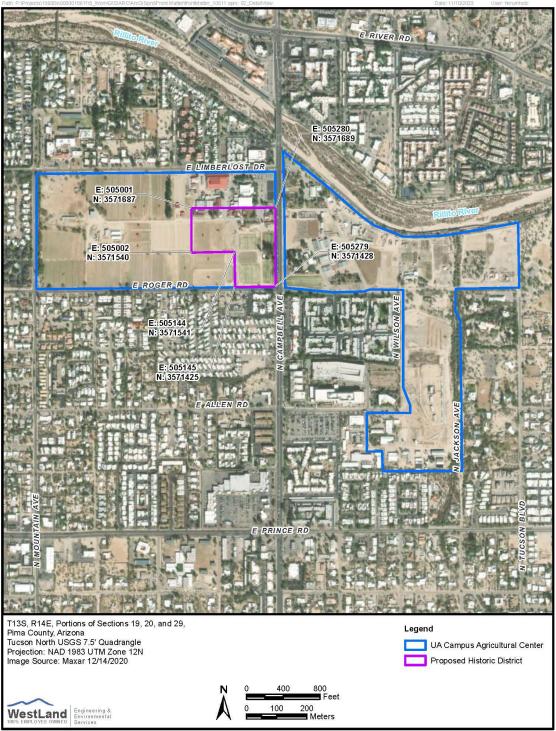
Figure 2. Detail view of the University of Arizona Campus Agricultural Center

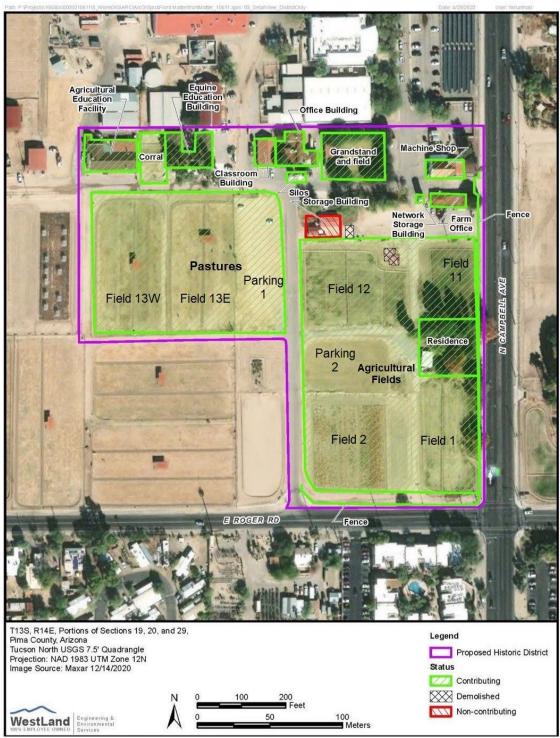
Figure 4. Map showing contributing and non-contributing resources within the CAC Historic District

The portion of the district that meets the requirements of a designed landscape includes the original buildings, the corral, grandstand, and original main entrance road, all located along the northern portion of historic district boundary. The remaining areas are vernacular in design and changed over time to accommodate the research and planning needs of the University. Within the district, 13 properties were found to possess the requisite significance and integrity for listing as contributing resources to the district, and one property was found to not contribute to the district based on its age (**Table 1, Figure 4**).

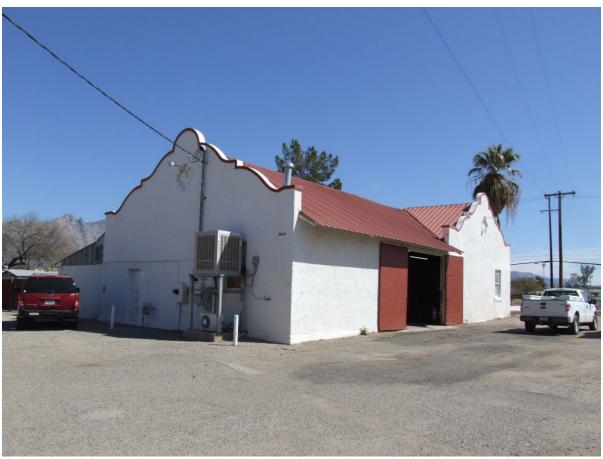
Photograph 9. West and south elevations of the Machine Shop; view facing northeast (AZ Pima County UA Campus Agricultural Center Historic District 0009)

The Machine Shop is a one-story Mission Revival style building with a rectangular footprint constructed of masonry brick walls covered in stucco on a concrete foundation. The walls are topped by a medium pitch cross gable roof constructed of galvanized steel with low overhanging eaves. There is a Mission-style arched parapet with brick coping on the west, north, and south elevations, with stucco quatrefoil details around the attic vents. (**Photograph 9**). The parapet on the Machine Shop differs slightly from the other buildings in that the parapet has been stuccoed over and painted, while others have been left as exposed brick.

The exterior walls are penetrated by the original wood casement and double hung windows and original wood doorways with glass panels. Located on the south elevation is a painted sliding barn door, likely historic. A shed roof addition is located on the north elevation and is constructed of CMU with stucco sheathing and topped with a galvanized steel roof. Additionally, there is a historic concrete water holding tank and water pump located in front of the east elevation (**Photograph 10**).

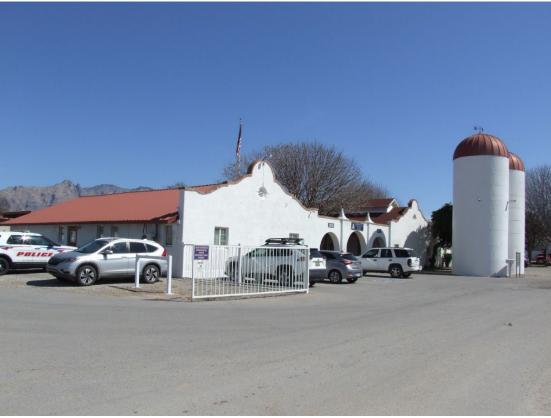
Photograph 18. West and south elevations of the Classroom Building; view facing northeast (AZ Pima County UA Campus Agricultural Center Historic District 0018)

The Classroom Building is a one-story building with a rectangular footprint. The exterior walls are constructed of brick masonry covered in stucco on a poured concrete foundation. The walls are topped by a medium-pitch gable roof with a north-south axis with slightly overhanging eaves, with the roof constructed of galvanized steel over wood frame. There is a Mission-style parapet on the north and south elevations. There are attic vents near the gable ends that are surrounded by decorative stucco quatrefoils. The exterior walls are punctuated with fixed vinyl and steel casement windows along the south, west, and east elevations. The building has original solid wood doors and replacement modern doors with glass panels located on the east, west, and north elevations.

As noted in the previous description for the Office Building, there is a central courtyard between the Classroom Building and the Office Building uniting them into a single composition. A modern fence encloses the courtyard along the north elevation, connecting the Classroom Building and the Office Building, and a steel stairway is located along the north (back) elevation for access to the attic. A former doorway on the south elevation has been filled in (**Photograph 18**).

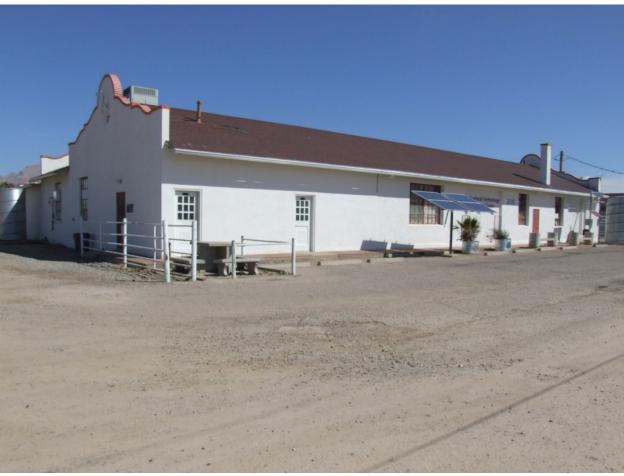
Photograph 21. West and south elevations of Agricultural Education Facility; view facing northeast (AZ Pima County UA Campus Agricultural Center Historic District 0021)

The brick and stucco Agricultural Education Facility is a single-story Mission Revival style building with a rectangular plan. The building is constructed of brick masonry walls covered in stucco that are set on a poured concrete foundation. The building's walls are topped by a medium-pitch asphalt shingle gable roof with shallow overhanging eaves. There is a Mission-style parapet on the east and west elevations, in addition to attic vents near the gable ends that are surrounded by quatrefoils. The chimney is flush with the south elevation (**Photograph 21**).

The building's exterior walls are punctuated by original steel casement windows along all elevations. The building's 1930s-era exterior doors have been replaced with modern steel doors along the south and west elevations. Americans with Disabilities Act (ADA)—compliant ramps are located along the main entryway on the west elevation and are constructed of concrete and brick pavers.

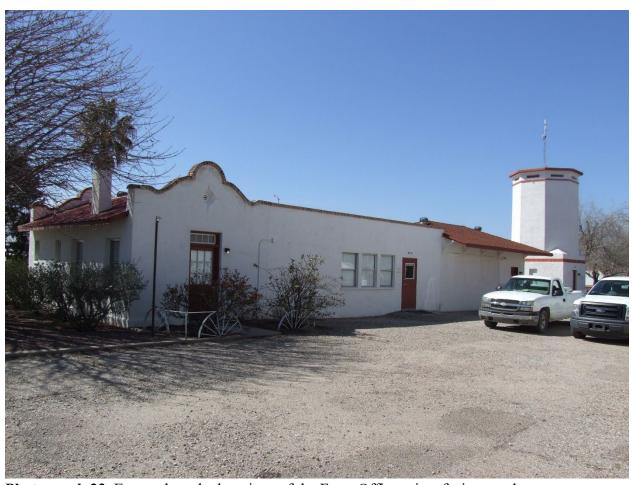
Photograph 23. East and north elevations of the Farm Office; view facing southwest (AZ_Pima County_UA Campus Agricultural Center Historic District_0023)

The exterior walls are pierced by steel casement and double-hung aluminum windows. The doors, except for the main entrance door at the northeast corner of the building, which is topped by a transom window, have been replaced. There is an L-shape addition that extends to the west that is constructed of frame and covered in stucco. Historically the addition in the center of the two ends of the building was built last, with the original farm office on the east, the second building on the west, both free-standing. The center of the building was a later added to connect the two buildings together. The westernmost end/addition is constructed of masonry walls that are covered in stucco with a painted wood veneer on the northwest corner (**Photograph 24**). Historic aerials indicate that the central and western most additions occurred sometime after 1980.

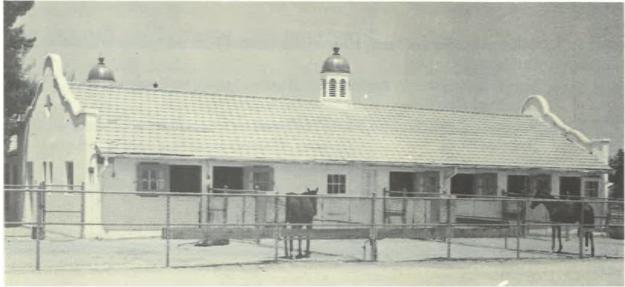
Figure 11. 1982 image of the Equine Barn (now Equine Education Building) and Corral. This was one of several buildings identified as needing updates and repair per the University of Arizona's Comprehensive Master Plan (image courtesy of UA Comprehensive Master Plan July 1982).

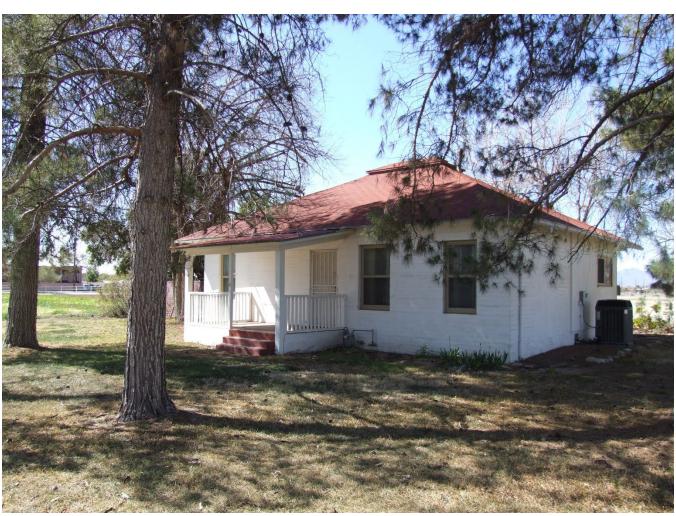
Photograph 1. East and north elevations of the Residence; view facing southwest (UA_Pima County_UA Campus Agricultural Center Historic District 0001).

A single residence is located within the CAC Historic District, on the west side of North Campbell Avenue. The main residence is a one-story American Territorial/National Folk style building with a rectangular footprint. The exterior walls are constructed of board-formed cast-in-place concrete. The original portion of the house has an L-shaped footprint (**Photographs 1–3**). The former porch on the northwest corner was later filled and framed in with wood frame and is covered with painted wood veneer. The walls are topped with an asphalt shingle pyramidal roof with slight overhanging eaves with exposed rafters and a hipped ridge vent at the top (**Photograph 4**). There is a chimney located on the west side. The original wood sliding sash and double hung windows have been replaced with vinyl sliding sash and double hung windows on all elevations.

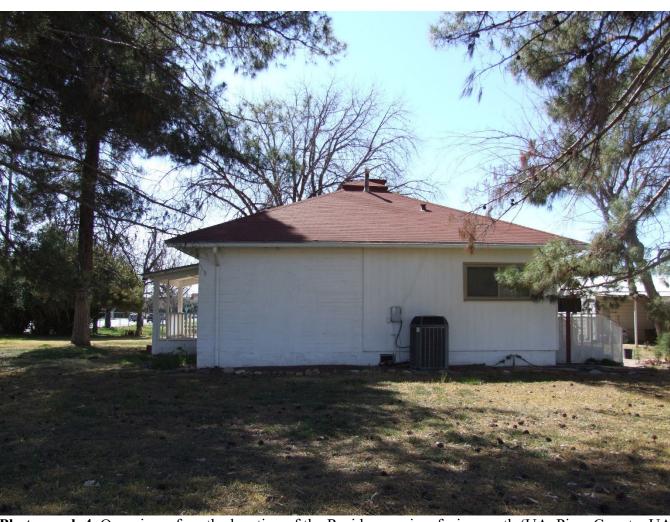
Photograph 4. Overview of north elevation of the Residence; view facing south (UA_Pima County_UA Campus Agricultural Center Historic District_0004).

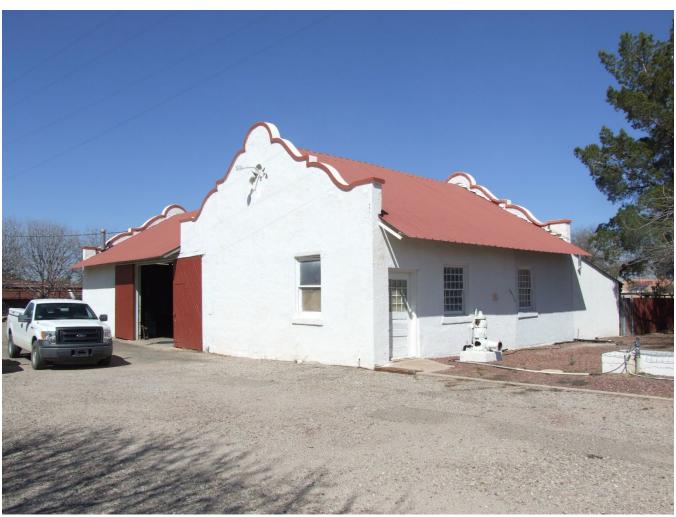
Photograph 10. East and south elevations of the Machine Shop; view facing northwest (AZ_Pima County_UA Campus Agricultural Center Historic District_0010).

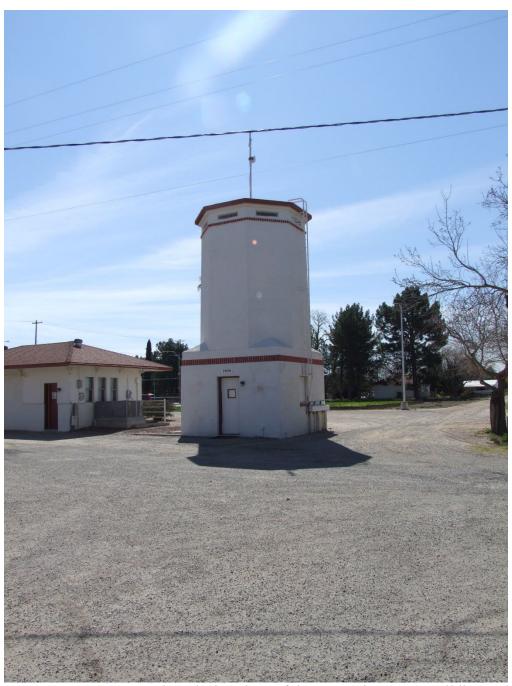
Photograph 11. East and north elevations of the Network Storage Building and Water Tower; view facing southeast (AZ_Pima County_UA Campus Agricultural Center Historic District_0011).

Within the CAC Historic District, Lyman was retained to construct the water tower in 1917 and his contribution is noted in Board of Regents meeting minutes from October 3, 1917, as "water tank for Experimental Farm, University of Arizona, Tucson by the firm of J. B. Lyman, Jr. Architect." Per the drawings cited by University of Arizona Architecture Professor Robert

Giebner, they appear to show the same water tower (now network storage building) as the existing octagonal-over-square tower (Giebner 1992). It is presumed that the original tile roof was either never constructed or was replaced historically by concrete; similarly, it is unknown if the stucco was applied in 1917 or later added in 1935–1936 to match the other buildings on campus. Nonetheless, while the building is not strictly Mission Revival in its design, Lyman clearly took a cue from the design of the 1913 Machine Shed directly adjacent to the Water Tower and created a functional building that corresponded with the design of neighboring architecture.

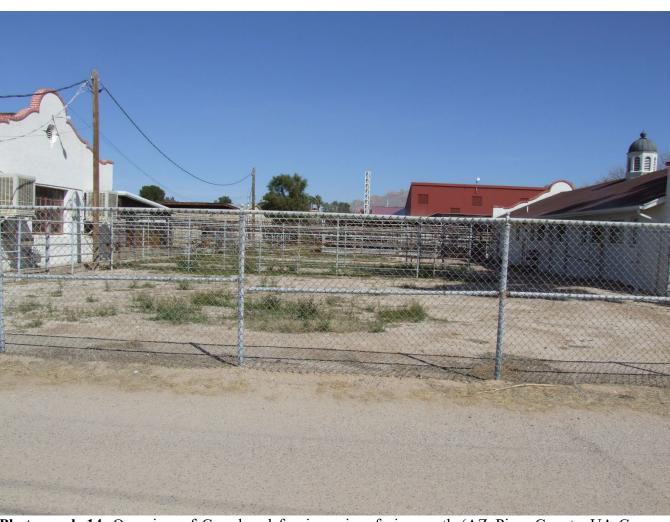
Photograph 14. Overview of Corral and fencing; view facing north (AZ_Pima County_UA Campus Agricultural Center Historic District_0014).

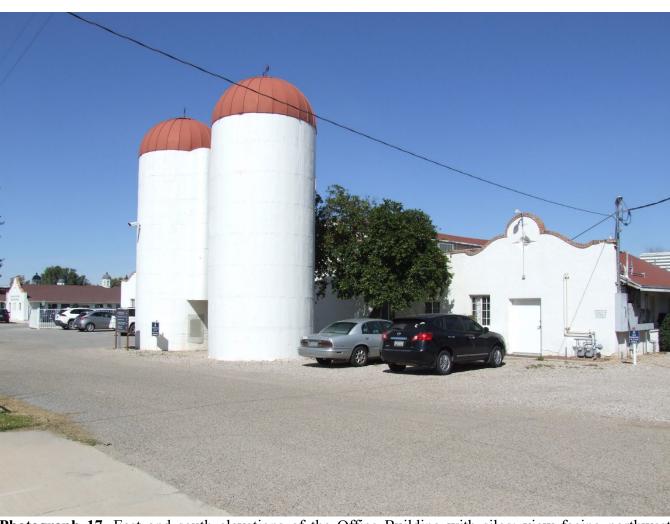
Photograph 17. East and south elevations of the Office Building with silos; view facing northwest (AZ_Pima County_UA Campus Agricultural Center Historic District_0017).

Two paired silos situated immediately south of the Classroom Building and the Office Building are approximately 41 feet tall, with poured concrete walls sheathed in a thin plaster whitewash set on a concrete apron foundation. Both silos are capped with galvanized standing seam domed roofs with a "U of A" weathervane on top. Both have enclosed stairwells facing each other between the silos, on the east and west elevations. An air vent is located near the base of the silos (**Photograph 15**).

The Office Building, also known as the former Dairy Barn, is a one-story building with a rectangular footprint. Its exterior walls are constructed of brick masonry and are sheathed in stucco resting on a poured concrete foundation. The walls are topped by a medium-pitch asphalt shingle gable roof with a north/south axis, with shallow overhanging eaves. A large monitor runs the length of the roof and once served as ventilation inside the Dairy Barn. There is a Mission-style arched parapet on the north and south elevations with brick coping and quatrefoils around the attic vents. The walls are punctuated with aluminum and vinyl sliding sash windows with ornamental grilles that replaced the original steel casements. The building also has a mix of original solid wood doors and modern doors with glass panels (**Photograph 16**).

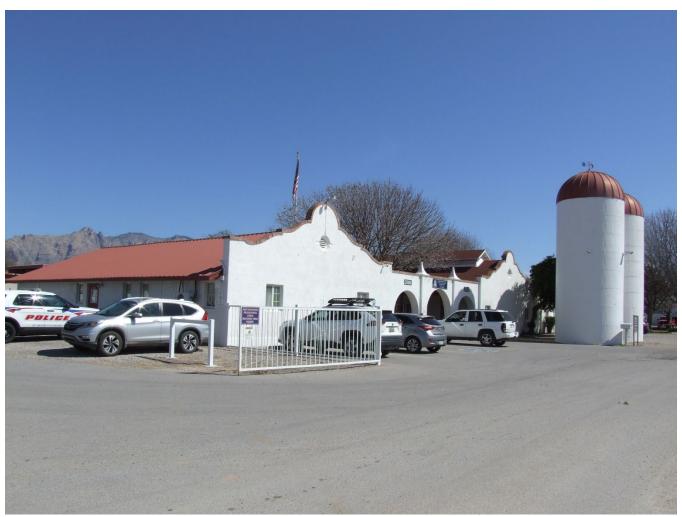
Photograph 18. West and south elevations of the Classroom Building; view facing northeast (AZ Pima County_UA Campus Agricultural Center Historic District_0018).

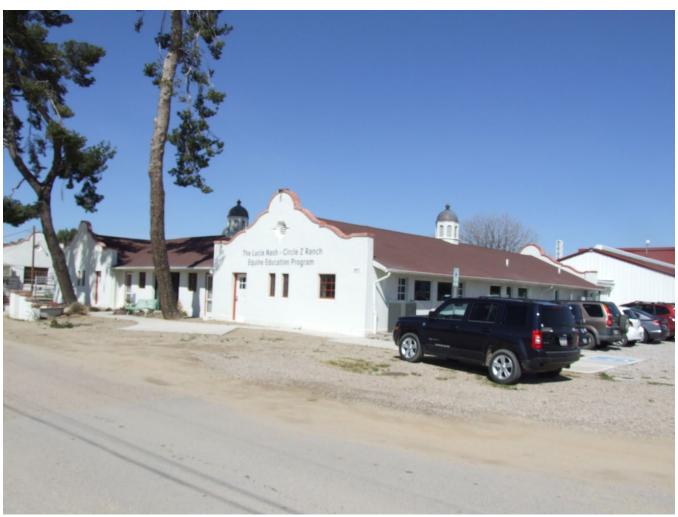
Photograph 19. East and south elevations of the Equine Education Building; view facing northwest (AZ_Pima County_UA Campus Agricultural Center Historic District_0019).

The Equine Education Building, formerly known as the Horse/Equine Barn, is a one-story building with a U-shaped footprint. The exterior walls are constructed of brick masonry and are covered in stucco on a poured concrete foundation. The walls are topped by a medium pitch gable and cross-gable roof with asphalt shingles and shallow overhanging eaves. There is a Mission-style parapet on the north and south elevations with quatrefoils surrounding attic vents on the gable ends. Two decorative copulas with copper domes are located in the center of the east gable and the middle cross gable portions of the roof (**Photograph 19**).

Fenestrations include vinyl windows and modern doors. The east and west wings previously had Dutch door openings for each of the horse stalls, but all of these have been filled in and the windows have been replaced. There is a metal fence connecting the east and west wings, creating an open space/courtyard between each wing (**Photograph 20**). More recently the building was rehabilitated from a stable to a classroom and office space.

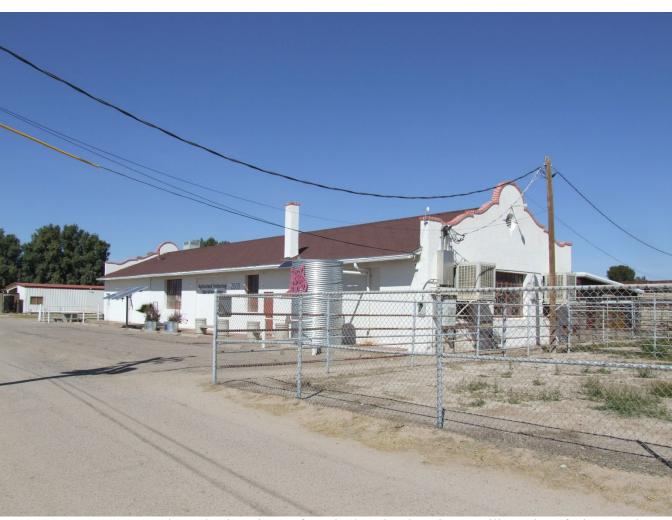
Photograph 22. East and south elevations of Agricultural Education Facility; view facing northwest (AZ_Pima County_UA Campus Agricultural Center Historic District_0022).

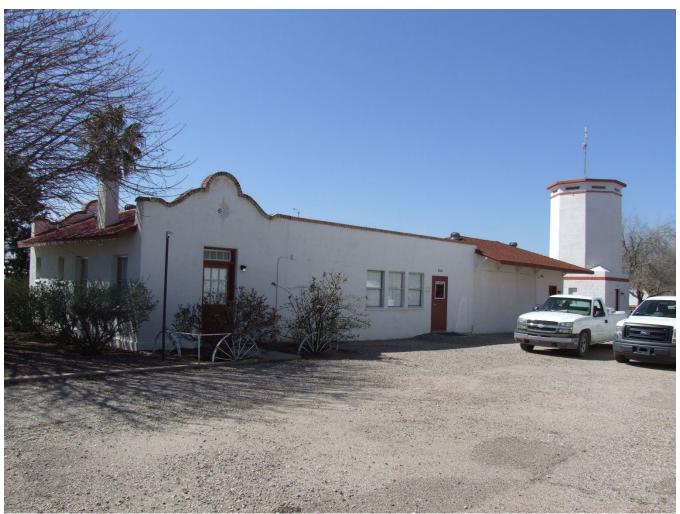
Photograph 23. East and north elevations of the Farm Office; view facing southwest (AZ_Pima County_UA Campus Agricultural Center Historic District_0023).

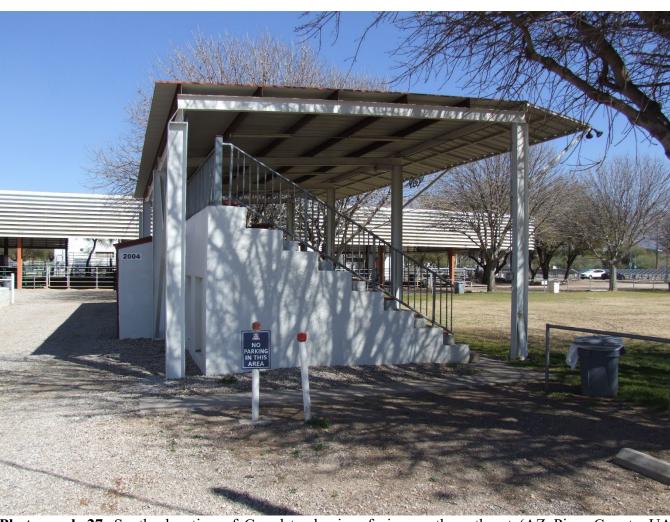
Photograph 27. South elevation of Grandstand; view facing north-northeast (AZ_Pima County_UA Campus Agricultural Center Historic District_0027).

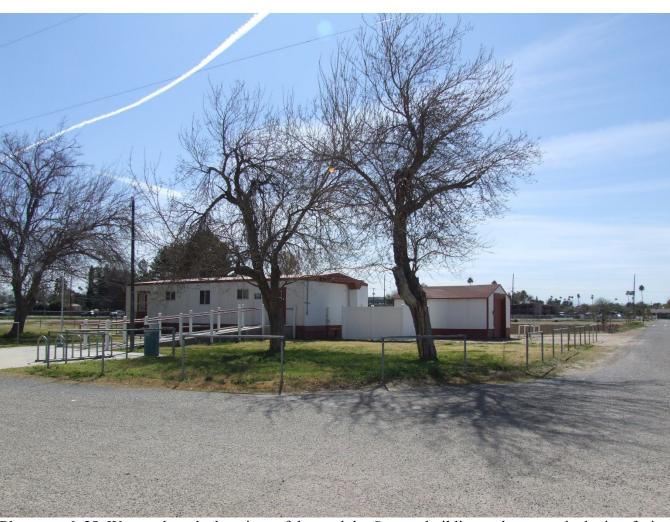
Photograph 28. West and north elevations of the modular Storage building and storage shed; view facing southeast (UA Pima County UA Campus Agricultural Center Historic District 028).
